**Program Latihan Penguatkuasaan Untuk  
Pegawai JPS Bagi Pelaksanaan Perintah  
Kualiti Alam Sekeliling (Perwakilan Kuasa  
- Penyiasatan Ke Atas Kawalan Hakisan  
Dan Kelodakan)**

# BMPs INSPECTION

THE GOOD , THE BAD AND THE BMPs  
OPTION AND SELECTION

**Cad. Skim Perumahan 195 Unit Rumah Di Atas Lot  
30086 dan Lot 30087, Mukim Setapak, Kuala Lumpur  
oleh SUNWAY MELAWATI SDN BHD**

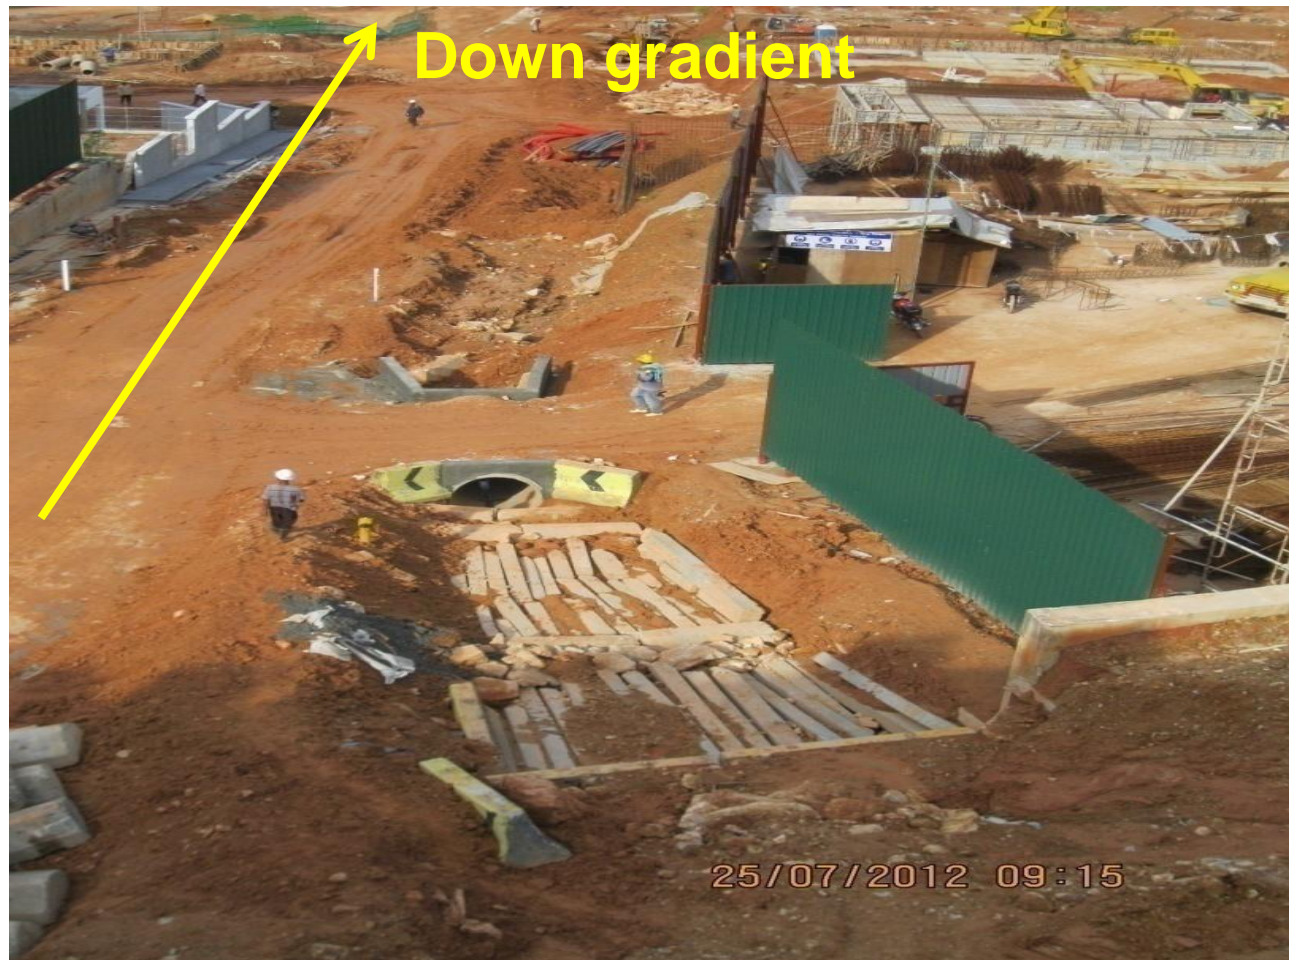
# Active Construction Road 1 (5-8 % gradient)

- ◆ Actives construction roads preferably must implement stabilization with gravels or crusher run.
- ◆ Wherever required, maximize the use of rolling dip, broad-based dip and water bar BMPs along the sloping or grades access to break and divert the potential runoff erosive flow, volume and direction.
- ◆ Establishing the road ditch is among the best method to control sediment-laden runoff. Construction of slot checks along the ditch may settle the sediment. Channel lined (riprap) with suitable stone sizes and mixtures with respect to runoff flow rate may reduce runoff velocity to weaken the erosive flow and promote settling capability.
- ◆ Method of grading by establishing in-slope and out-slope will naturally construct earth drain.
- ◆ Construction of earth bank along the critical side slope of the alignment may help to prevent runoff running onto the slope.

◆ EIA-4-08

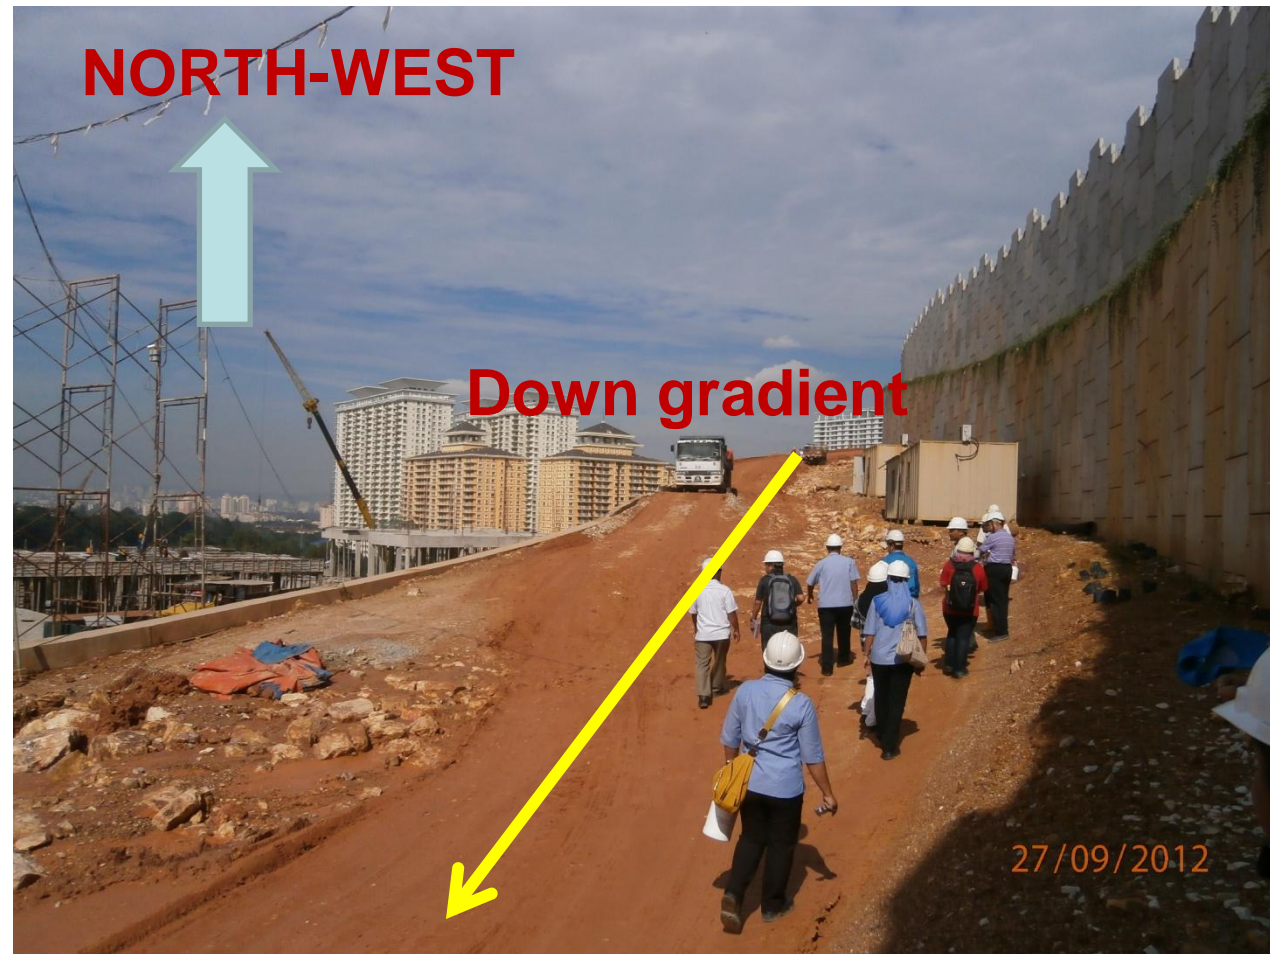
# Active Construction Road 2 (5-10 % gradient)

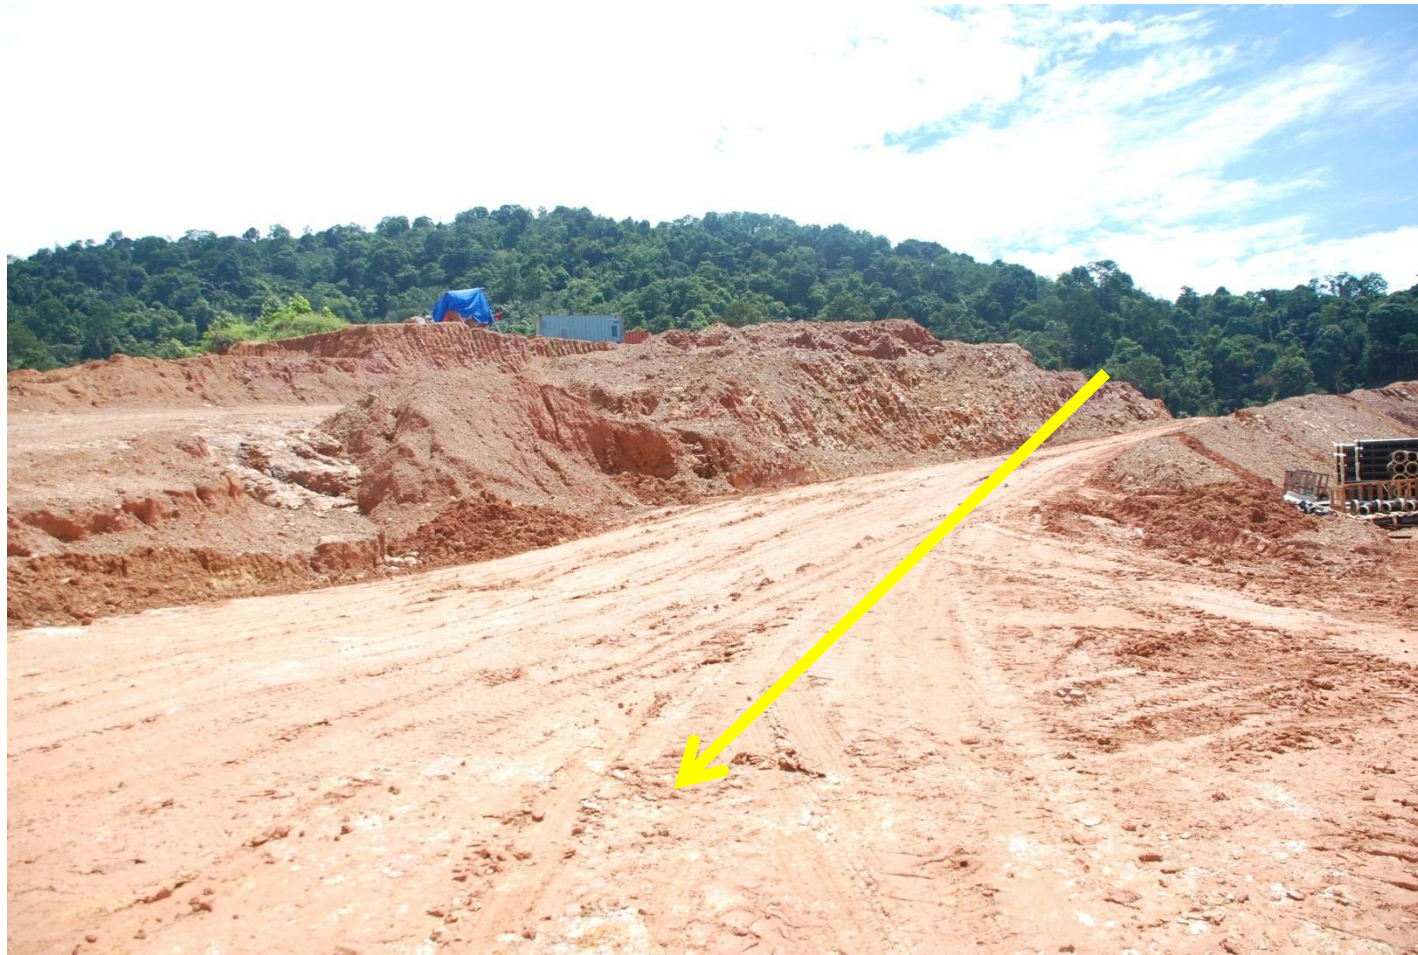
# Active Construction Road 2 (5-10 % gradient) green northern boundary

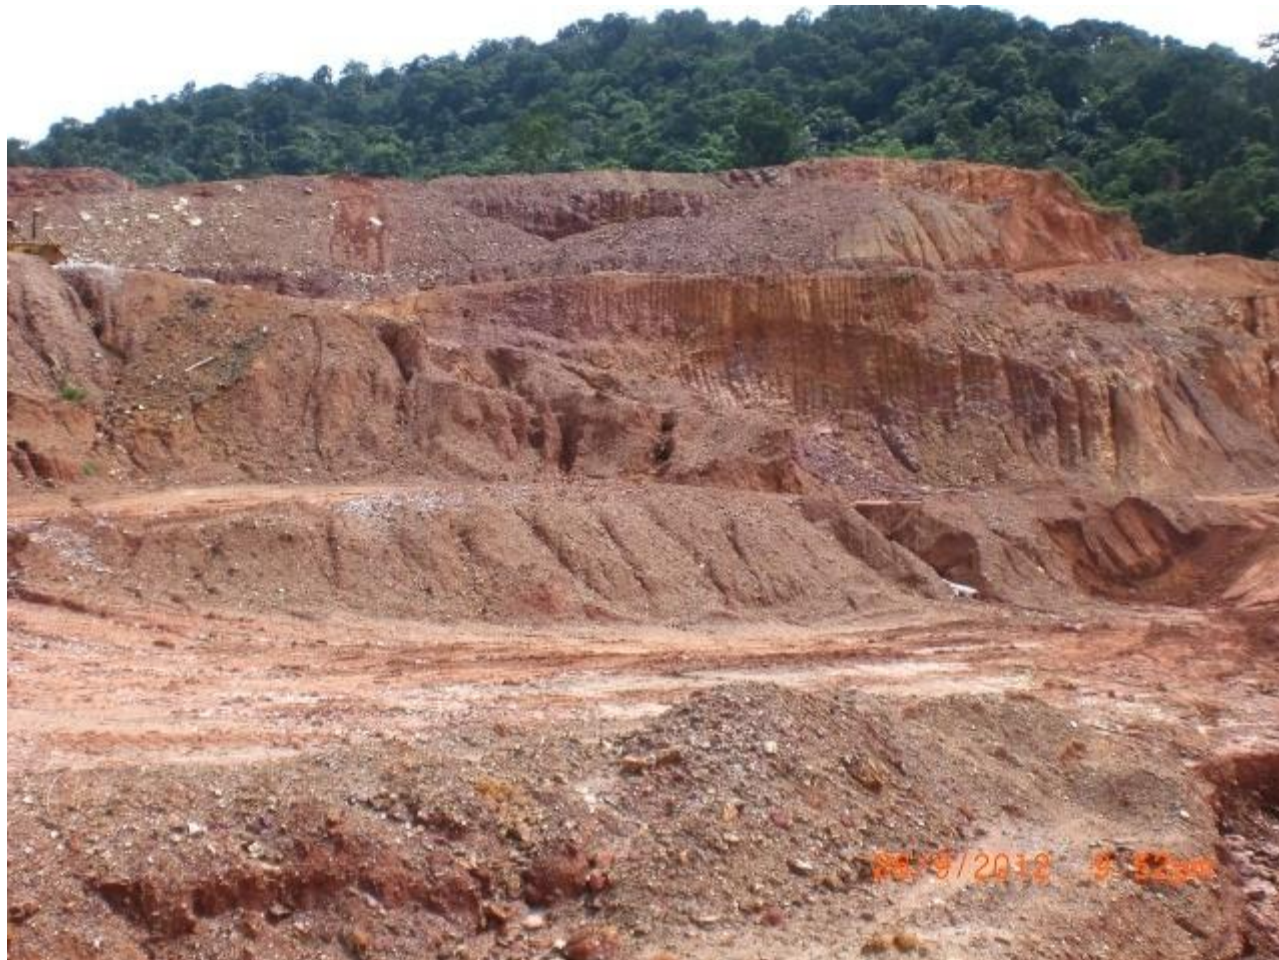
## Slopes were not protected

- ◆ Cut and fill skills of slopes plays an important role in reducing the potential erosion problem. To complete certain cut/fill slope may take month, so method used such as terraces, benches and rounding the edge of the unfinished cutting of the most upslope shall reduce the vulnerability of the slope surface.
- ◆ Application of runoff BMPs such as temporary earth, interceptor, toe, cut-off and berms drains is mandatory in dealing with slopes formation process. Incomplete slopes formation that left exposed of more than 2 weeks shall be temporarily covered.

- ◆ EIA 4-08
- ◆ Notice S31

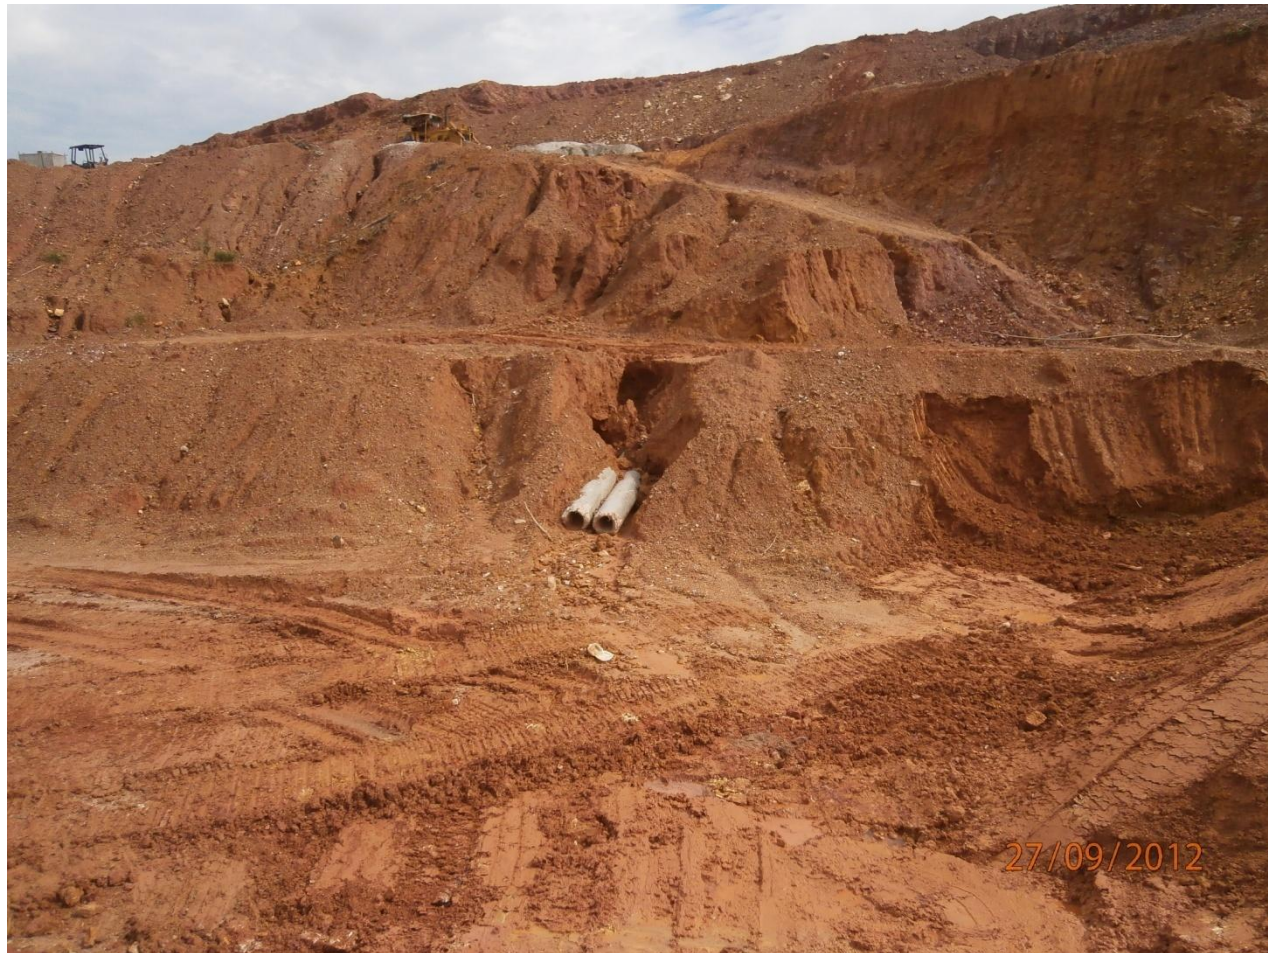
# Unprotected

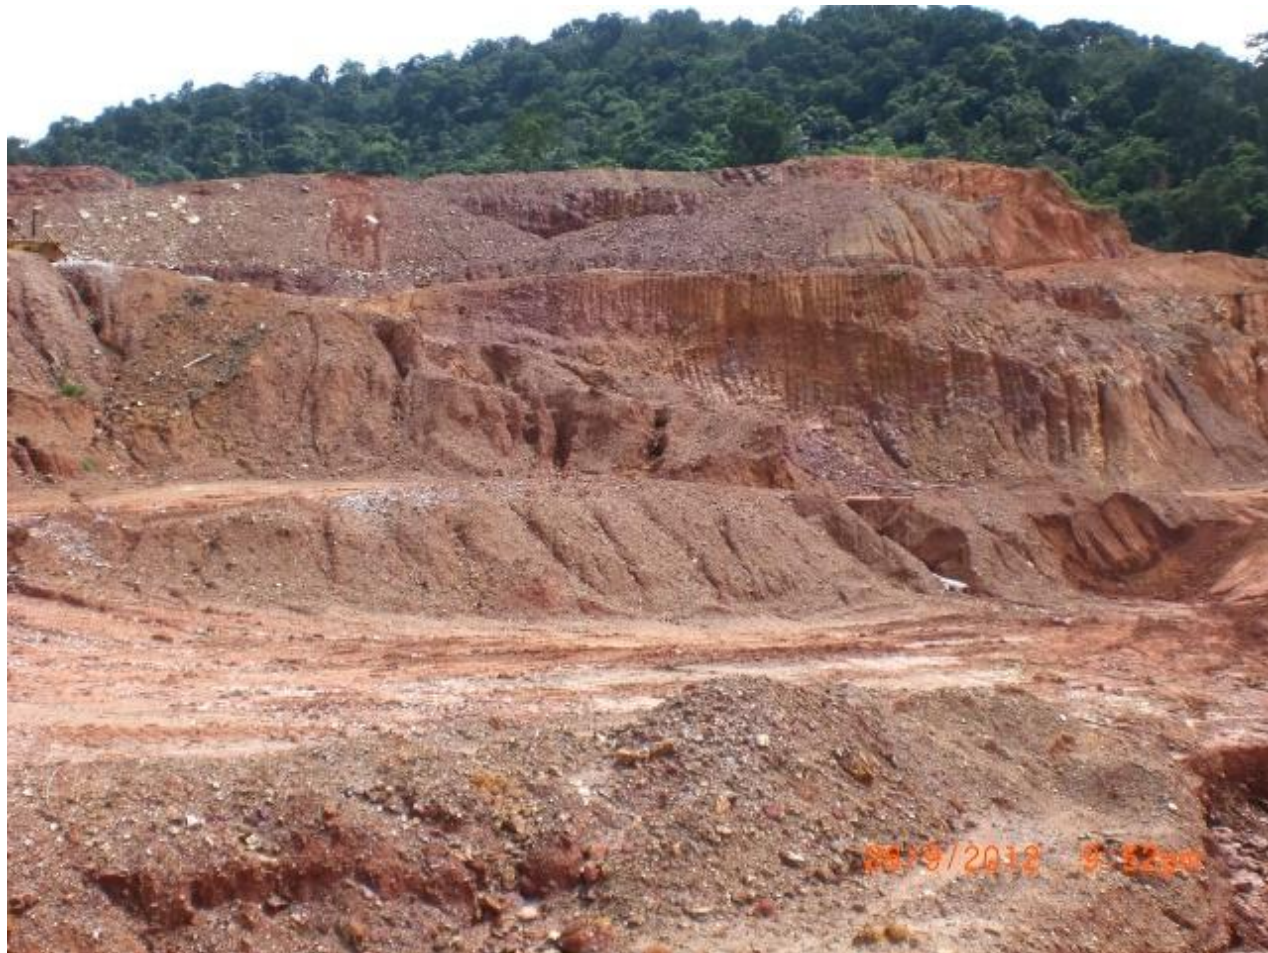
## Gullies not likely to form maybe due to hard soil surface properties

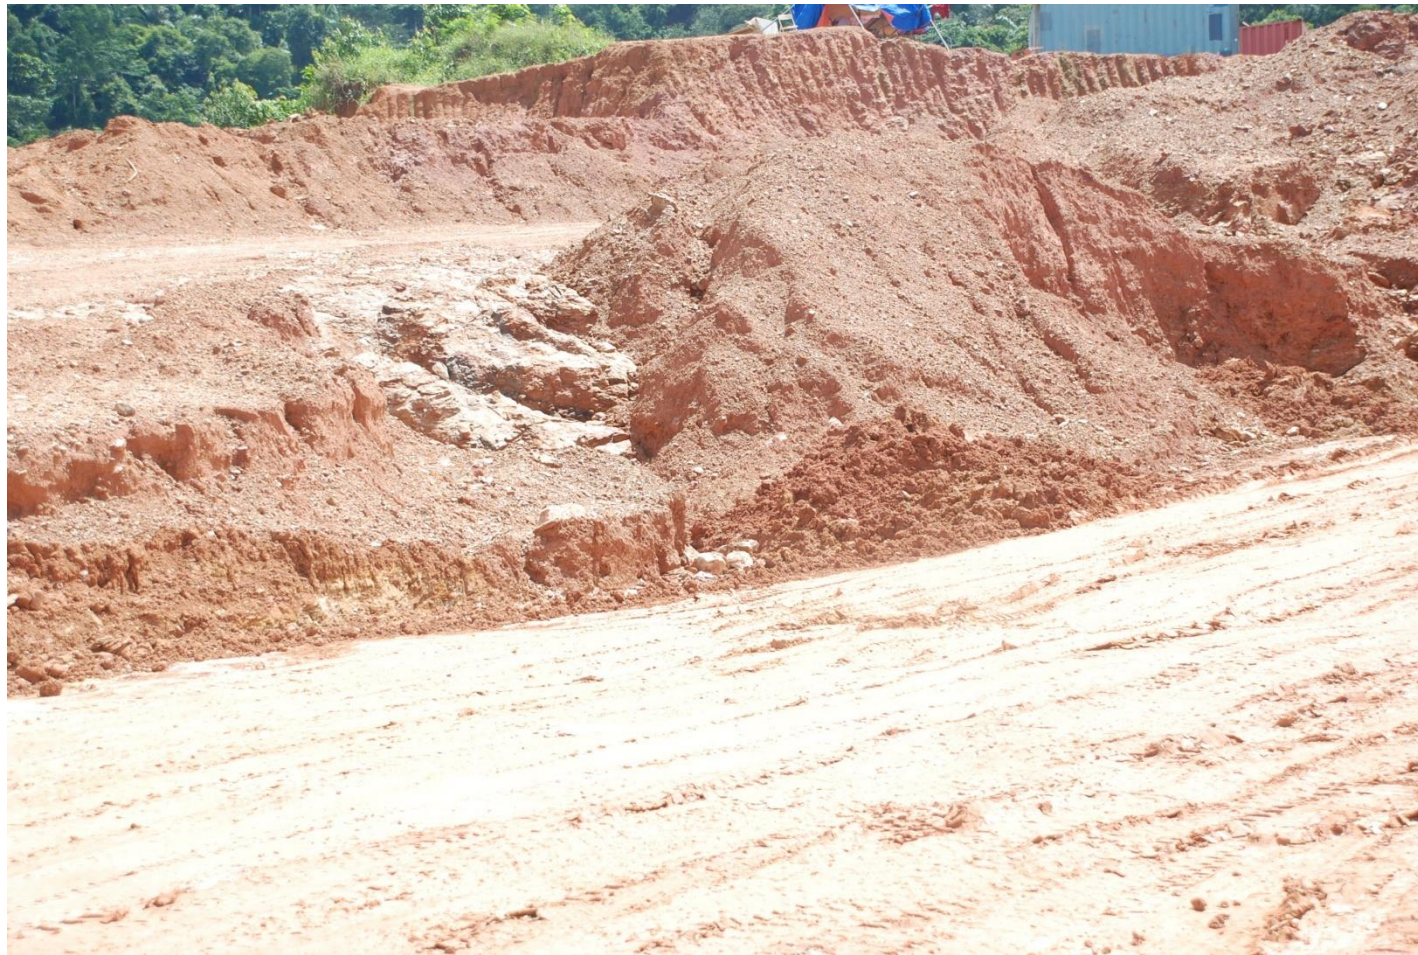
# Almost all of the active construction area left unprotected

- ◆ Not a single effort to temporarily cover with seeding or hydroseed seen around this project area particularly active or changing site elevation and condition.

- ◆ EIA 4-08
- ◆ Notice S31

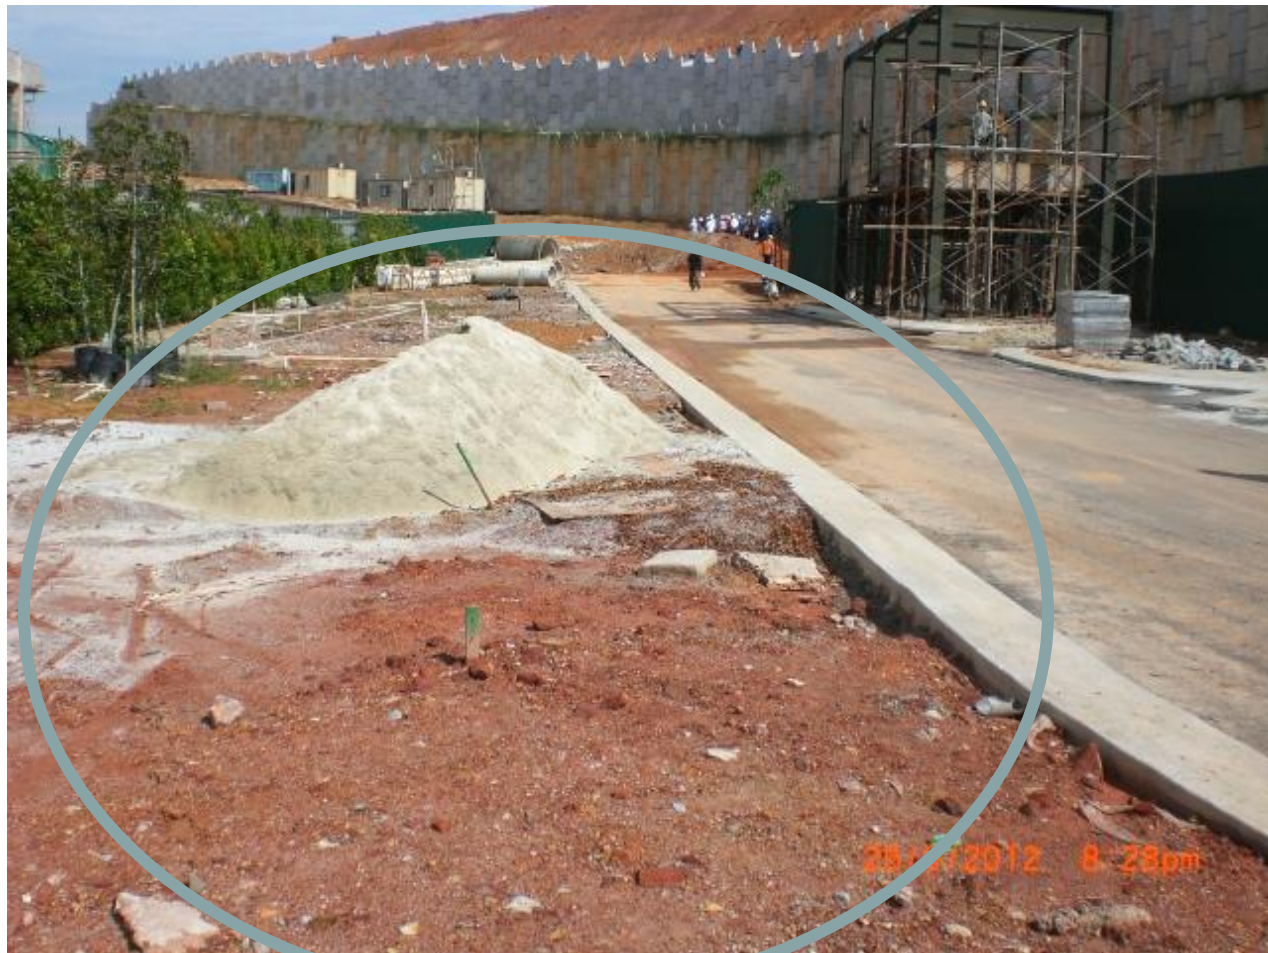
## Even awaiting for landscapes work to commence, shall be temporary covered

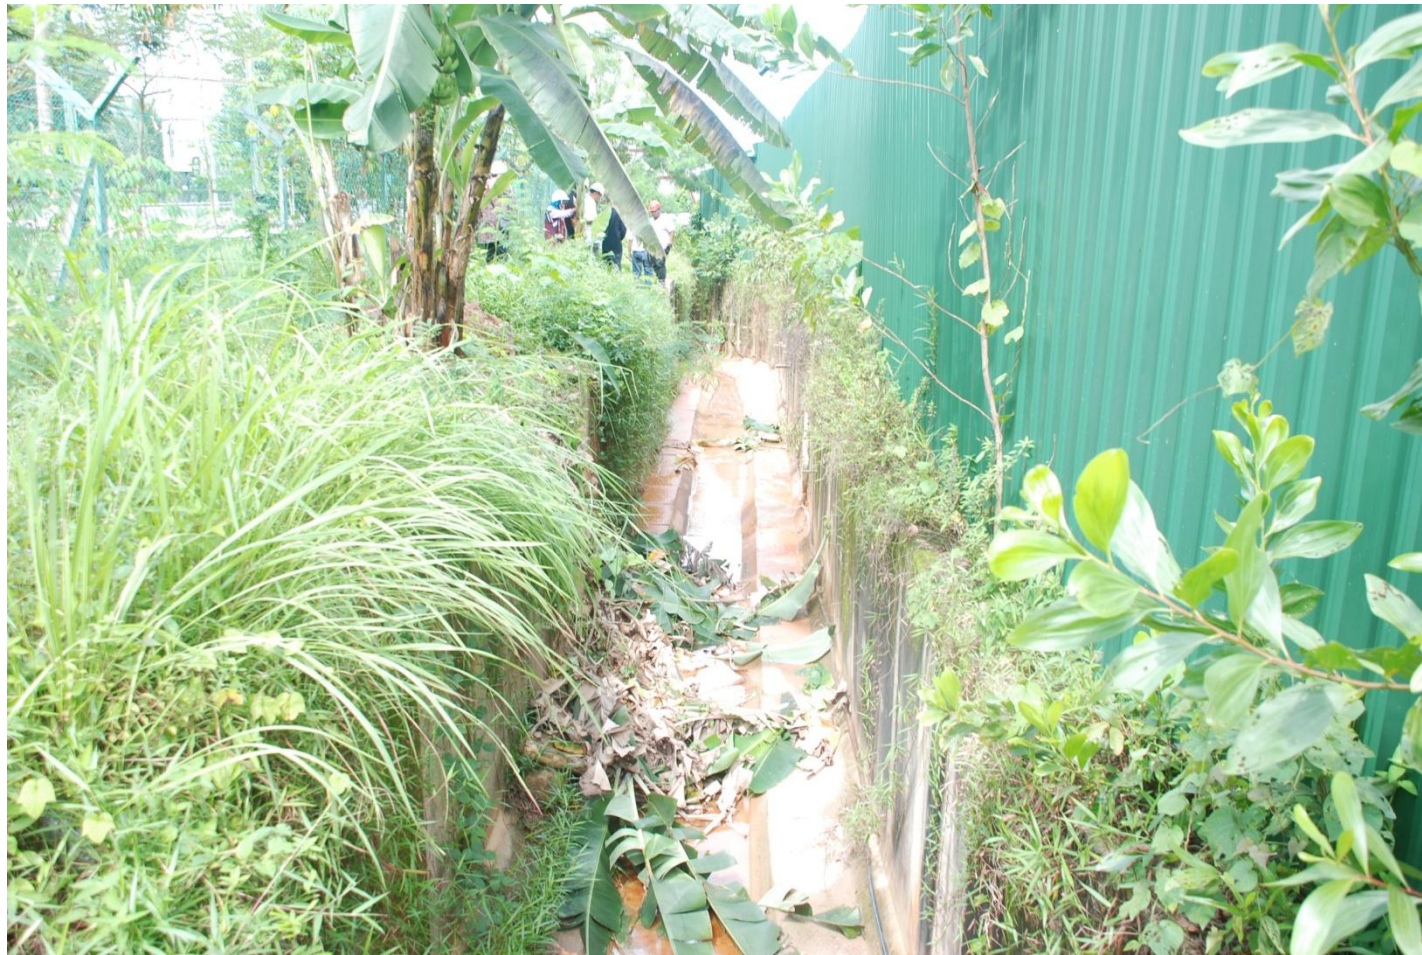
# Public neighbourhood drain

- ◆ Obviously this site is not complying as evidence of silts deposited not far from discharge point.
- ◆ Indicator.

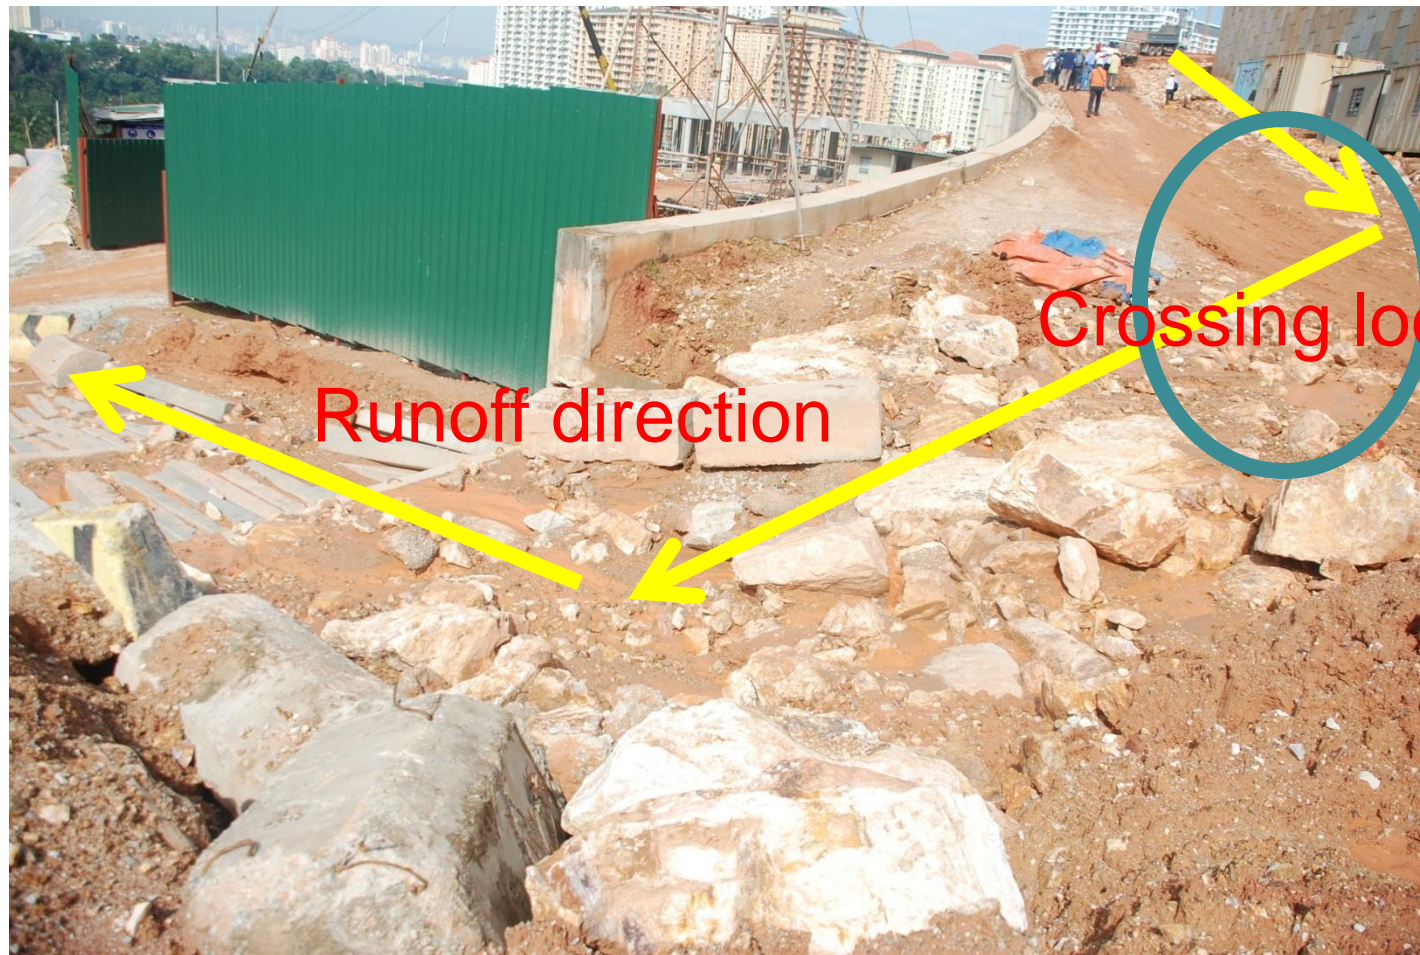
# Free runoff flow practice shouldn't be allowed for any reason

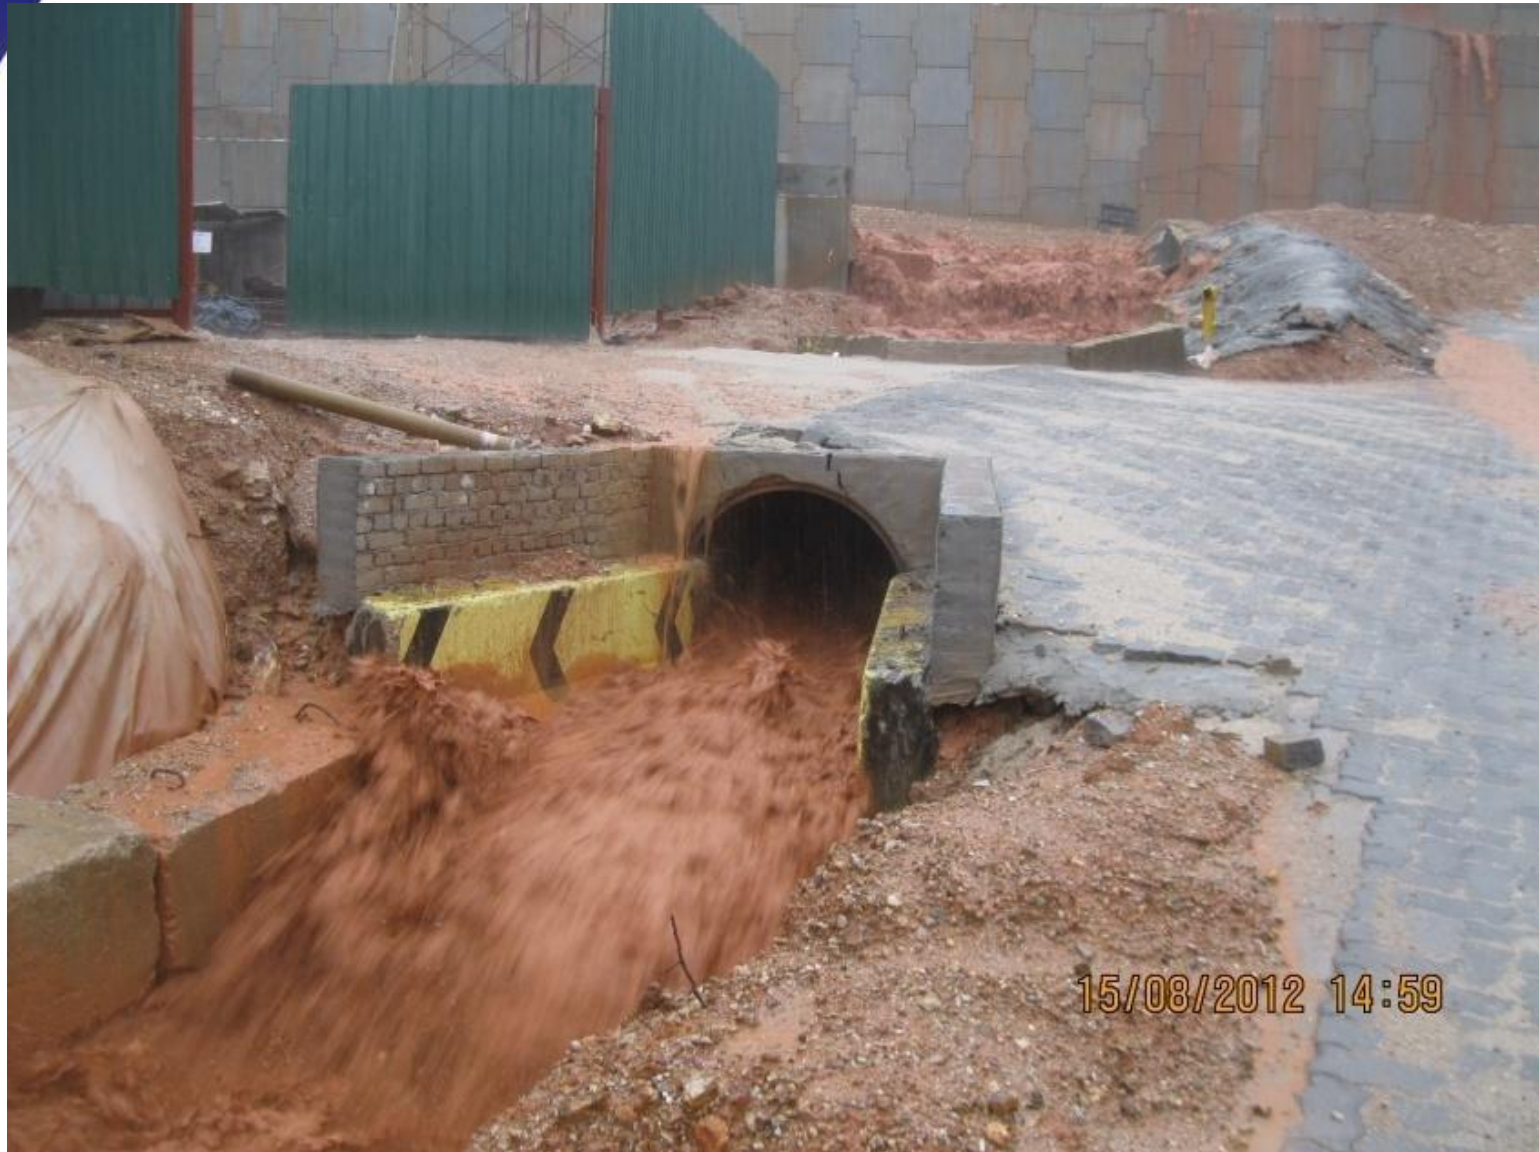
# Undermining

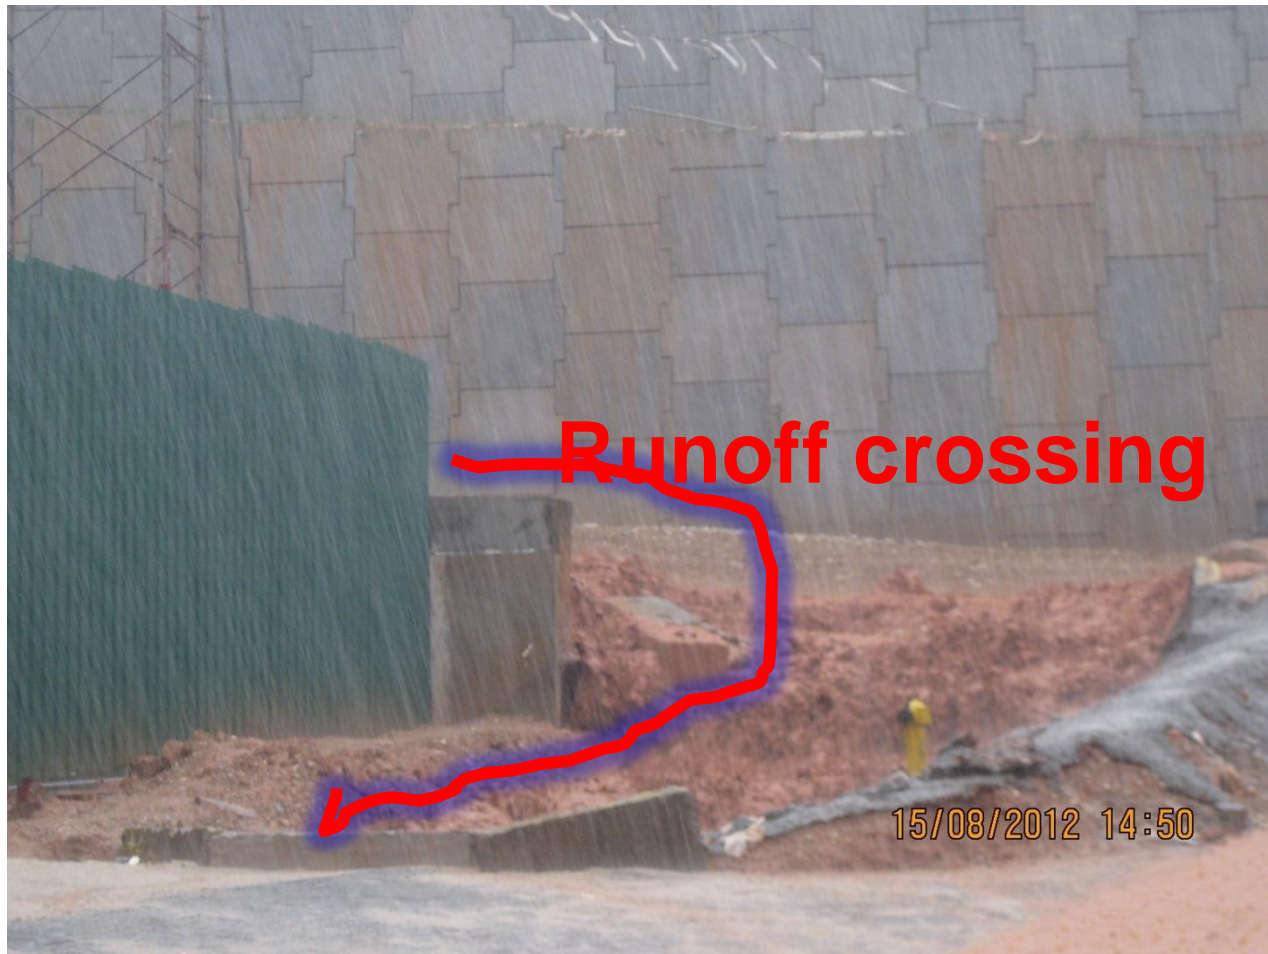
# Access road Crossing

# Another internal road crossing needs to install/construct Culvert or Broad-based dip BMPs

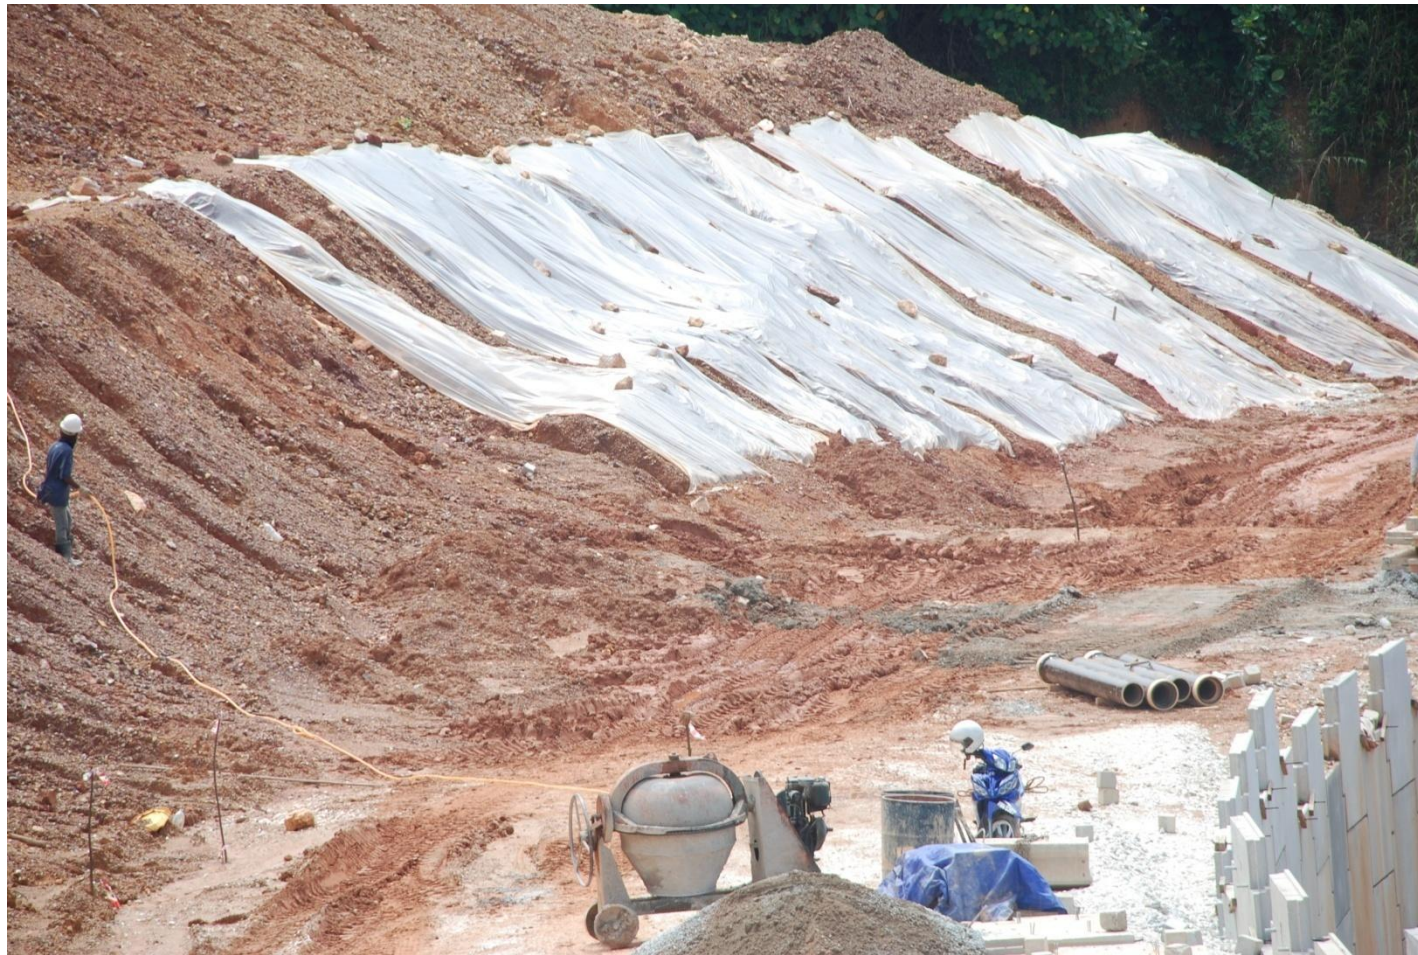
## Parcel 2: The only slope temporarily covered with low quality plastic sheet

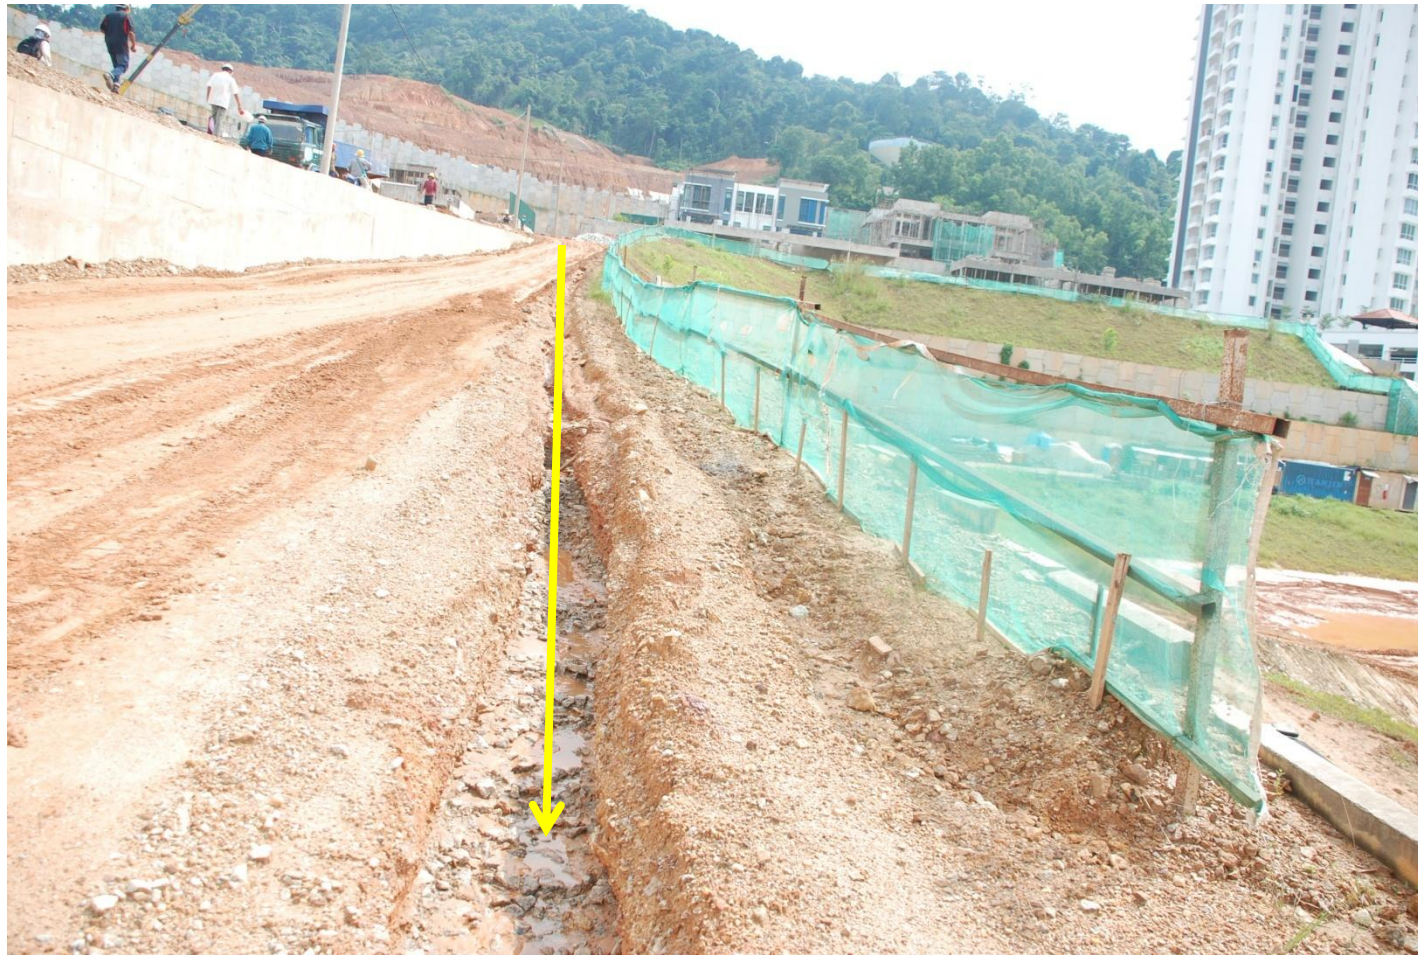
## Parcel 1: Earth drain (Access Rd 1)

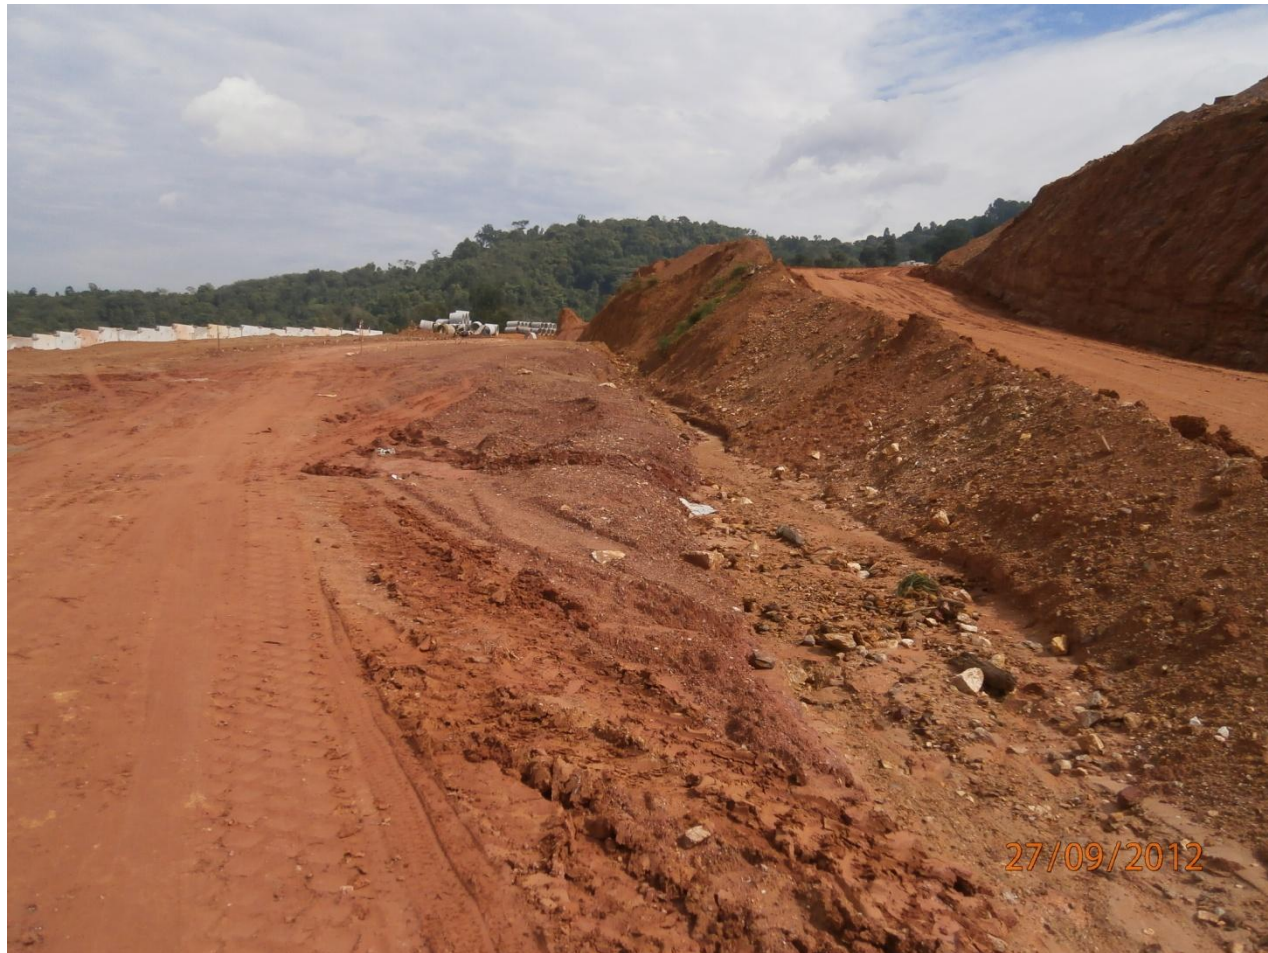
## Parcel 2: Earth drain

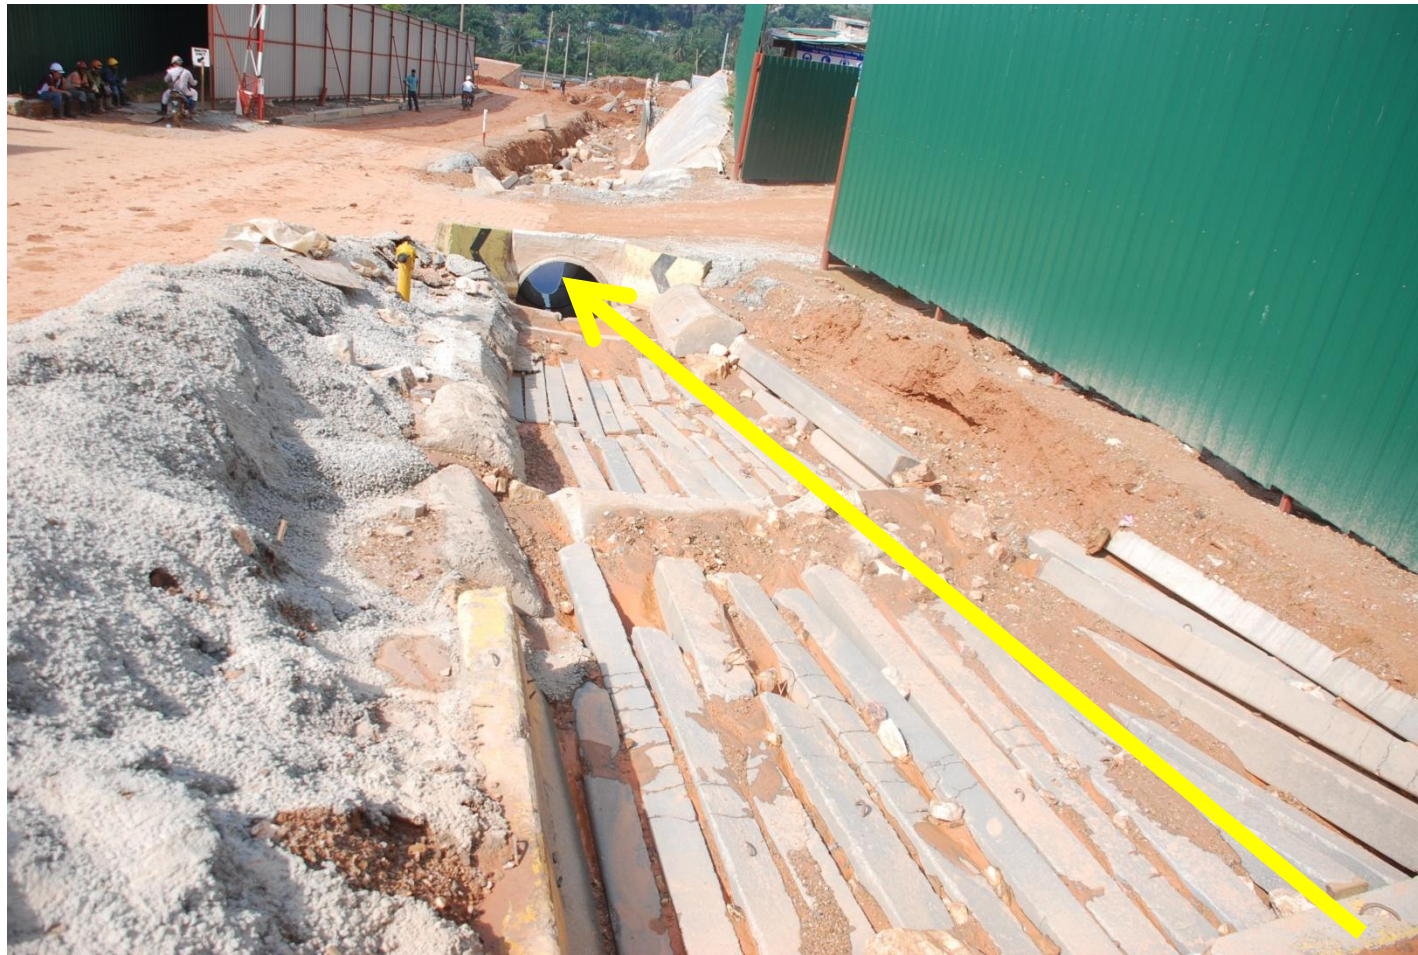
## Drains through culvert crossing (lined with concrete piles)

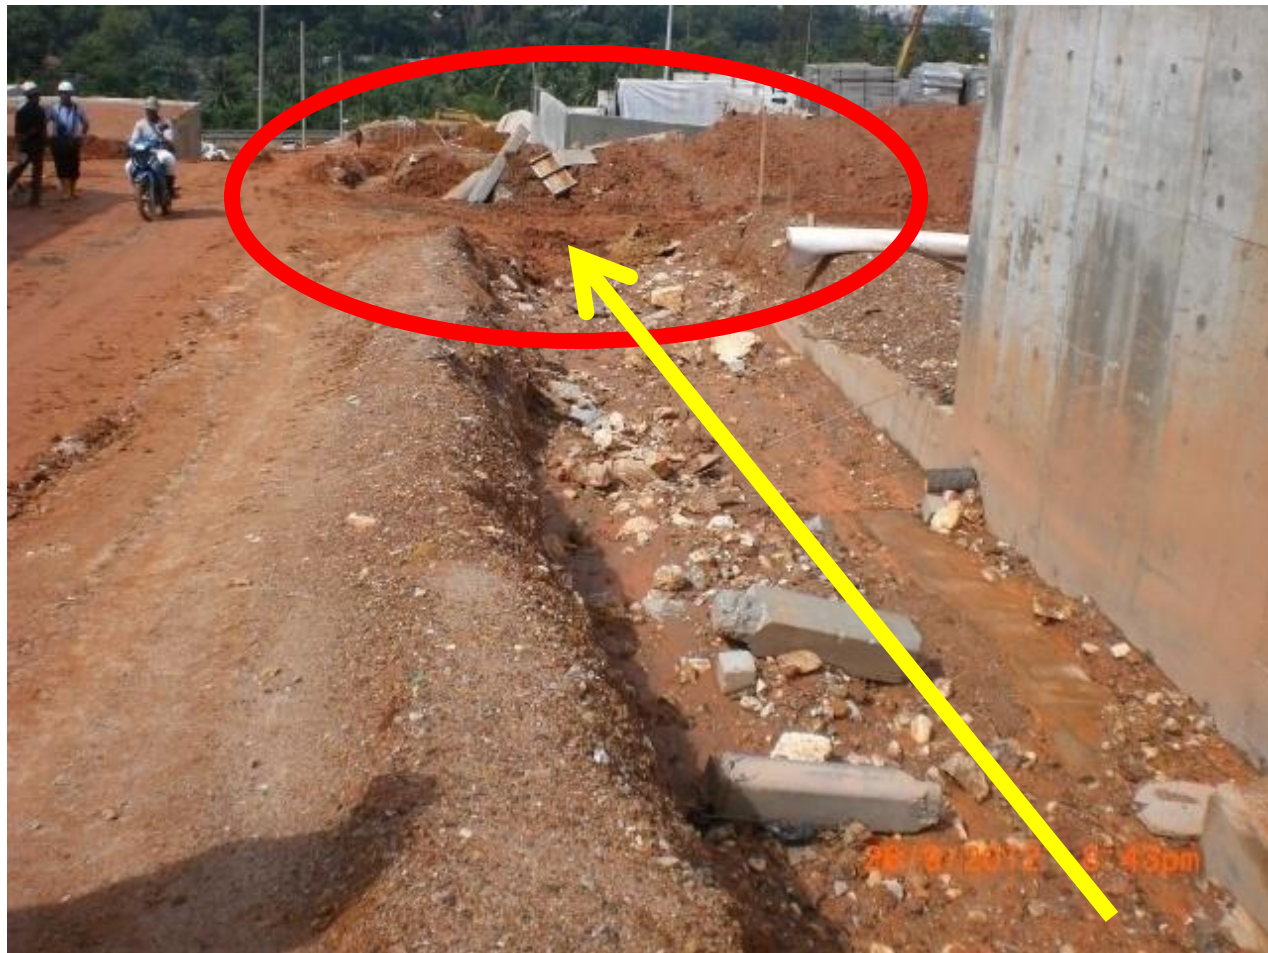
# Expected wash away material downstream during high flow. Another construction road crossing
