**Program Latihan Penguatkuasaan Untuk  
Pegawai JPS Bagi Pelaksanaan Perintah  
Kualiti Alam Sekeliling (Perwakilan Kuasa  
- Penyiasatan Ke Atas Kawalan Hakisan  
Dan Kelodakan)**

# BMPs INSPECTION

THE GOOD , THE BAD AND THE BMPs  
OPTION AND SELECTION

**Cad. Skim Perumahan 195 Unit Rumah Di Atas Lot  
30086 dan Lot 30087, Mukim Setapak, Kuala Lumpur  
oleh SUNWAY MELAWATI SDN BHD**

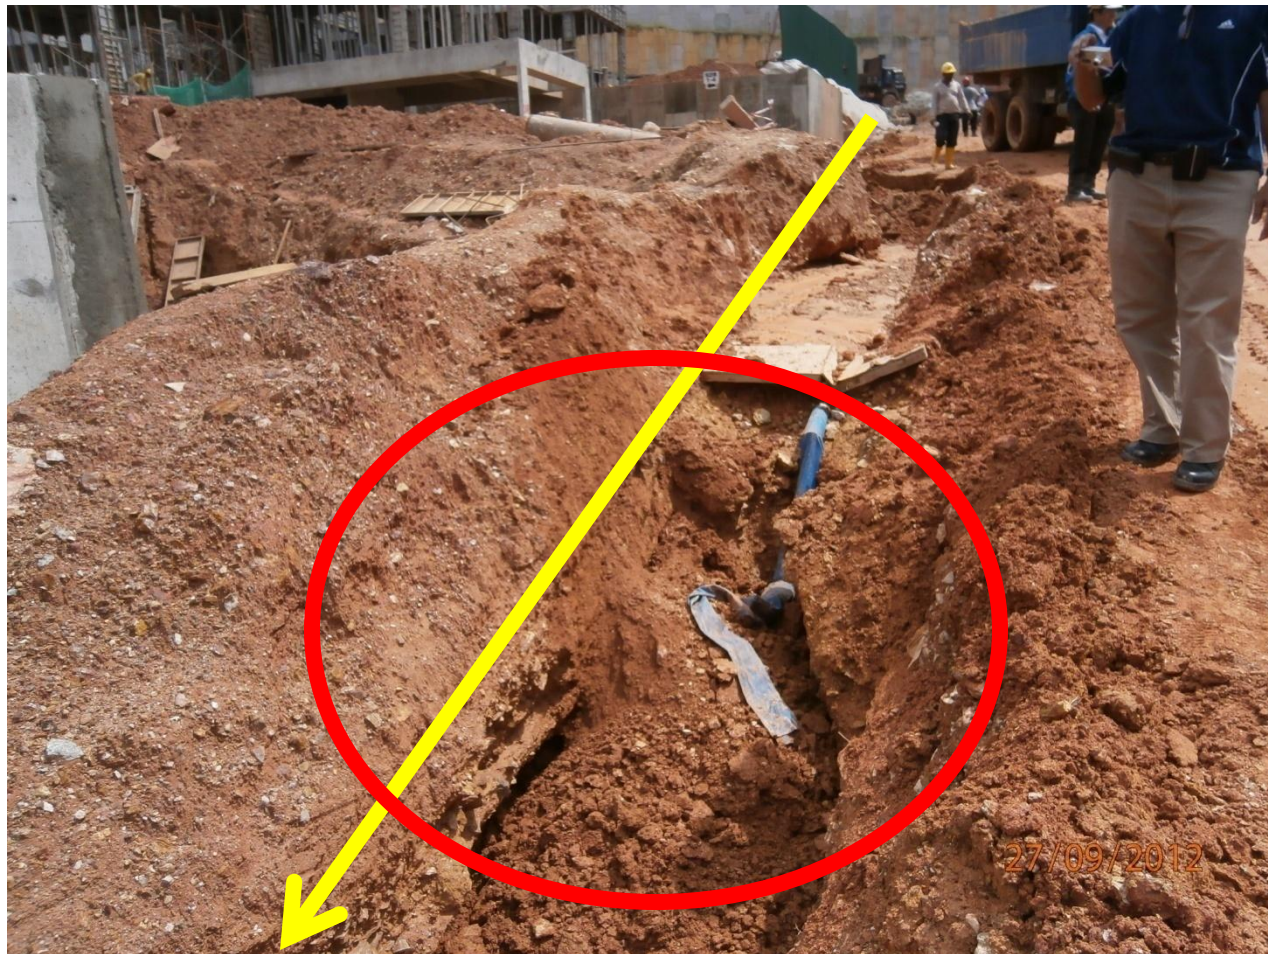
# Runoff turned erosive with increase gradient and starts to undercut channel bed.

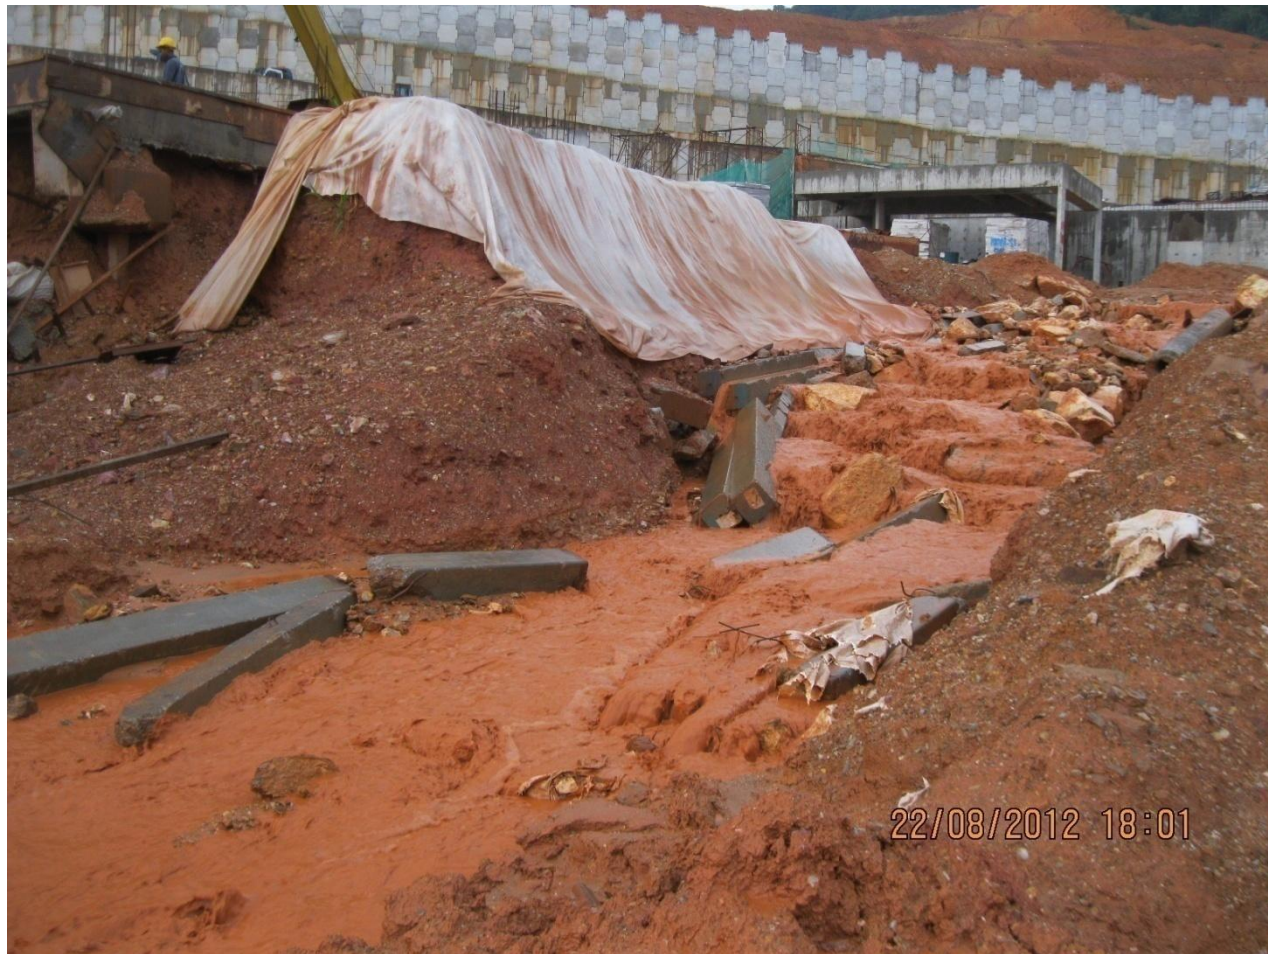
## Observe wash away concrete piles

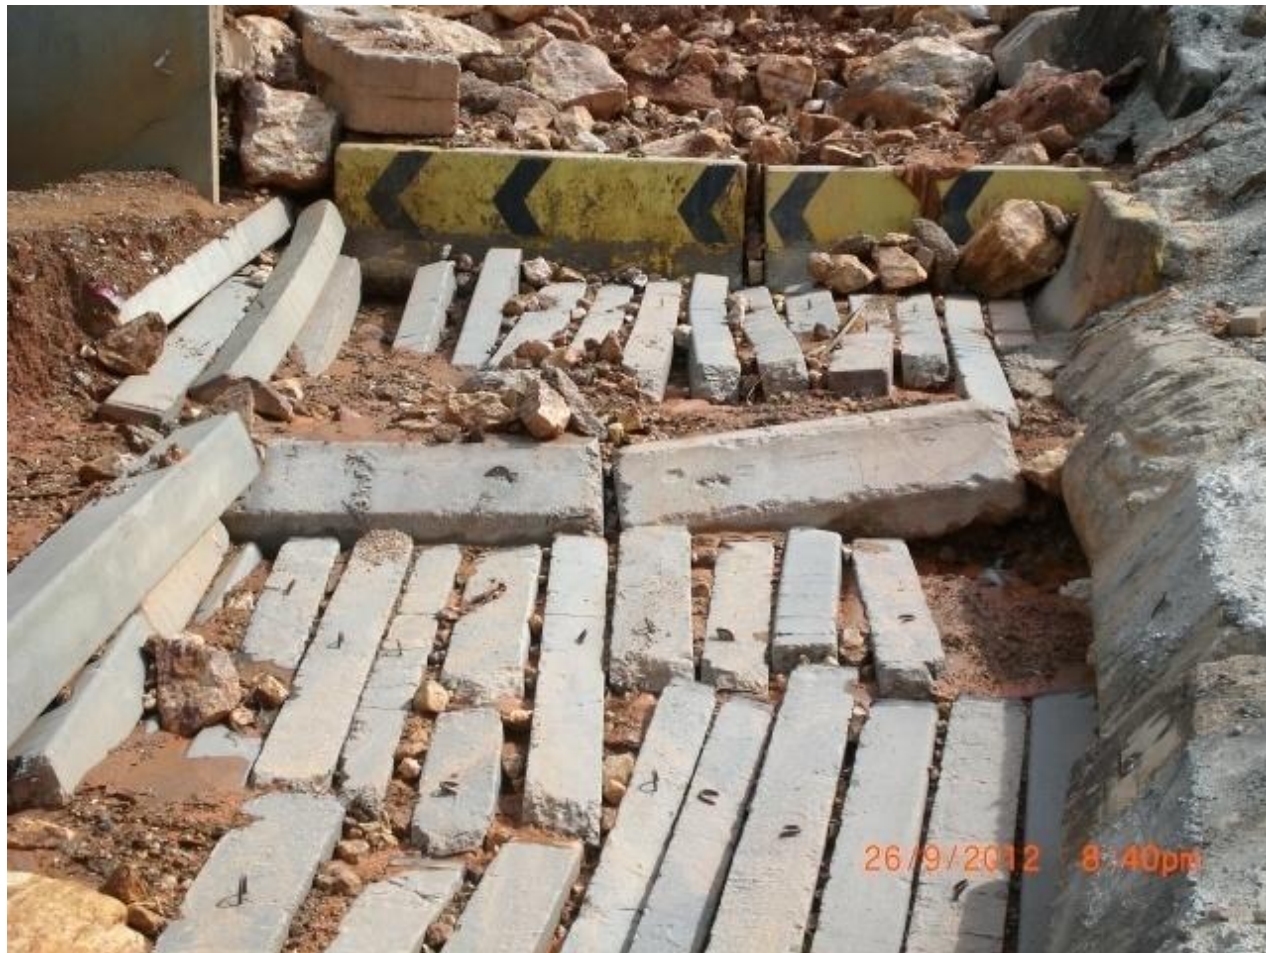
# IMPROPER CHECK DAM

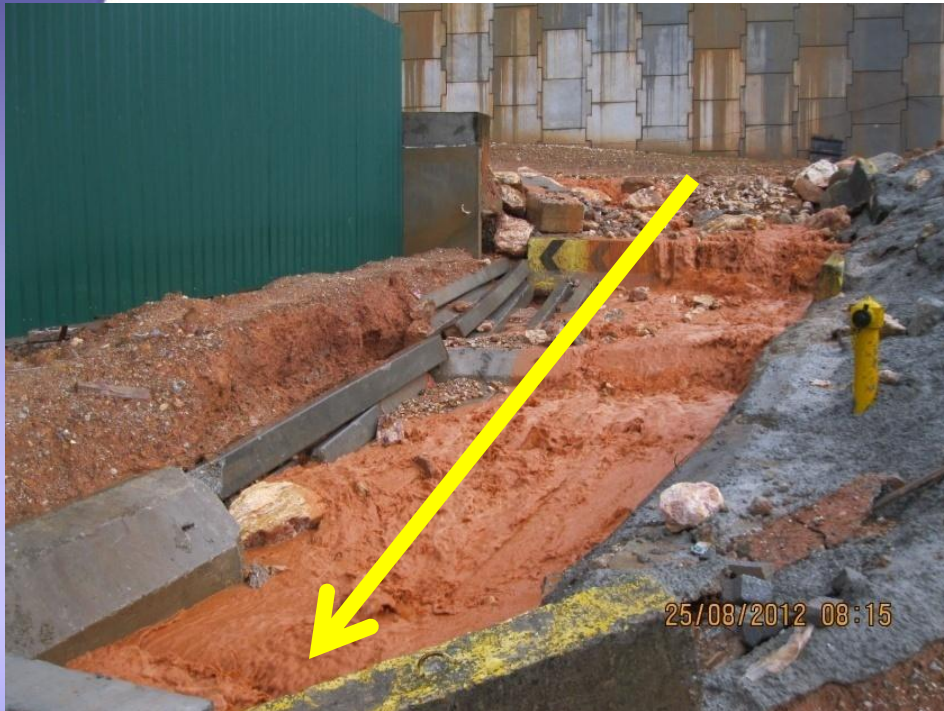
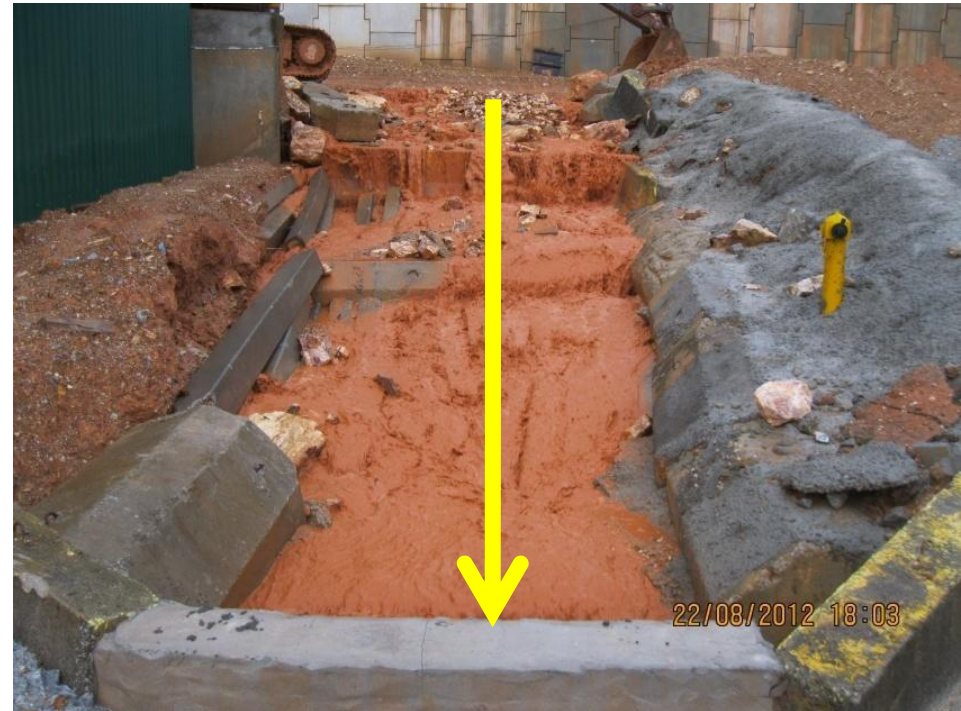
# Concrete dam (claimed as Check Dam)

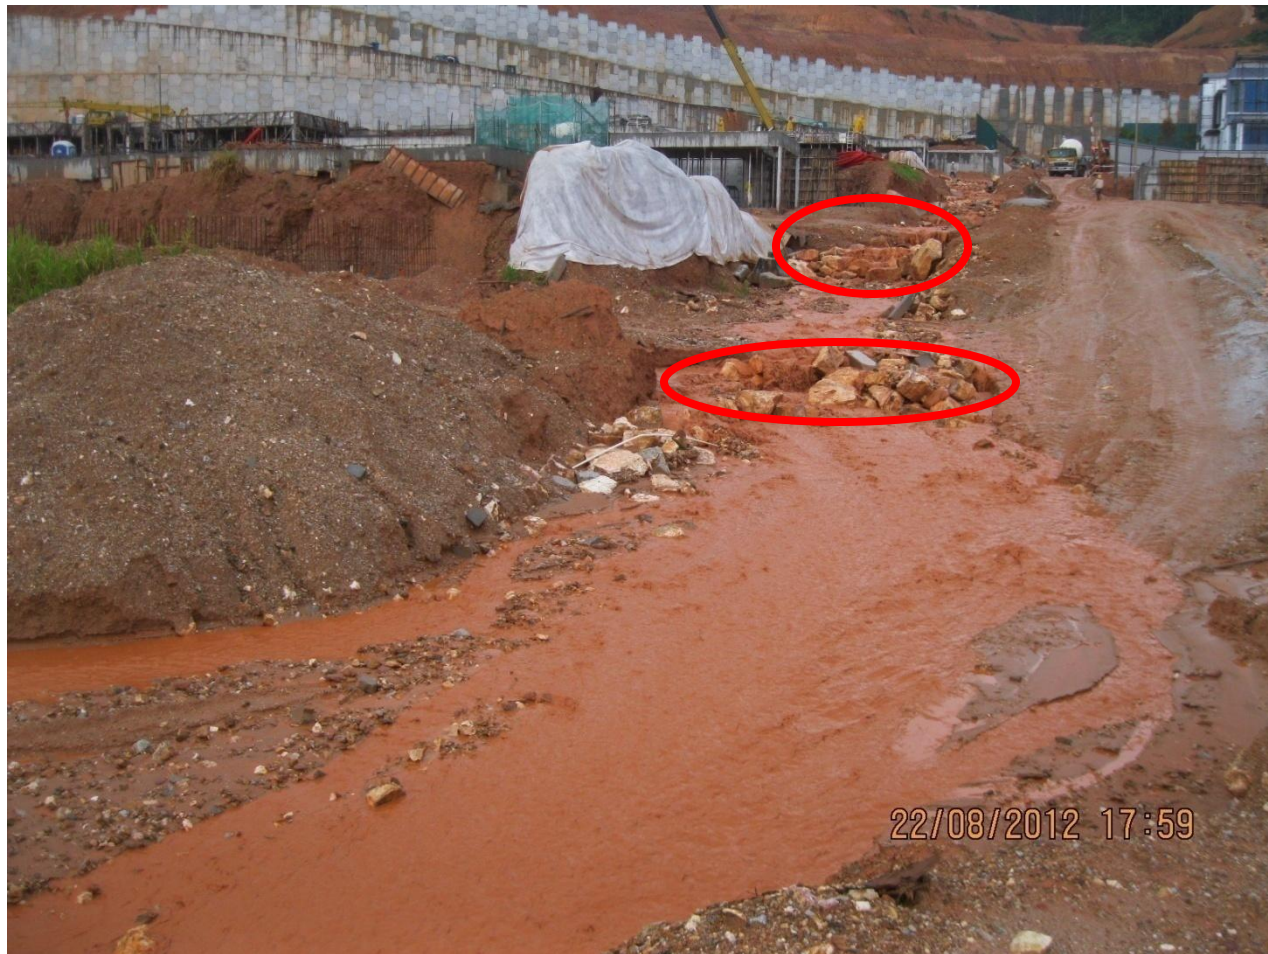
# IMPROPER CHECK DAM

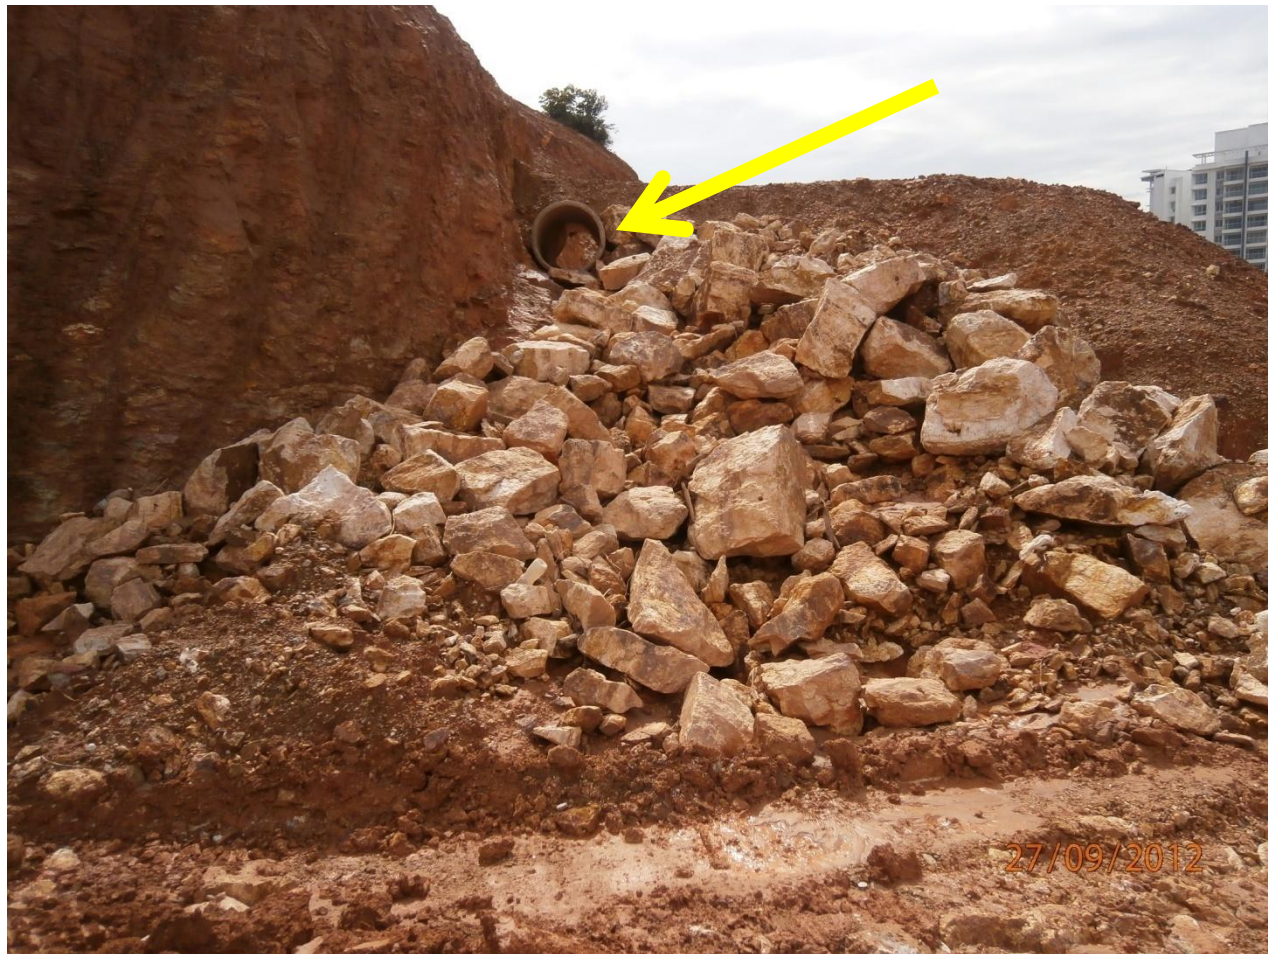
# Rock Outlet Protection

(Observe the stone placed in the pipe  
pose possibility of dam break)

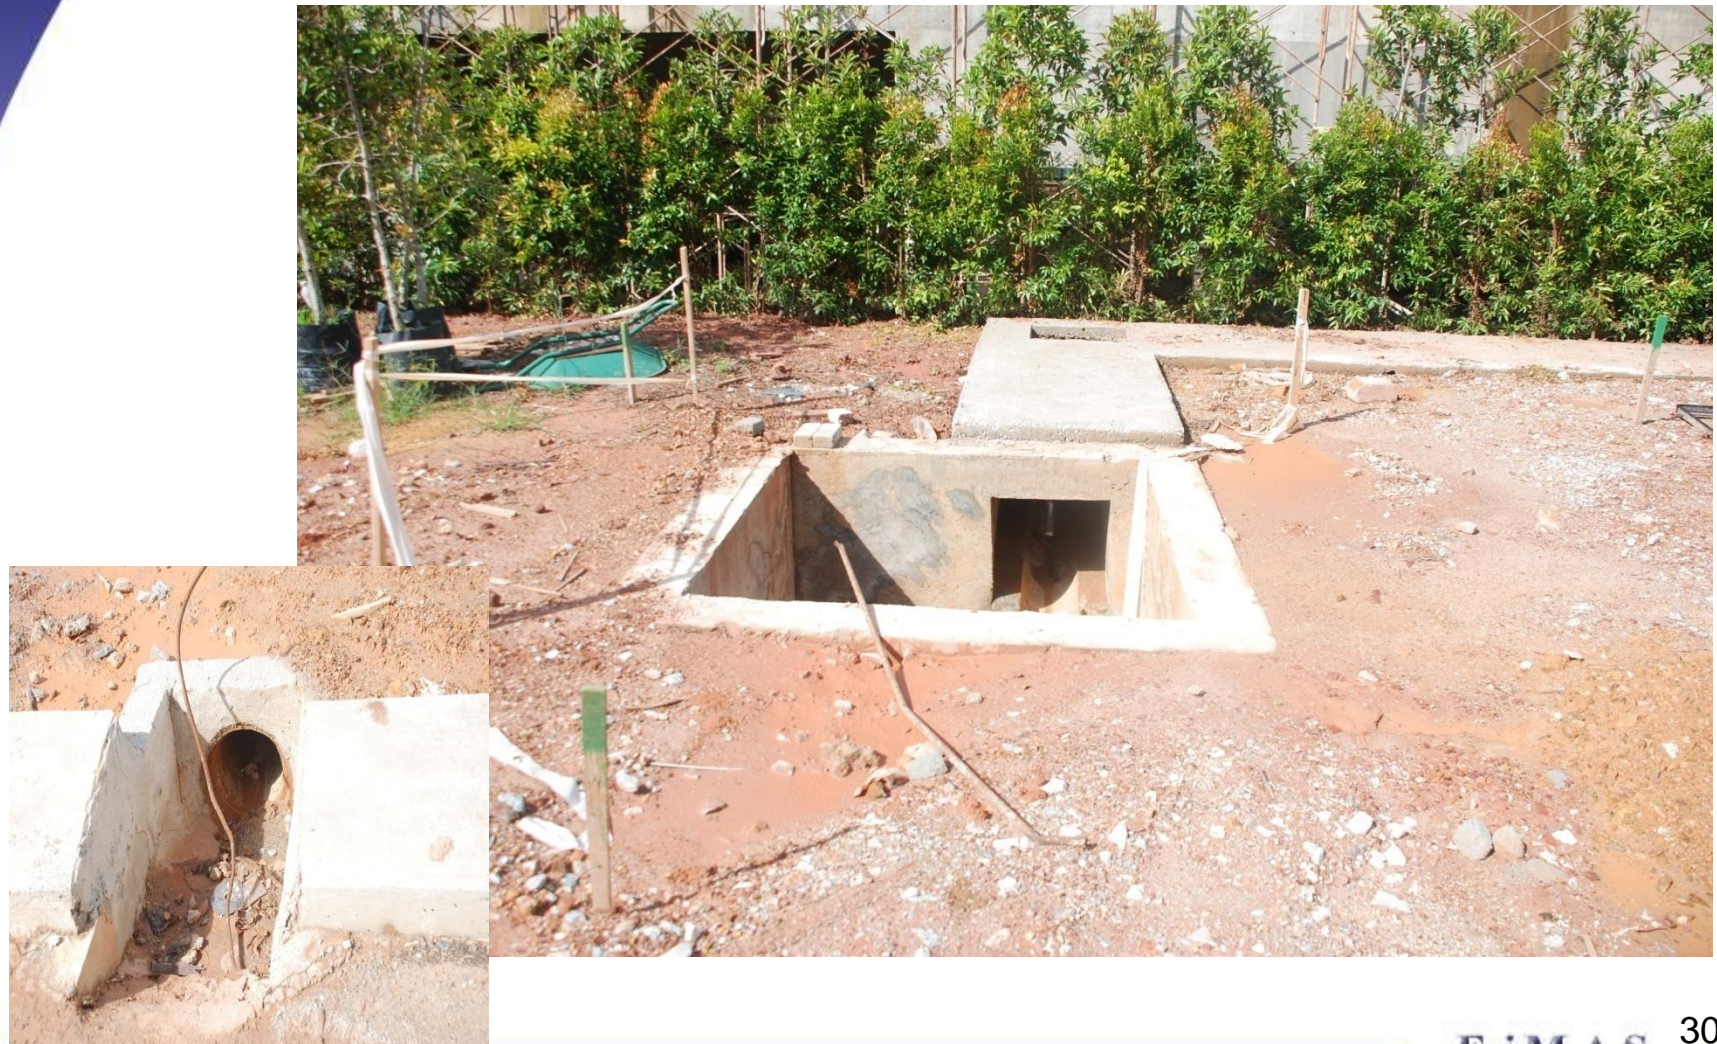
# No Storm Drain Inlet Protection

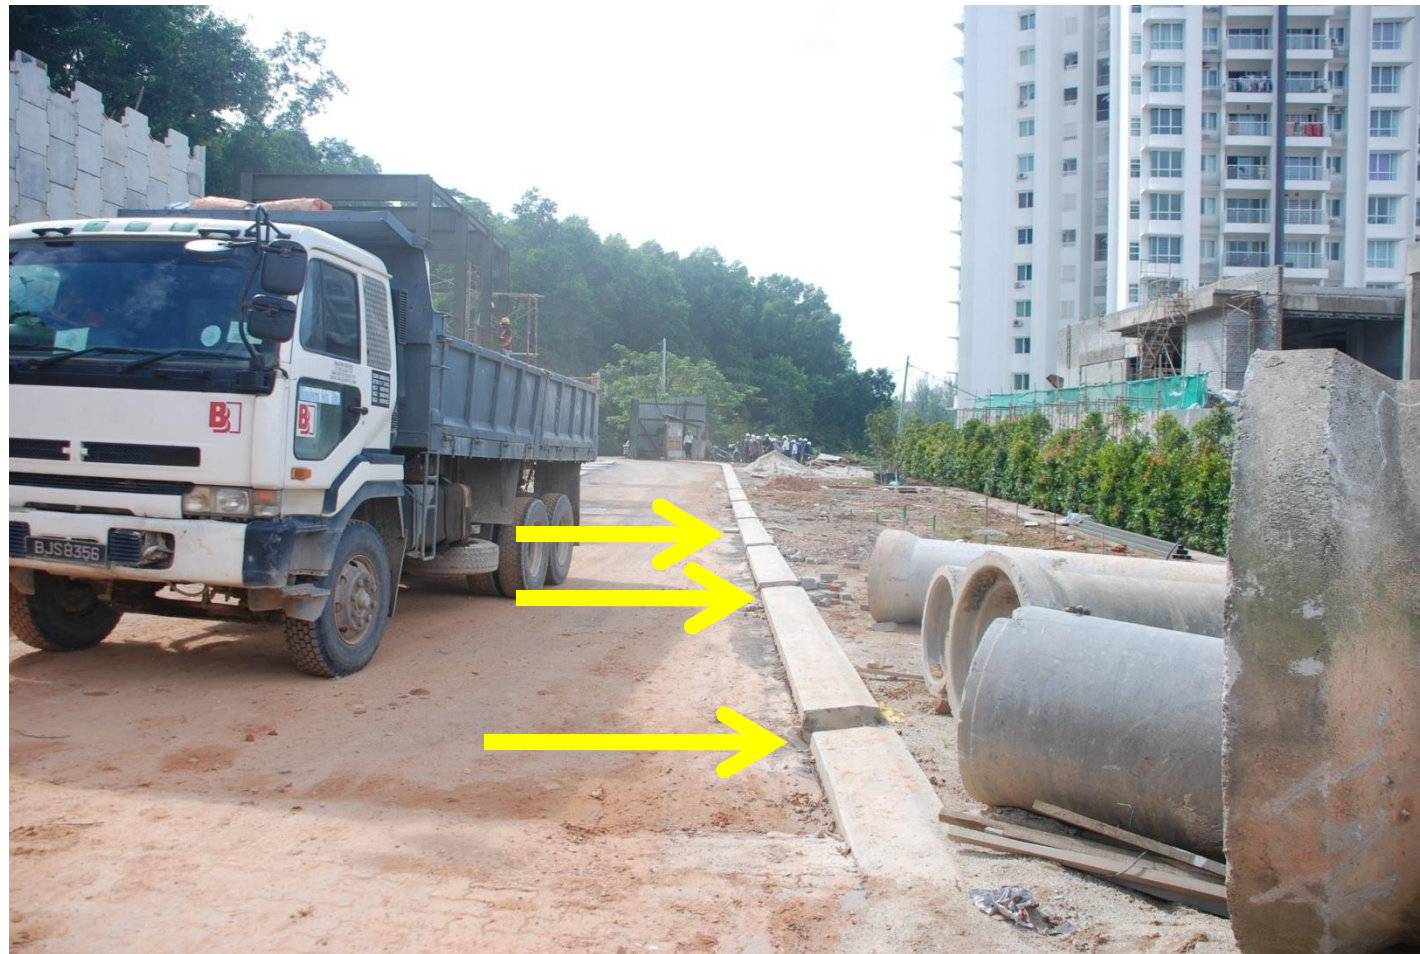
# No Storm Drain Inlet Protection

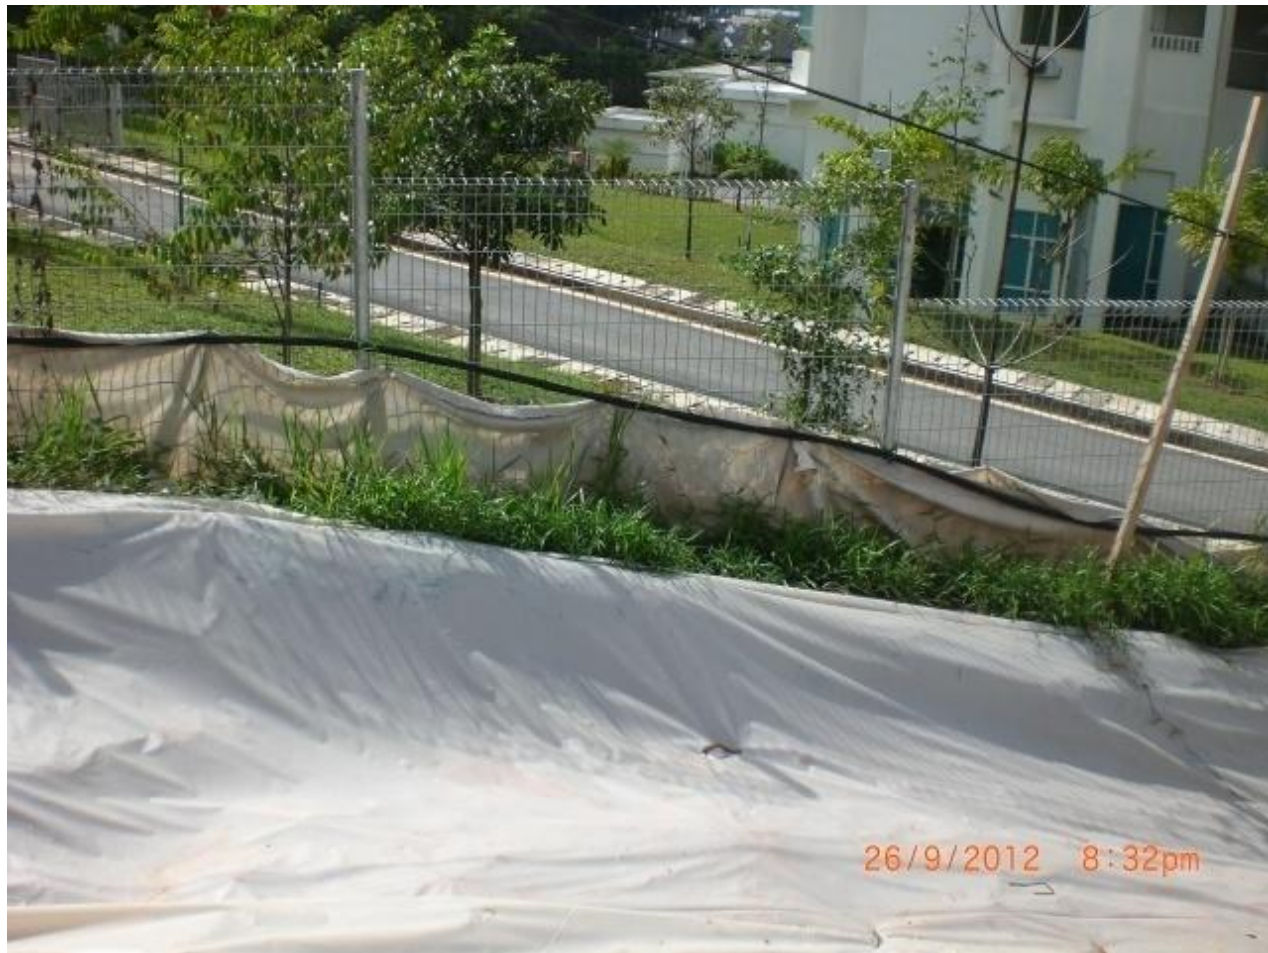
## Silt Fence – the only 50 metres installed

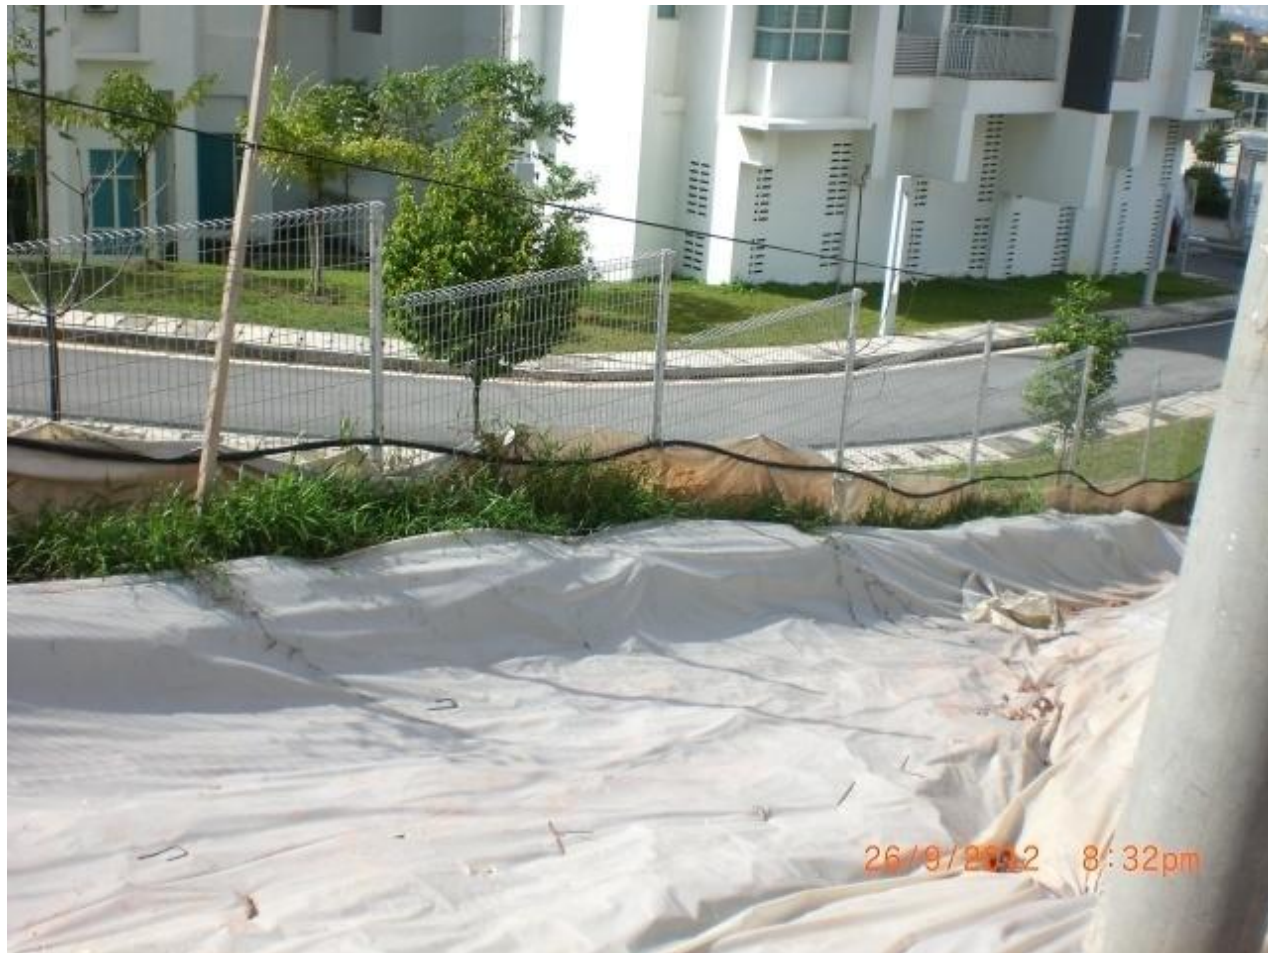
# Silt Fence – the only 50 metres installed

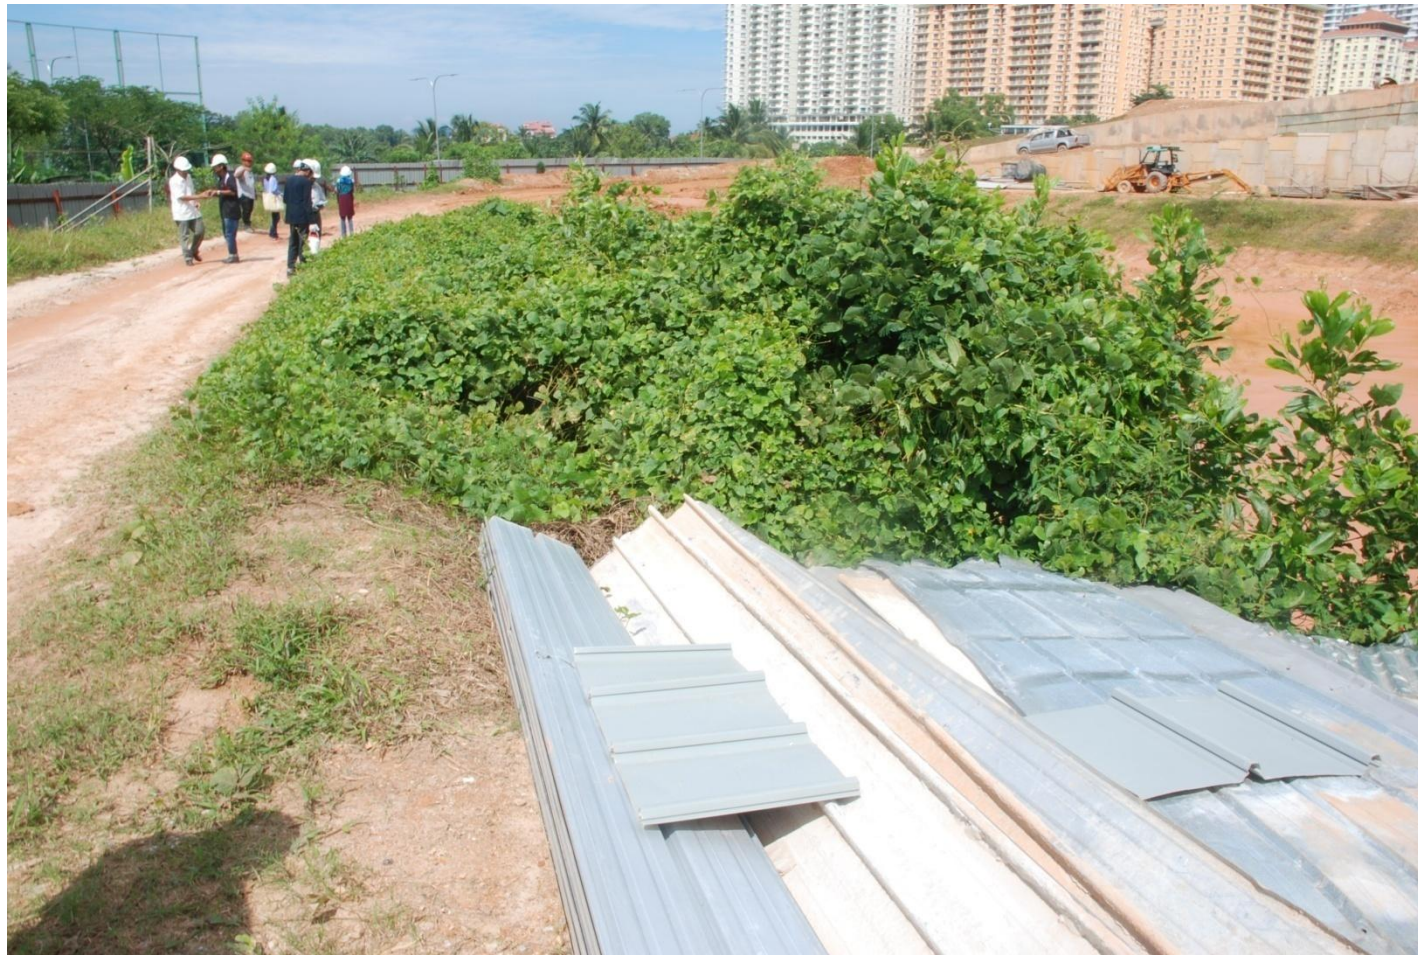
# Foreign material placed on the pond embankment

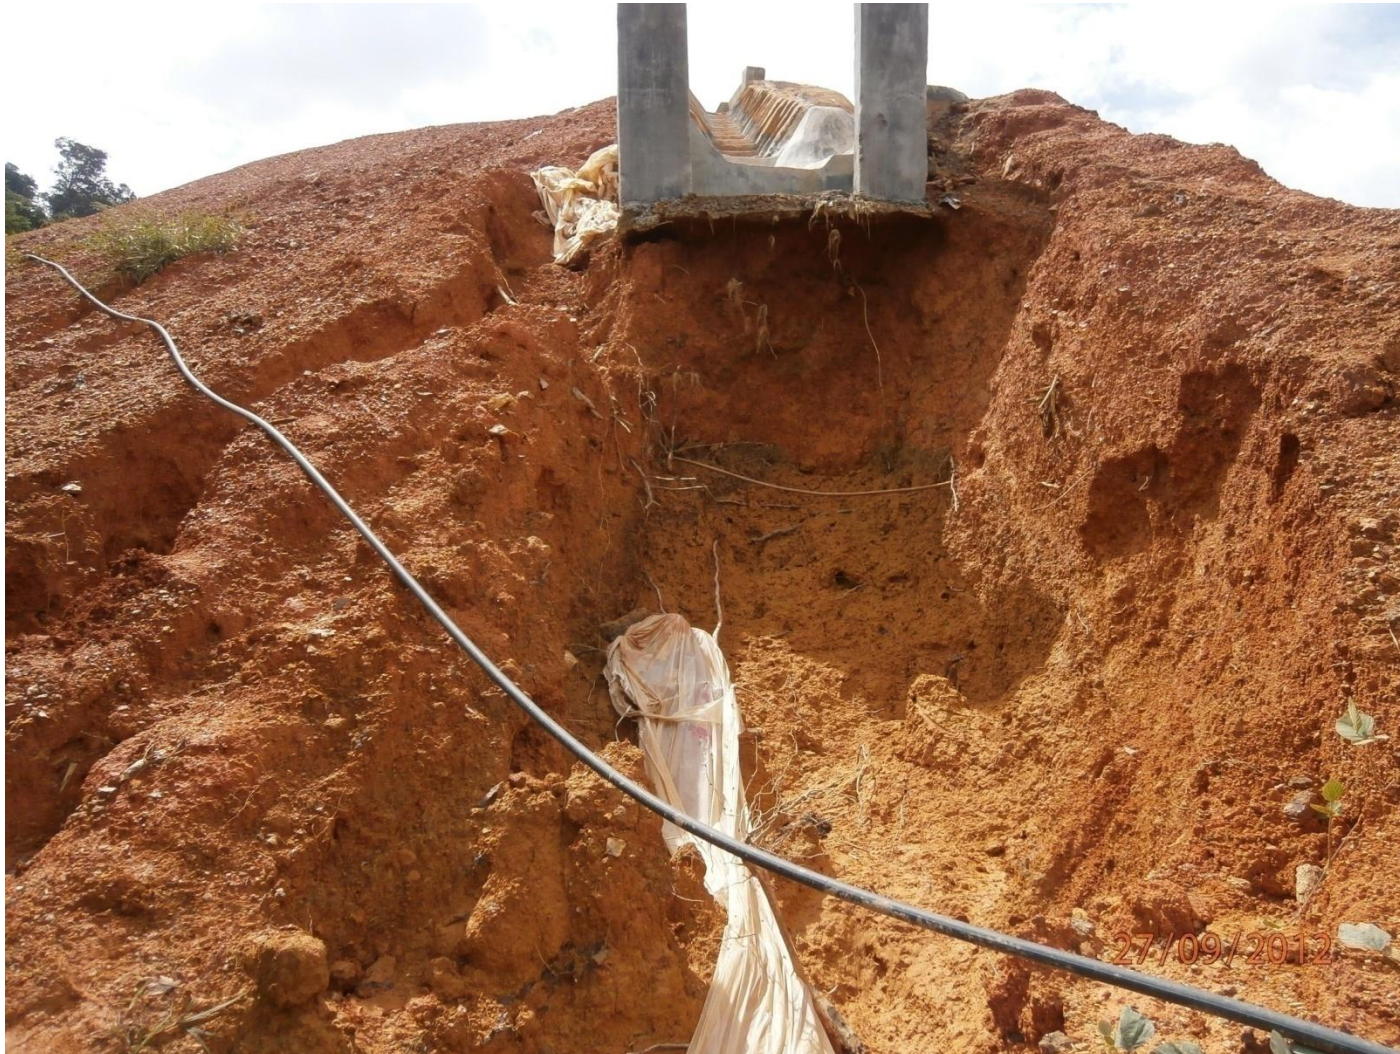
## Awaiting for cascade drain

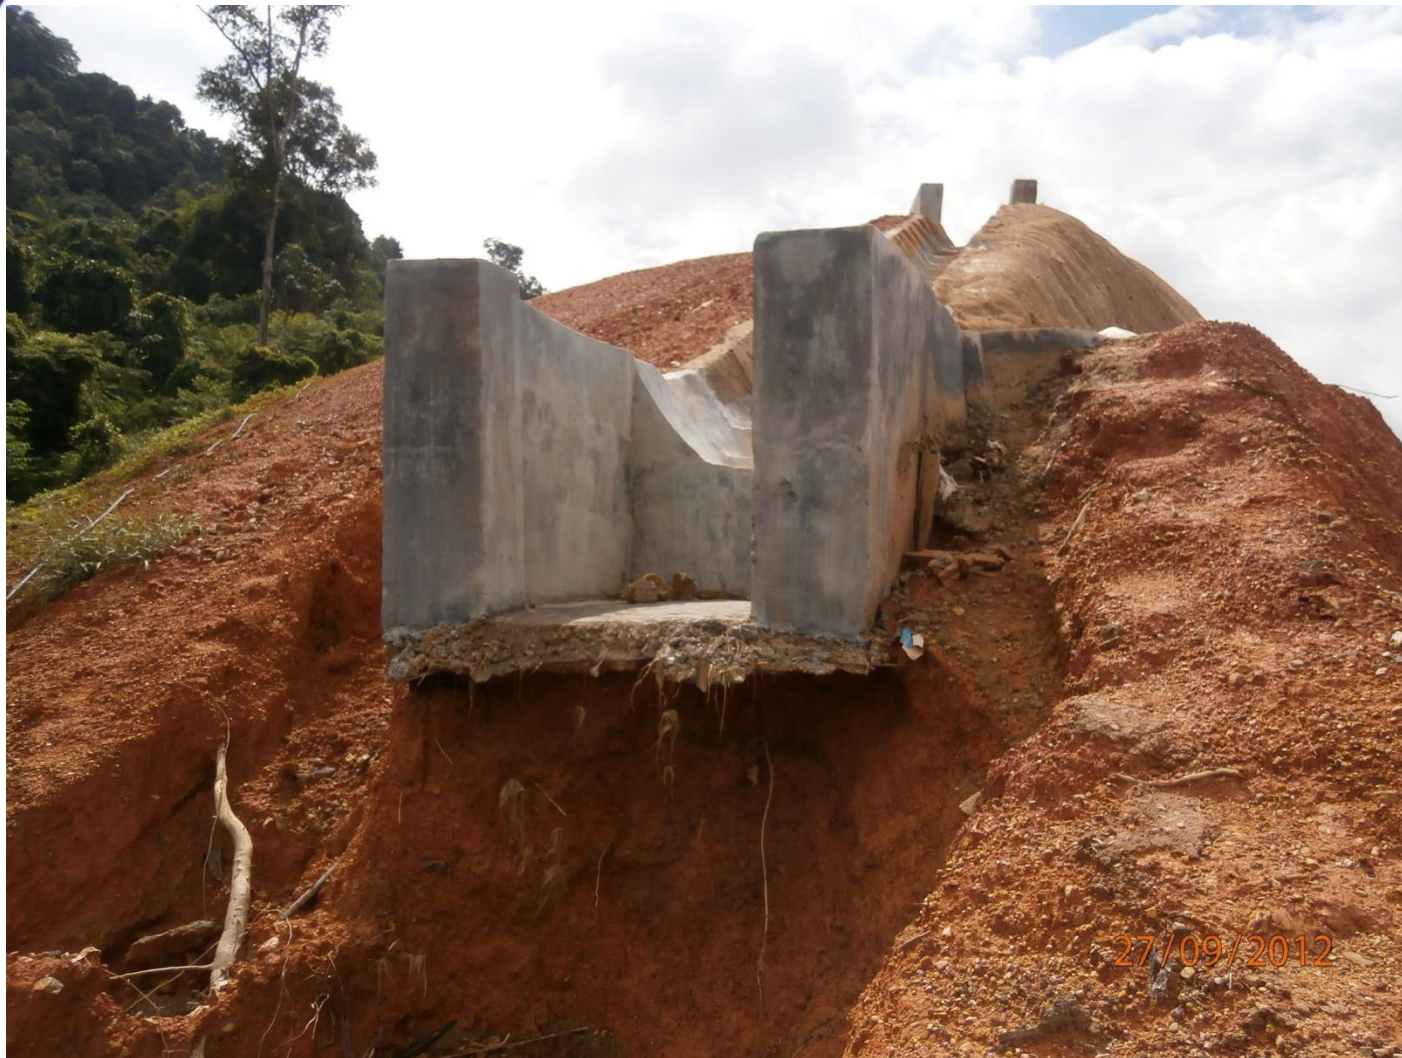
# Awaiting for cascade drain

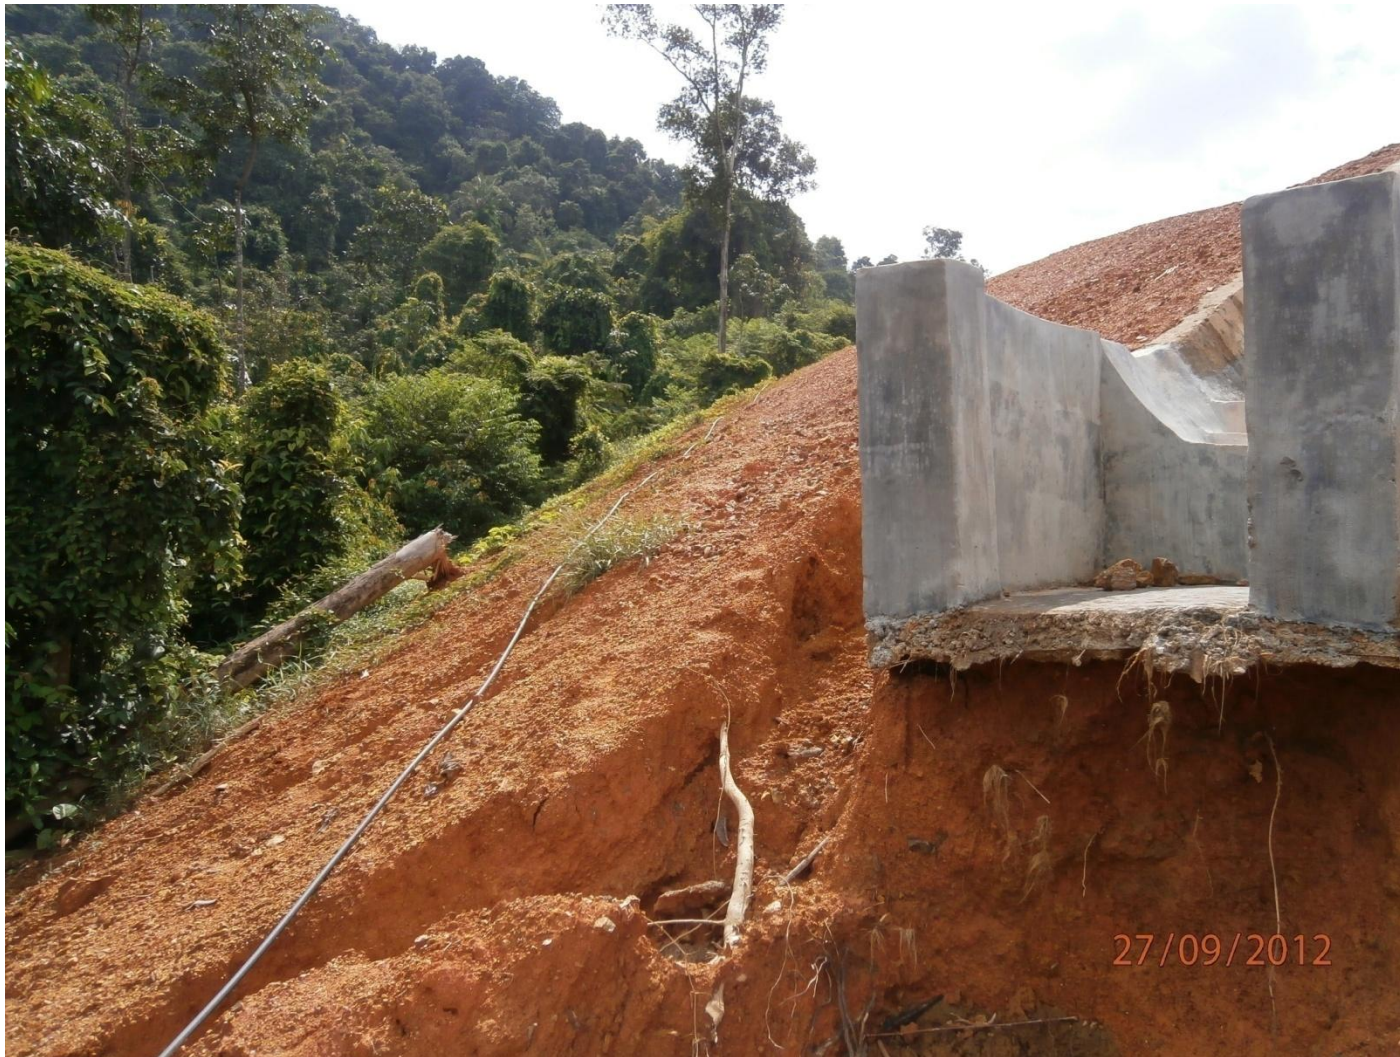
# Awaiting for cascade drain

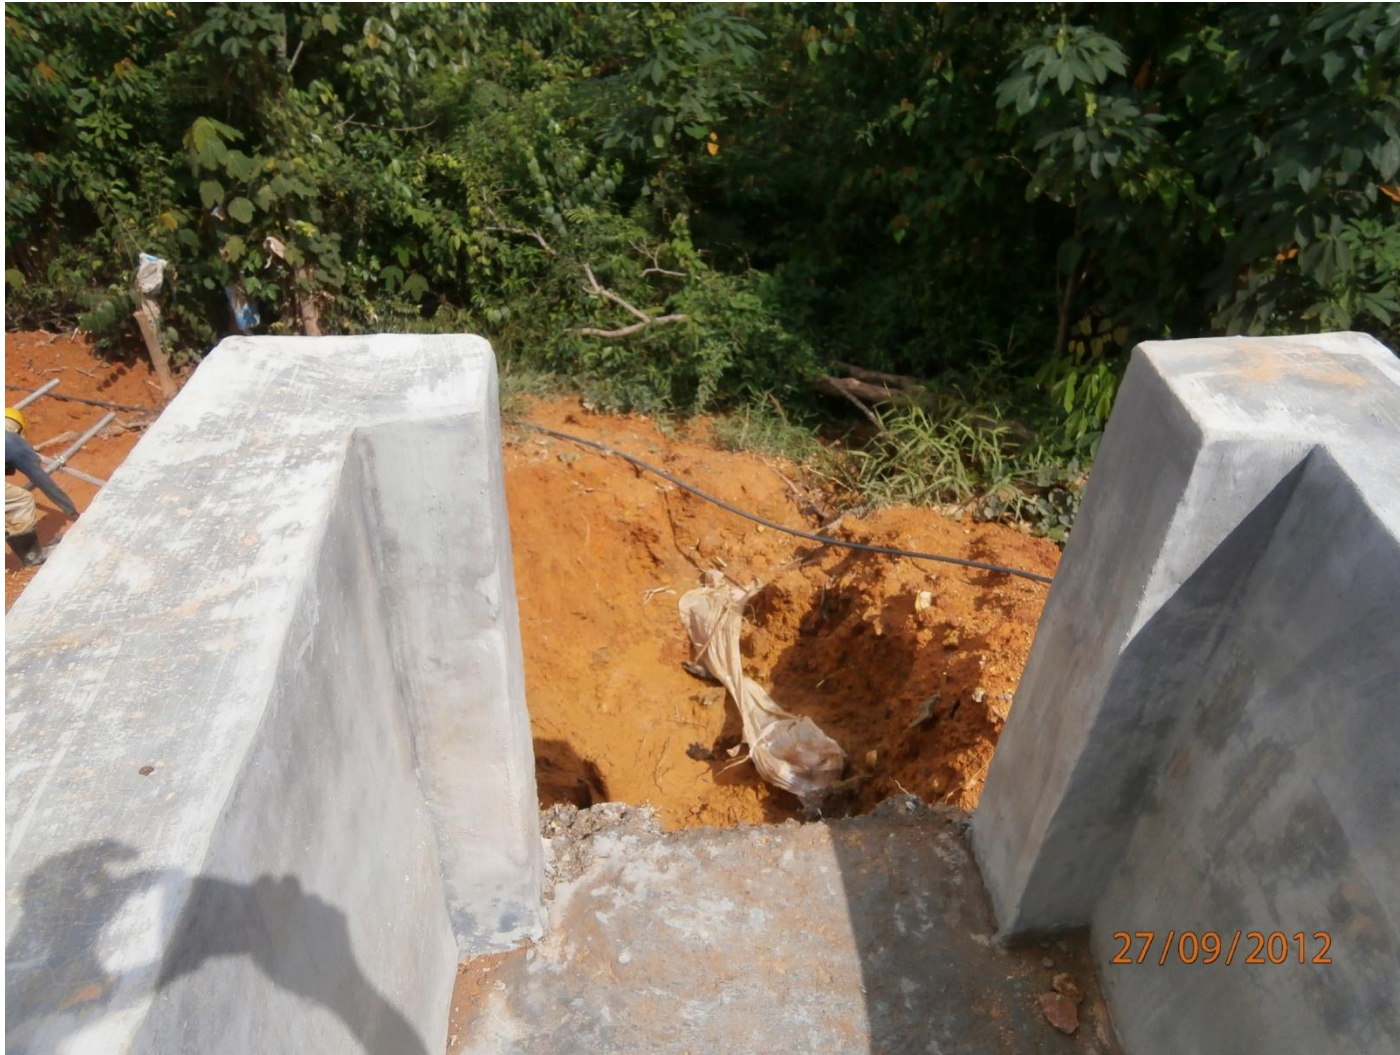
## Awaiting for cascade drain
