6 COLLIERY SPOIL HEAP STABILITY

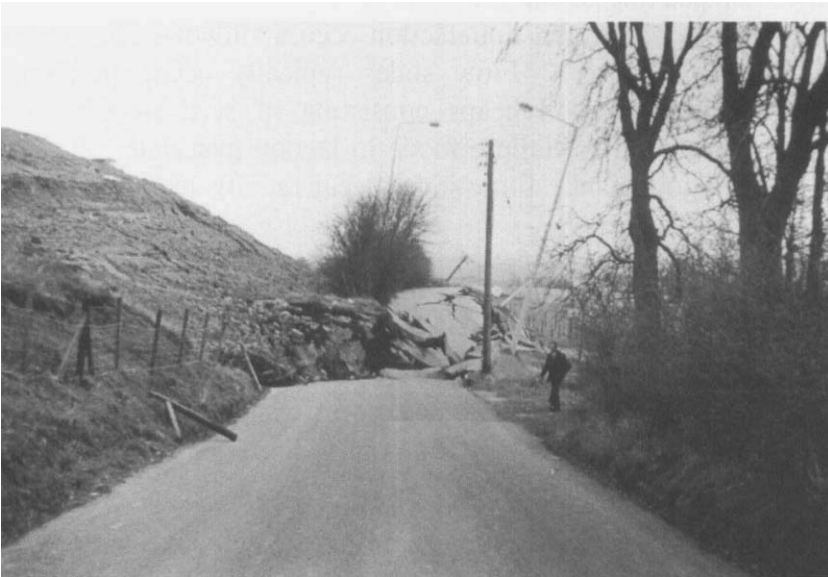
Photograph 6.1: Example of a rotational slip failure (source: I.G. Brown)

In rotational slips, movement takes the form of rotation about an axis which is generally outside the slope itself. The shape of the failure surface varies depending on the characteristics of the material in the tip (see Figures 6.2(a) to 6.2(d)). The first sign of slippage is usually a tension crack in the spoil above the failure surface, sometimes accompanied by slumping of the spoil in front of the crack (see Photograph 6.1). The rate of failure is generally relatively slow *i.e.* developing over a period of hours to days.

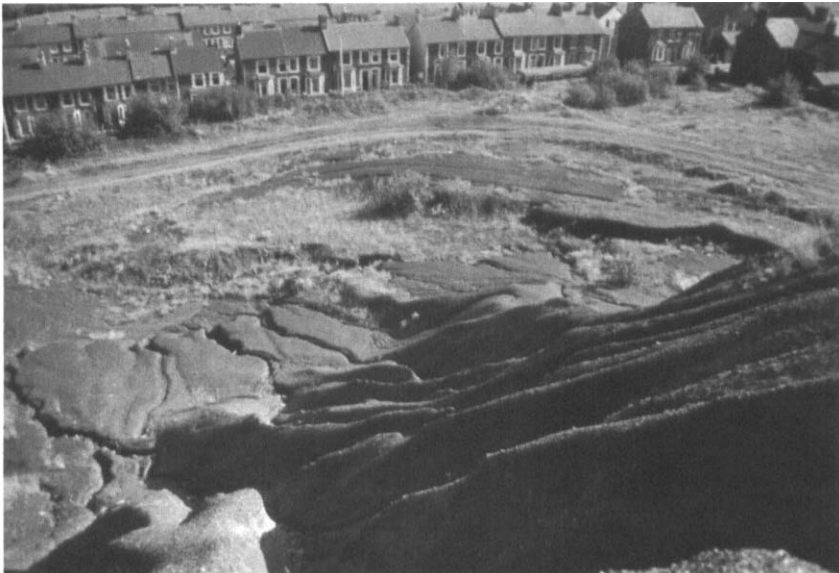
Photograph 6.2: Example of water erosion forming surface gulleys (source: Welsh Development Agency)

A mud run is a localised failure caused by a rapidly moving flow of water-borne soil having the consistency of mud. This is brought about following heavy rainfall by flows or issues of water eroding gulleys in the side slopes and forming mud runs at the base of the tip (see Photograph 6.2).
