# Herbicides/Dioxin Contamination Management in hotspots in Vietnam

Nguyen My Hang, PhD  
Office 33/Dioxin Project

# **Containment Landfill of Dioxin Contaminated Soil in Phu Cat airbase**

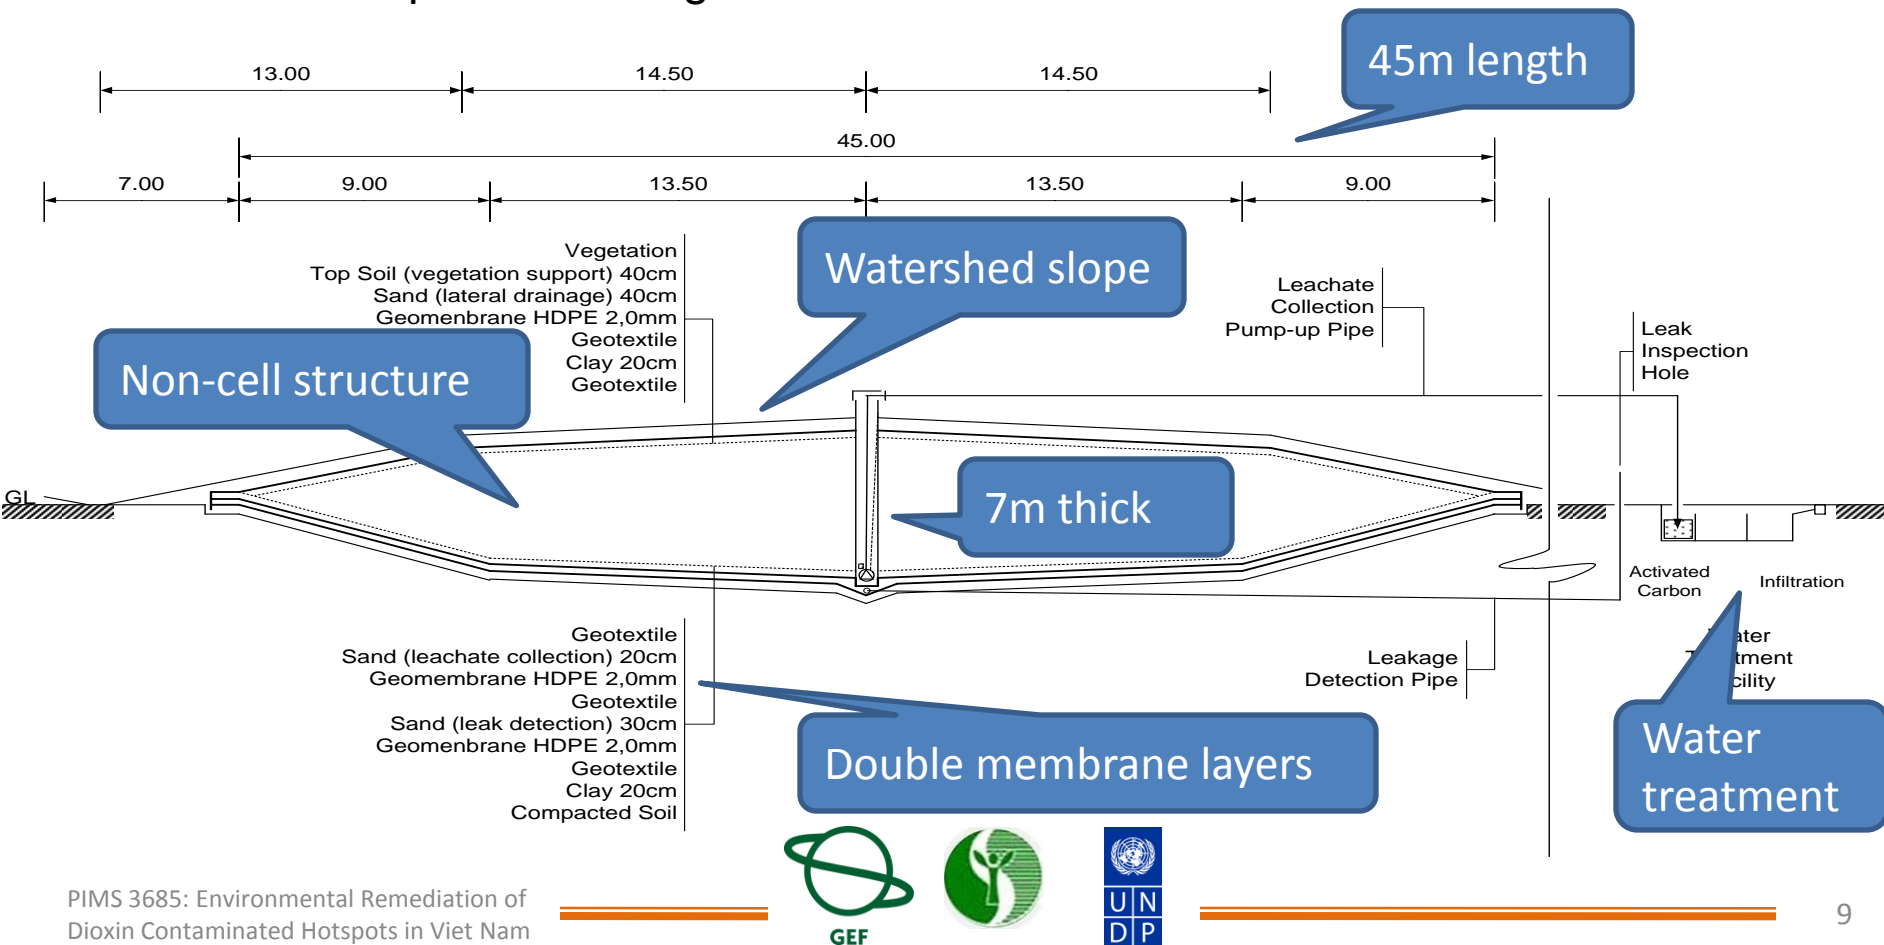
# Diagram of Landfill Structure

The bottom structure comprises with 2 HDPE insulation layers serves as leachate collection and leak detection.

Top structure was constructed to ensure smooth drainage of rainwater to minimize water intrusion into landfill.

Leachate water passes through activated carbon before it is released to environment.

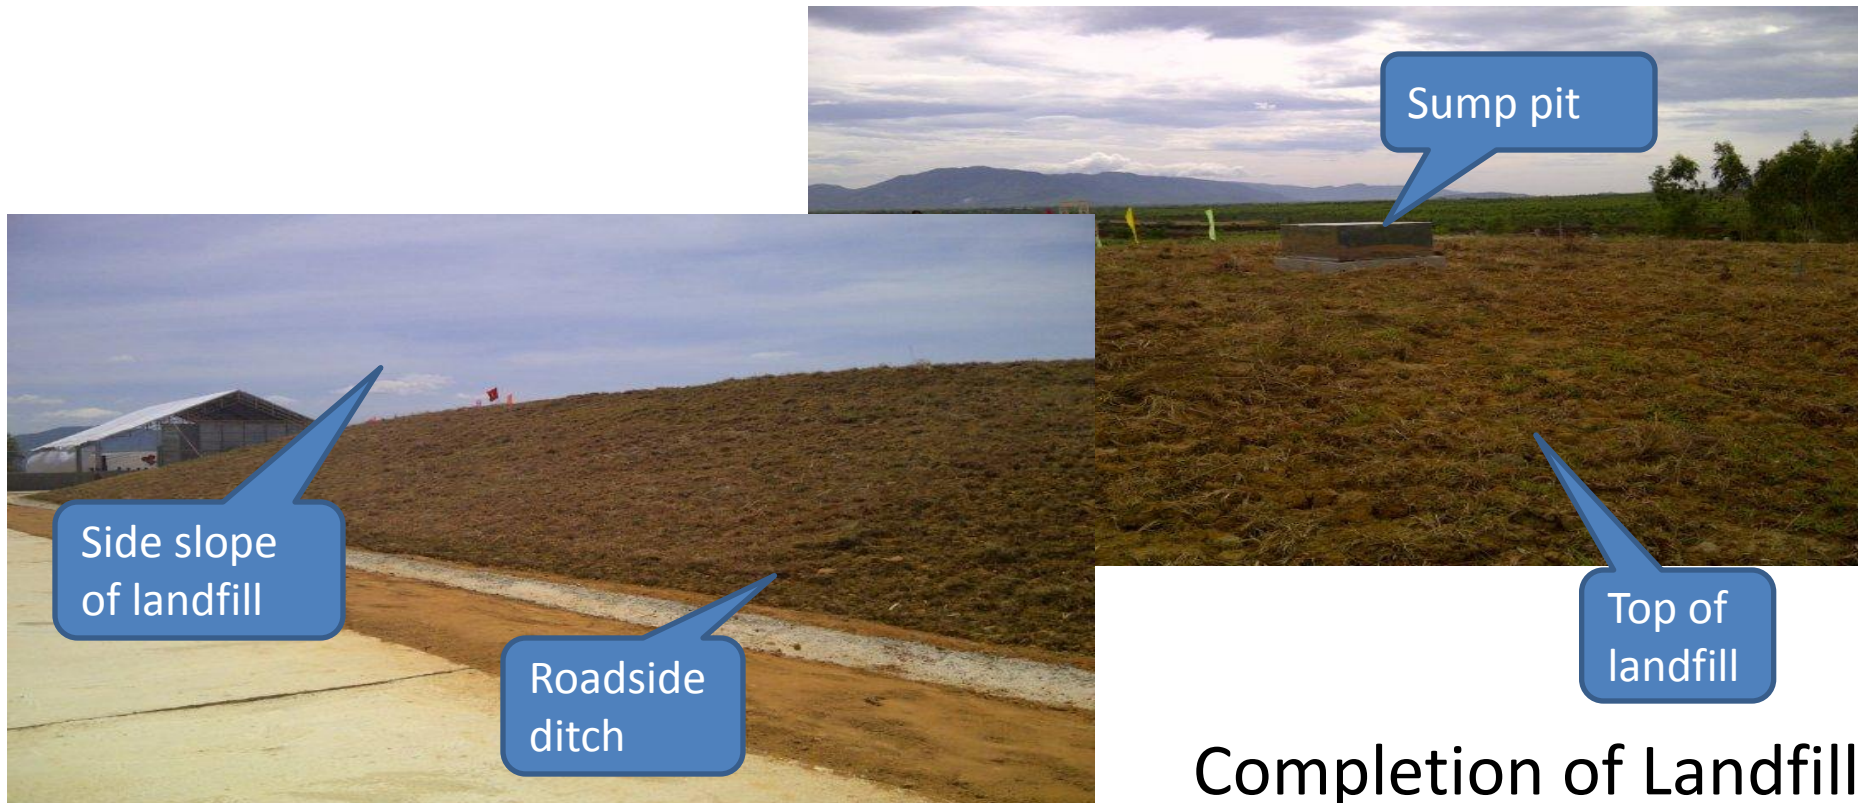
Side slope of the landfill is limited to the stable angle so that soil would not collapse during the construction and after completion.

Leachate water is pumped up at sump pit and transferred to the water treatment facility.

Smooth drainage of rainwater is secured with roadside ditch that surrounds entire landfill.

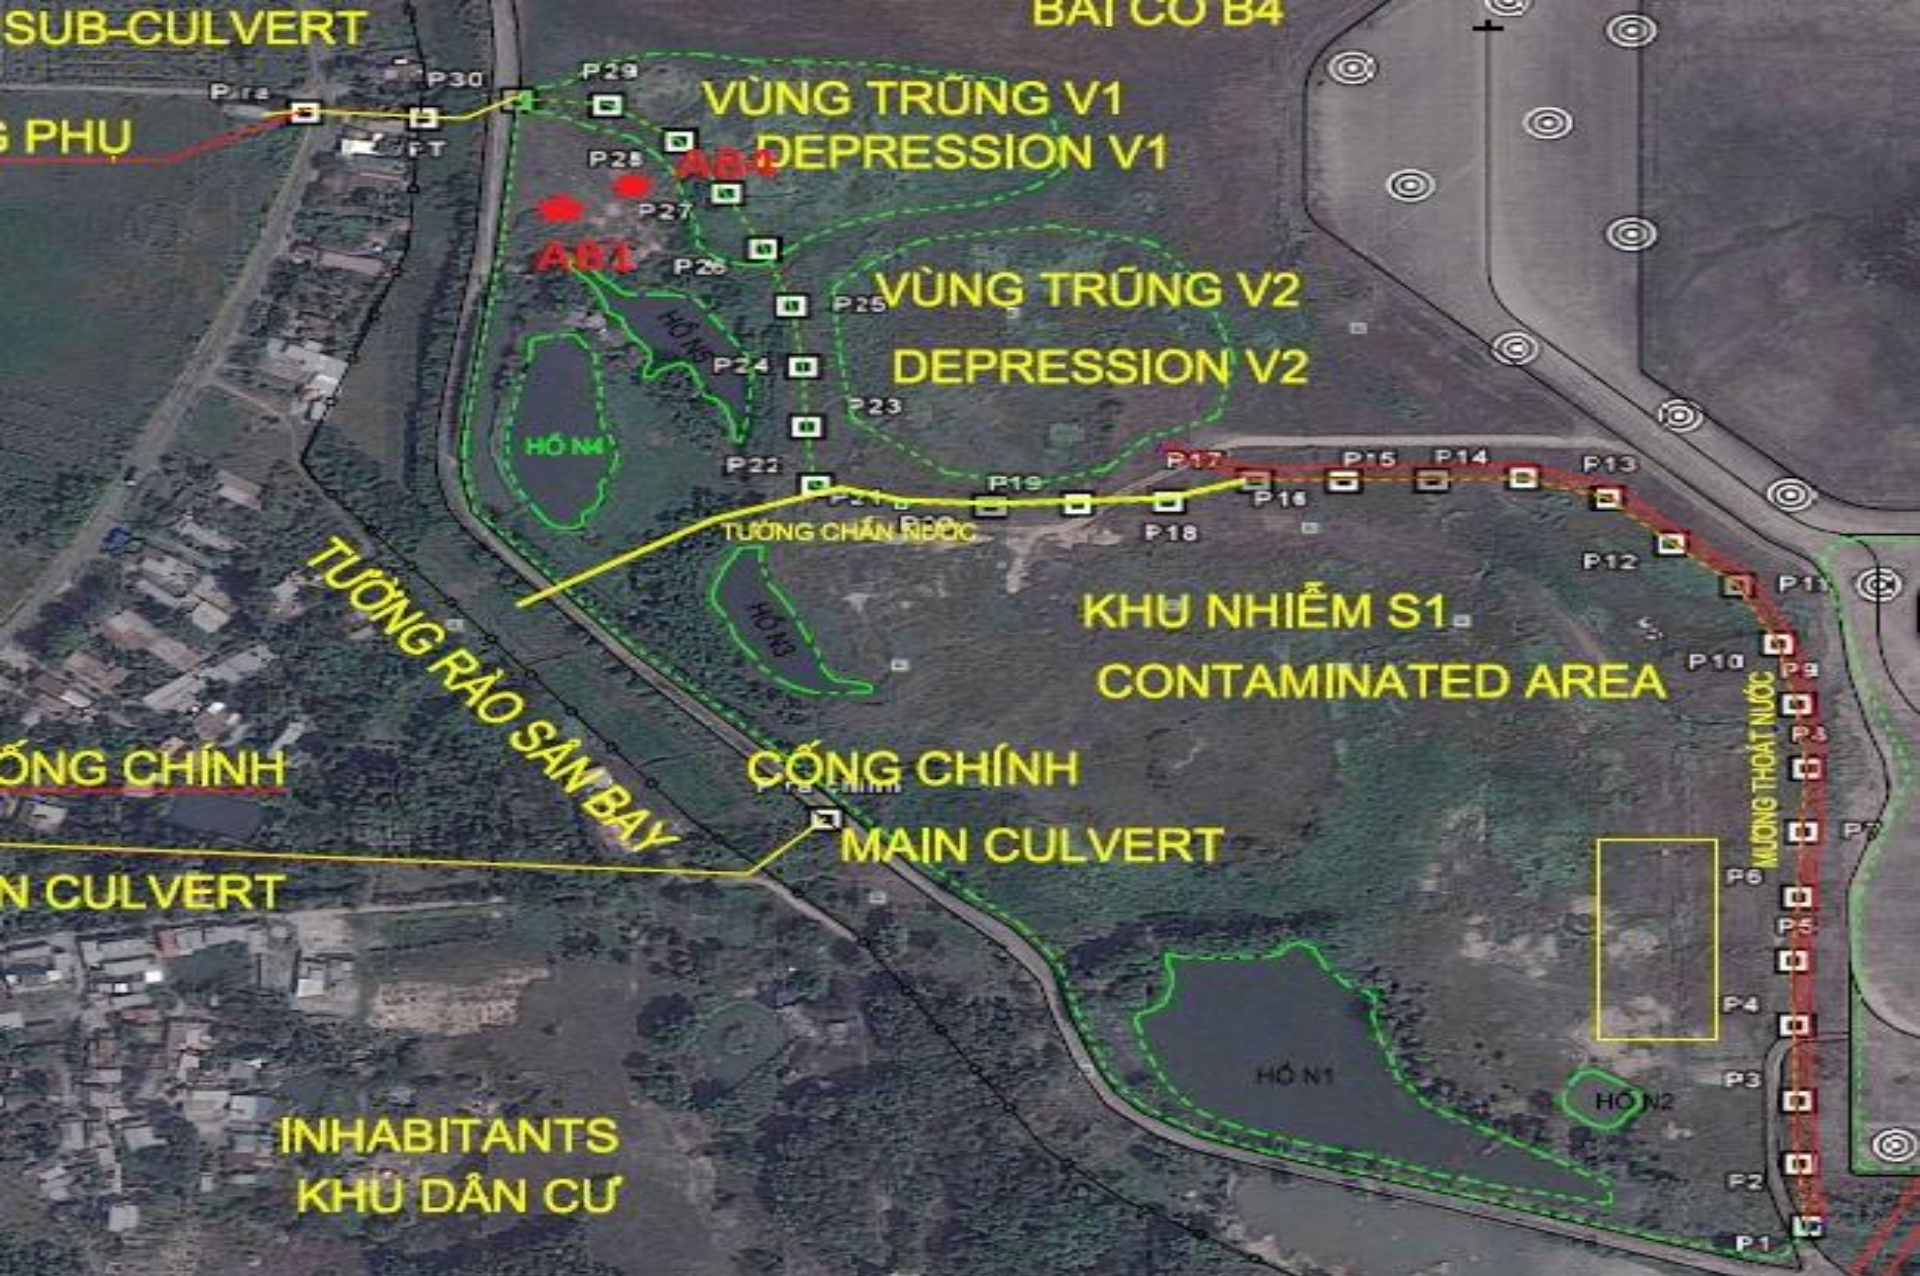
Khu vực hồ ông Hùng bỏ (ô nhiễm vượt tiêu chuẩn từ 2 đến 4 lần

Khu vực hồ ông Quý, ô nhiễm vượt tiêu chuẩn từ 1 đến 3 lần

Khu vực hồ mới: ô nhiễm vượt tiêu chuẩn từ 3 đến 7 lần

Hồ ông Bình, ô nhiễm vượt tiêu chuẩn đến trên 50 lần

Cụm hồ đầu đông, ô nhiễm vượt tiêu chuẩn từ 1,1 đến 7 lần

Hồ tam giác, ô nhiễm vượt tiêu chuẩn cho phép đến 22 lần

Hồ 3 và 4 ô nhiễm vượt tiêu chuẩn đến 19 lần, mức độ ô nhiễm phức tạp theo chiều sâu

Khu vực ô nhiễm nặng (Pacer Iv)

Hồ ông Học, ô nhiễm vượt tiêu chuẩn từ 2 đến 15 lần

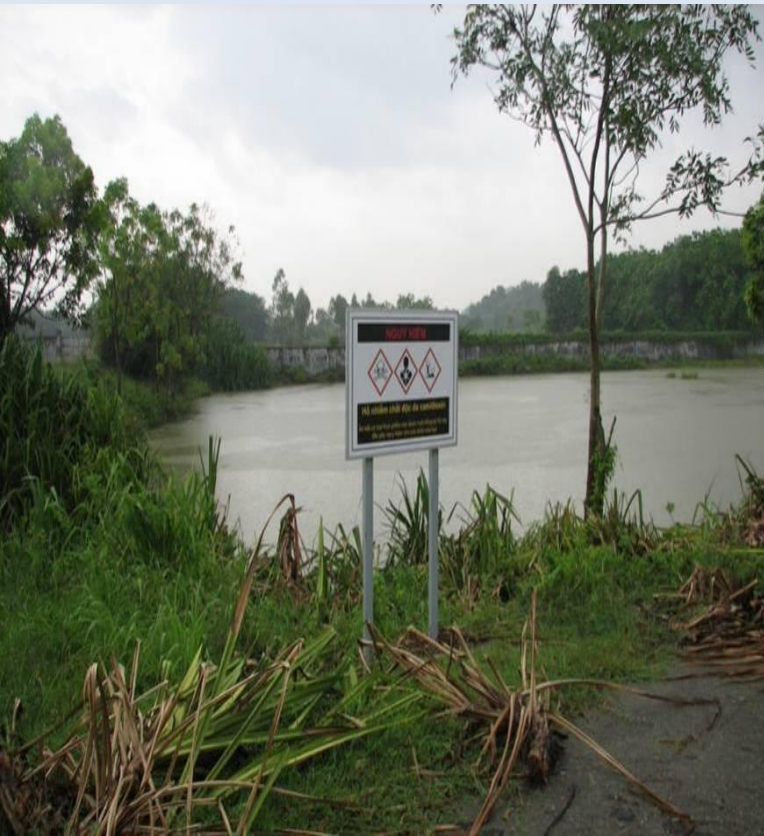
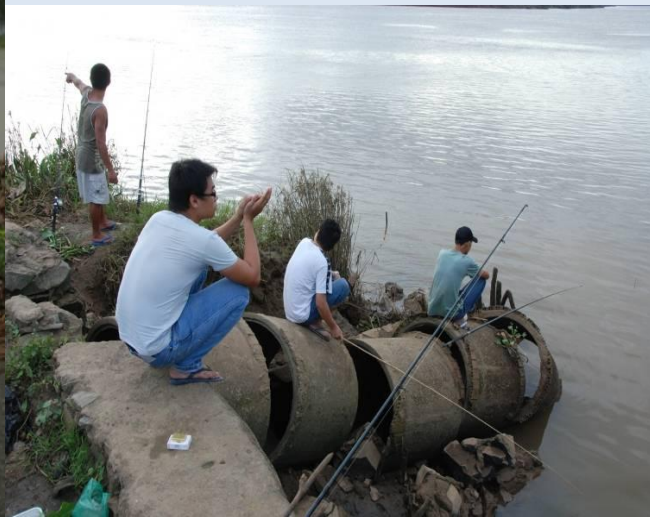
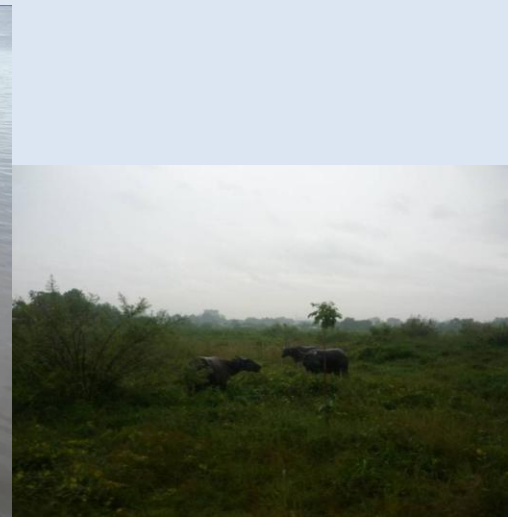
**3. Lakes inside airbase:** of 28 lakes survey, 26 lakes found to be contaminated located in Northeast and Northwest of the airbase

**Principles:** current lakes used buffer lakes to reduce the flow; construct overflow dams and dyke at dioxin high contaminated lakes
