ENVIRONMENTAL IMPACT ASSESSMENT

**Proposed Offsite Scheduled Waste Storage
Facility on CL.045322521, District of Tuaran,
Sabah**

EXECUTIVE SUMMARY

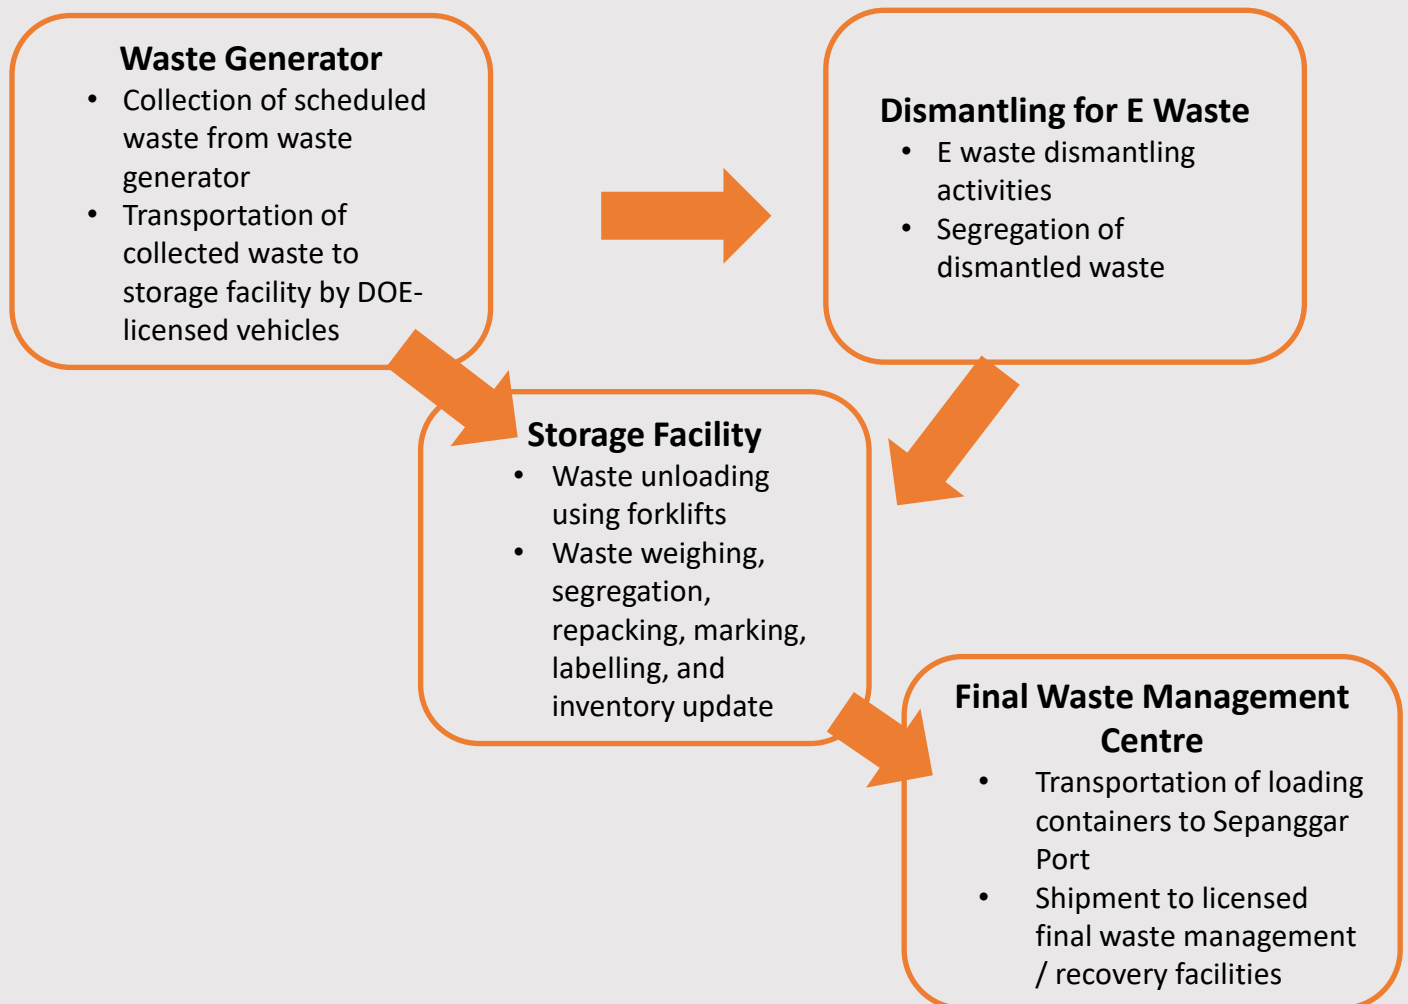
Project Flowchart

Existing warehouse building to store 100 MT/month of scheduled waste.

Scheduled Waste Codes: SW102 SW103 SW110

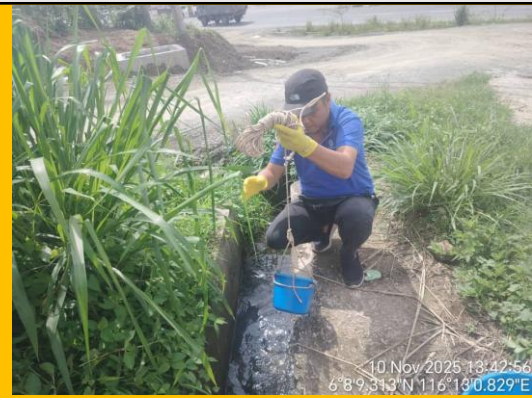
- **Surface water quality sampling** at existing drainage.
- Results complied with Class III NQWSM, except for DO, N.
- High level of DO is considerably good for aquatic lifeform.
- Higher N (Ammoniacal-Nitrogen) indicate upstream sewage leakage from settlements.

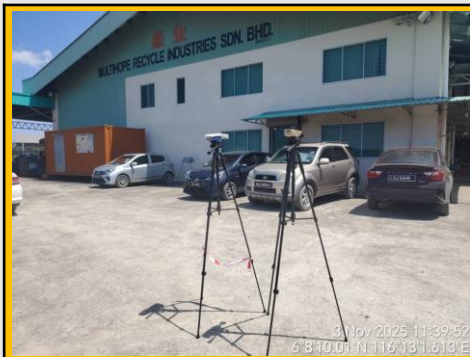
- **Ambient air sampling** (PM₁₀, PM_{2.5}) conducted at 2 points: project site boundary (A1) and Kg Berunggis (A2).
- Results complied with MAAQS (2020).

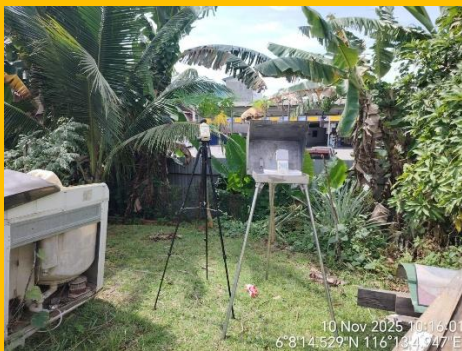
- **Noise level monitoring** conducted at 2 points: project site boundary (A1) and Kg Berunggis (A2).
- Results complies to the Guidelines for Environmental Noise Limits and Control, 2019 for Industrial Zones and Urban Residential,

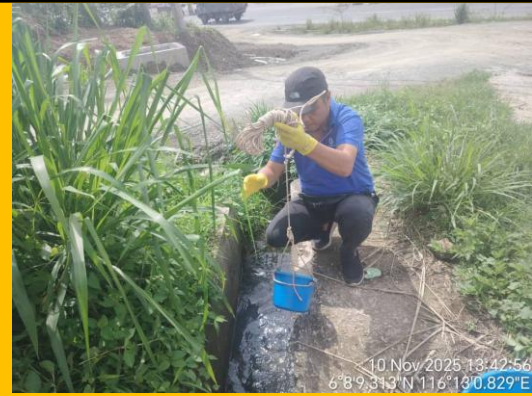
- **Persampelan kualiti air** di parit sedia ada.
- Keputusan mematuhi Kelas III NWQSM, kecuali untuk DO, dan N.
- Tahap DO yang tinggi adalah sangat baik untuk hidupan akuatik.
- Paras Nitrogen Ammonia ($\text{NH}_3\text{-N}$) yang tinggi mencadangkan kemungkinan pencemaran di bahagian hulu berpunca daripada kebocoran kumbahan dari kawasan penempatan berhampiran.

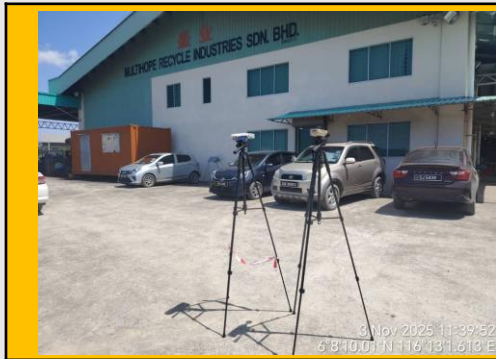
- **Persampelan udara ambien** (PM_{10} , $\text{PM}_{2,5}$) di 2 lokasi: sempadan tapak projek (A1) Kg Berunggis (A2).
- Keputusan parameter PM_{10} , $\text{PM}_{2,5}$, mematuhi MAAQS (2020).

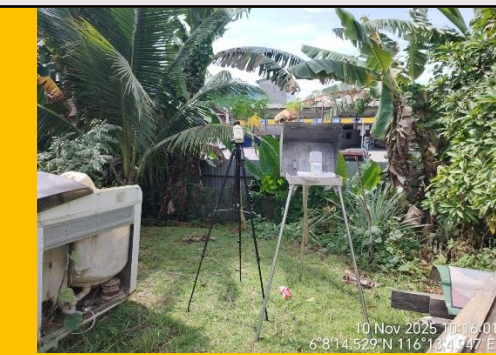
- **Pemantauan Tahap Bunyi Bising** di 2 lokasi: sempadan tapak projek (A1) Kg Berunggis (A2).
- Keputusan mematuhi *Guidelines for Environmental Noise Limits and Control, 2019*
