**Program Latihan Penguatkuasaan Untuk  
Pegawai JPS Bagi Pelaksanaan Perintah  
Kualiti Alam Sekeliling (Perwakilan Kuasa  
- Penyiasatan Ke Atas Kawalan Hakisan  
Dan Kelodakan)**

# BMPs INSPECTION

THE GOOD , THE BAD AND THE BMPs  
OPTION AND SELECTION

**Cad. Skim Perumahan 195 Unit Rumah Di Atas Lot  
30086 dan Lot 30087, Mukim Setapak, Kuala Lumpur  
oleh SUNWAY MELAWATI SDN BHD**

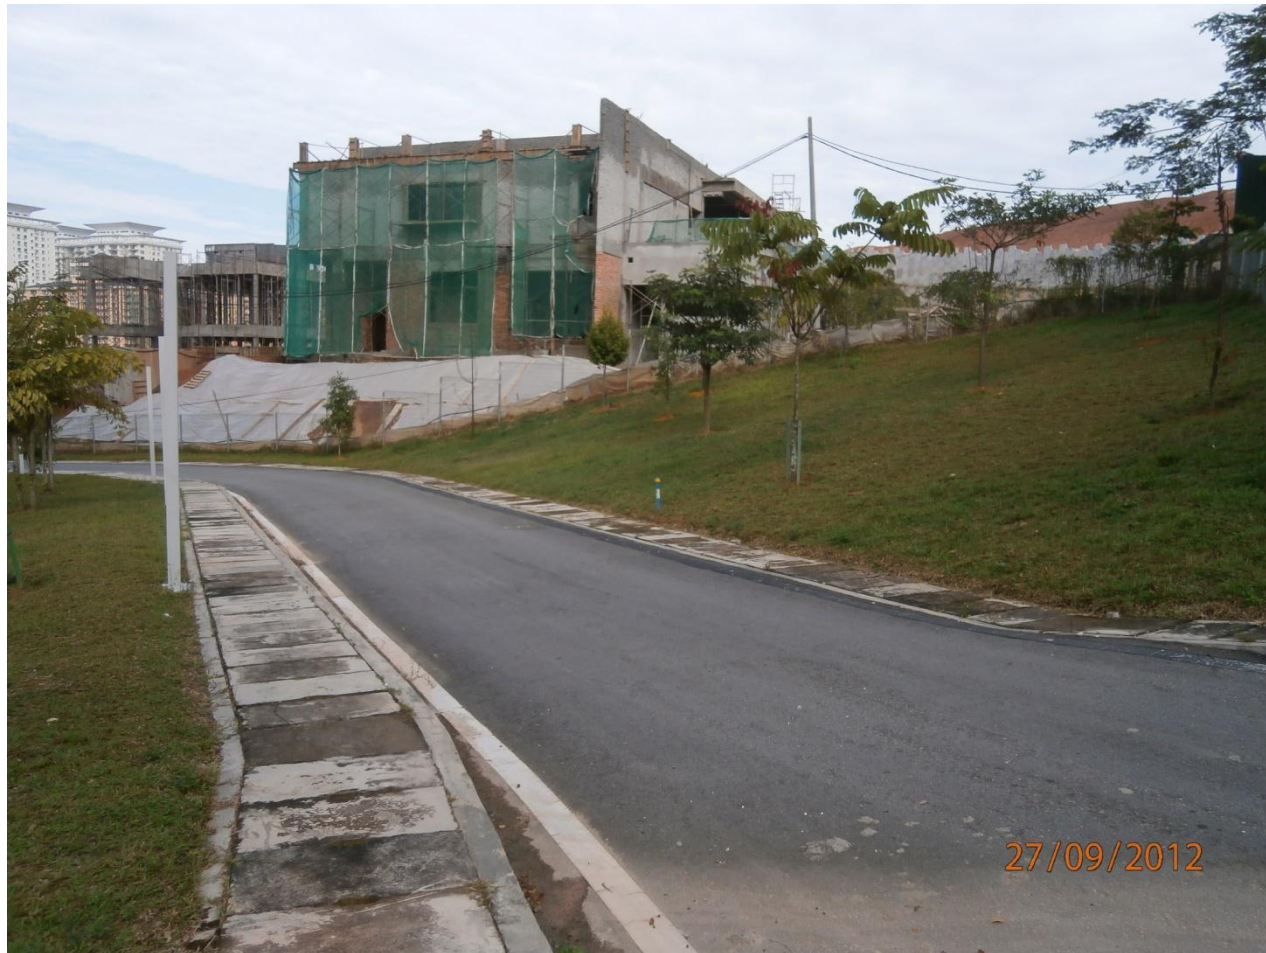
# Buildings on South-East (Clean)

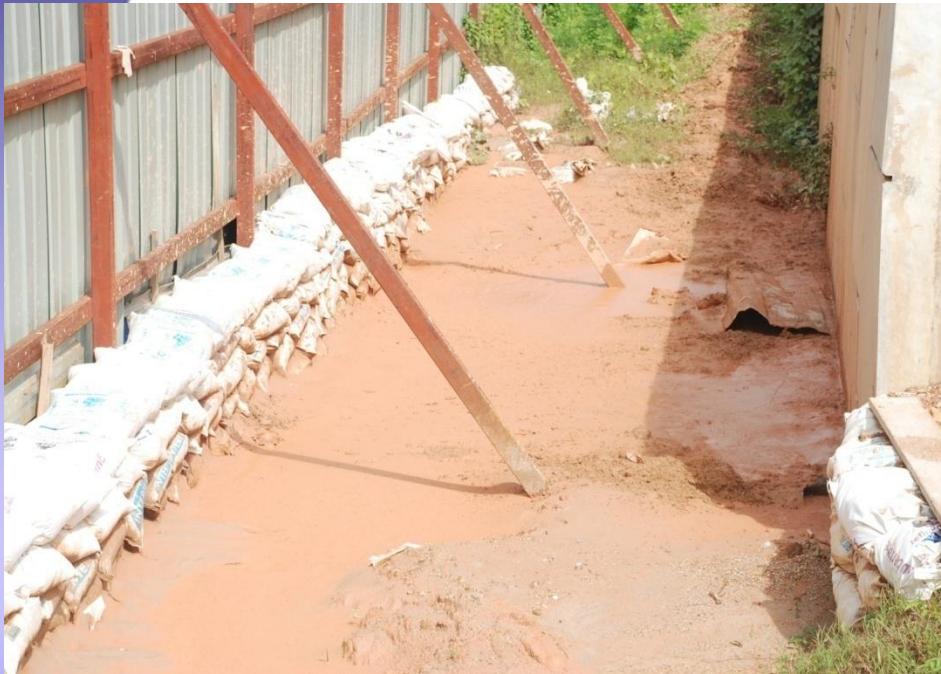
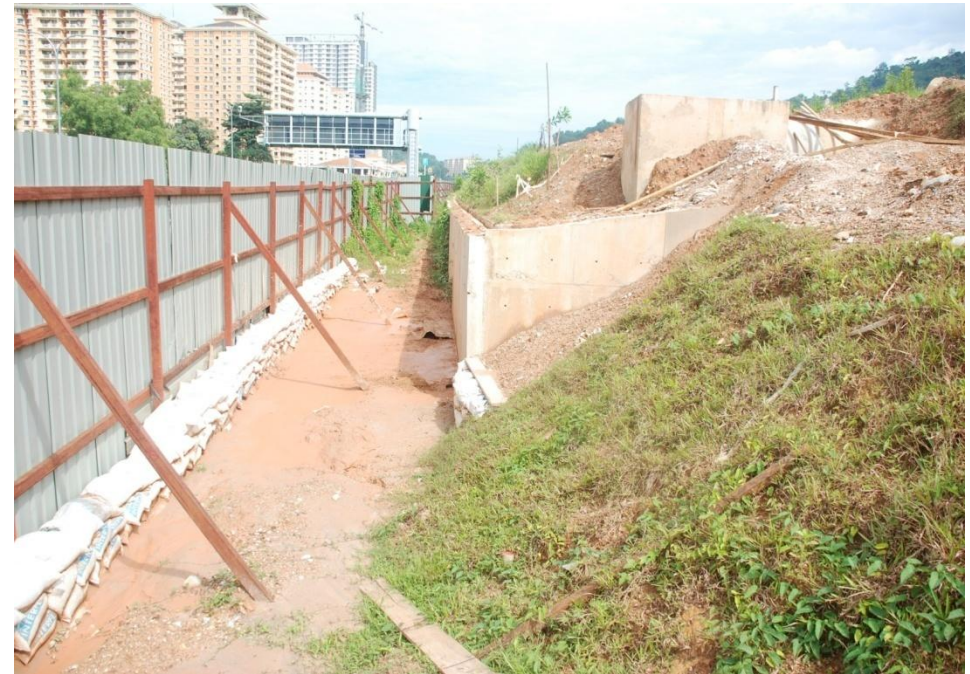
# MRR2 Highway on South-West: Evidence of silts deposition along the Sandbag perimeter barrier

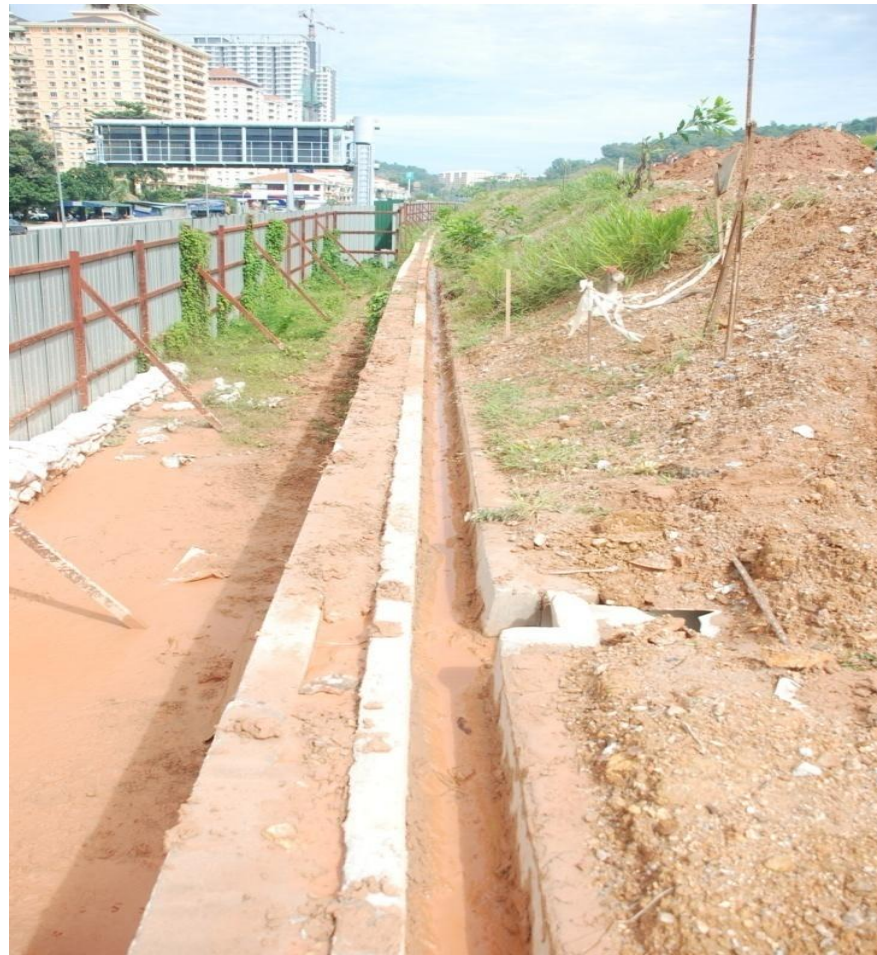
# MRR2 Highway on South-West: Evidence of silts deposition along the perimeter drain

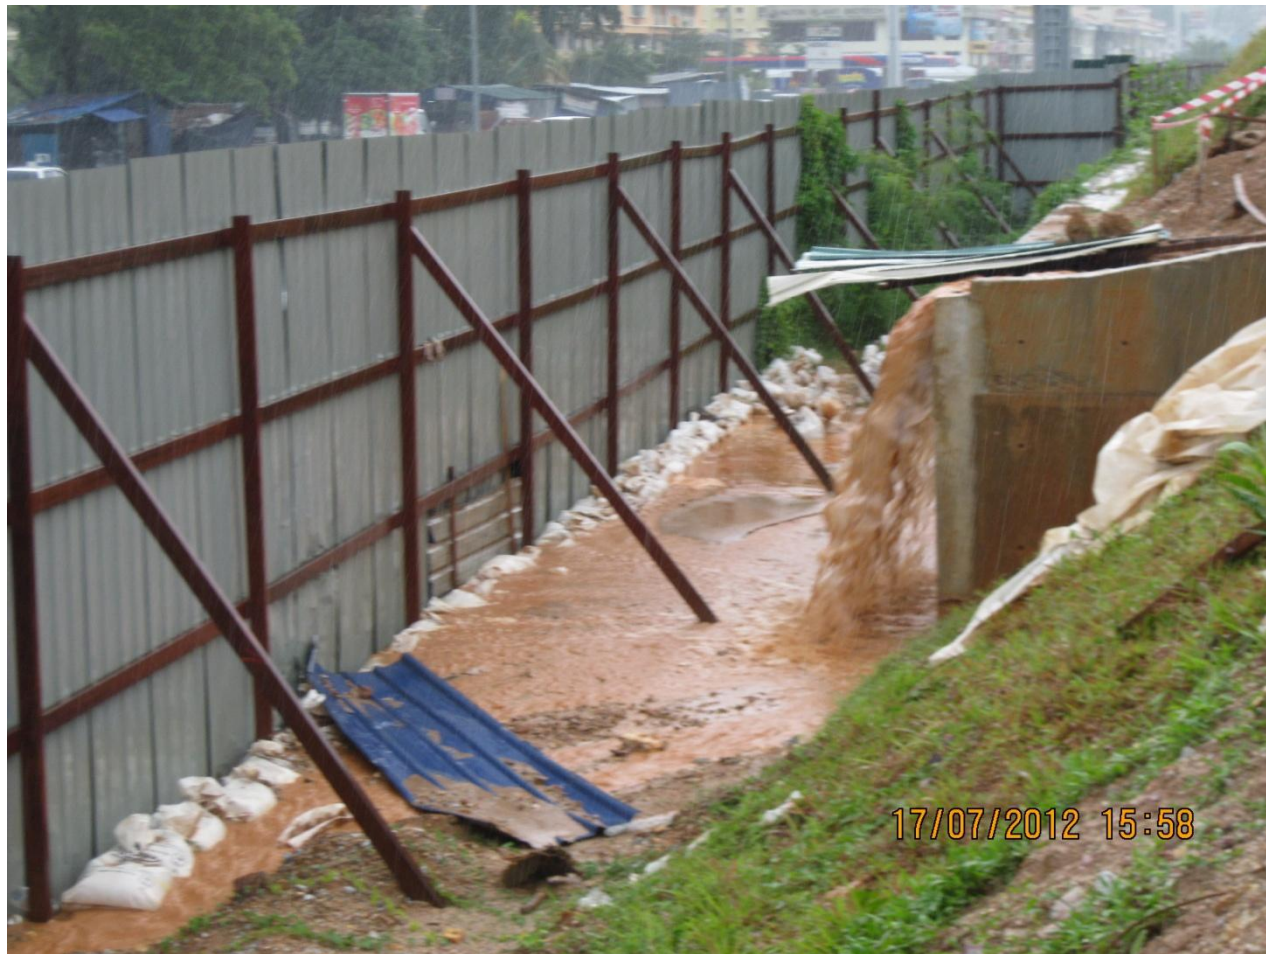
## At site perimeter during storm event

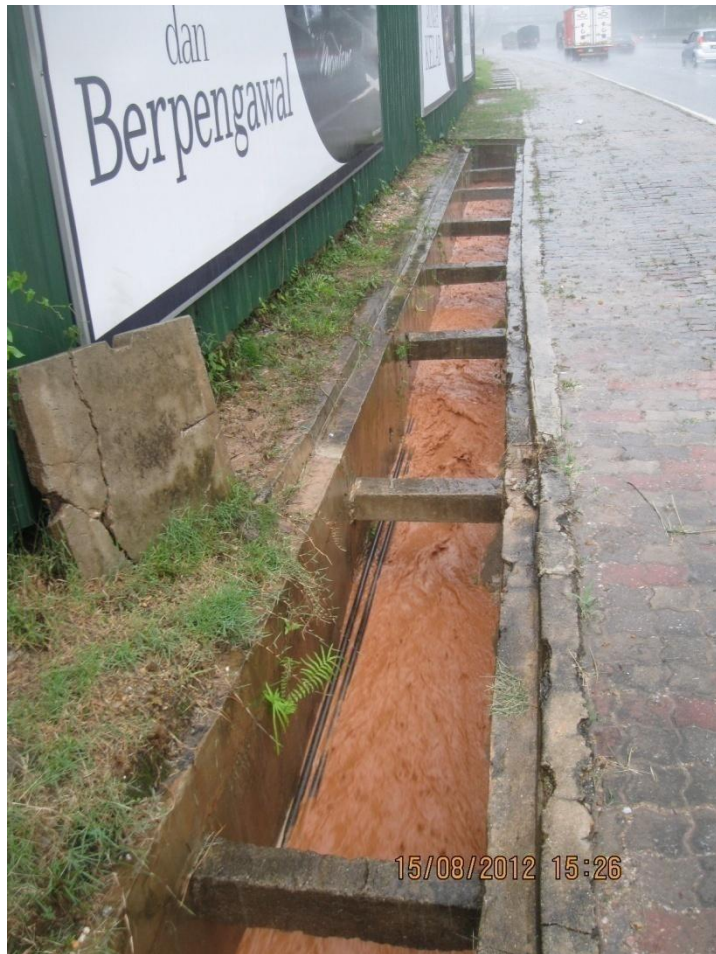
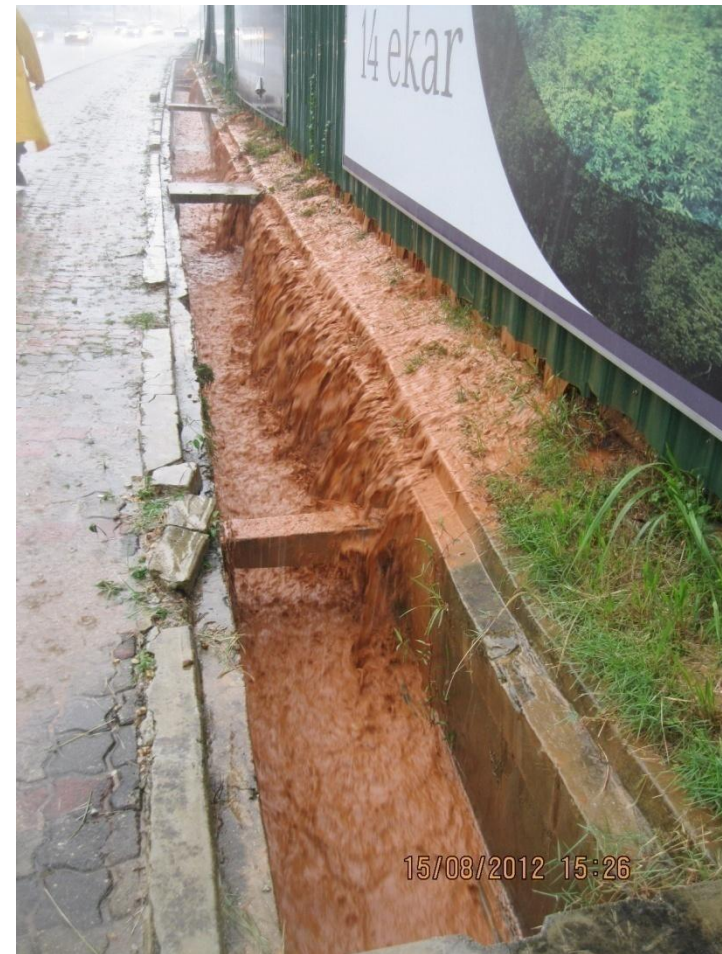
# Muddy water from the project site overflows into MRR2 highway roadside drain during heavy storm event.

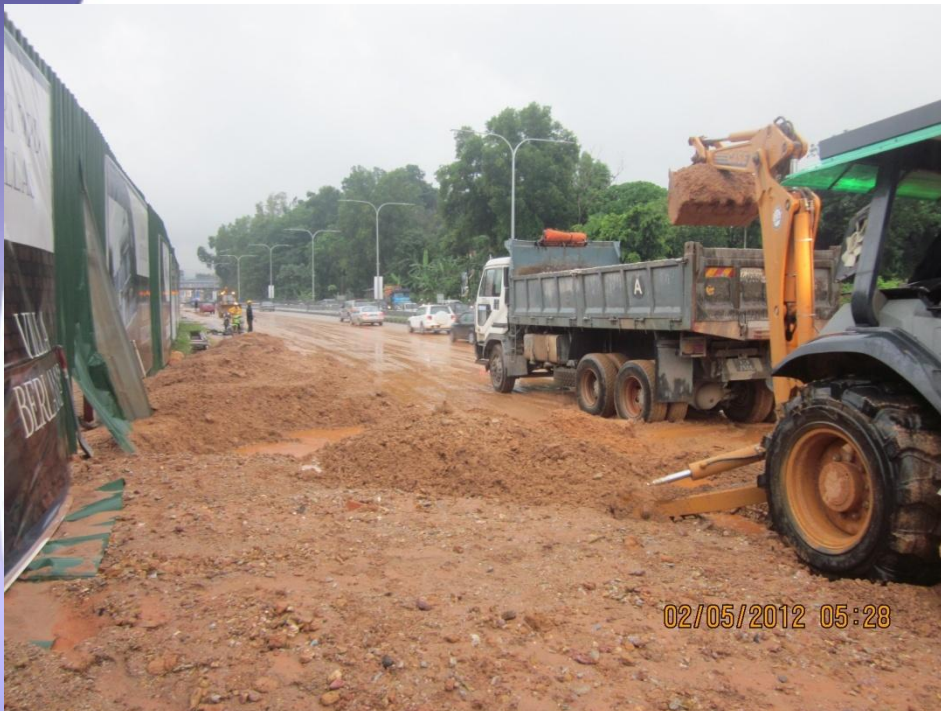
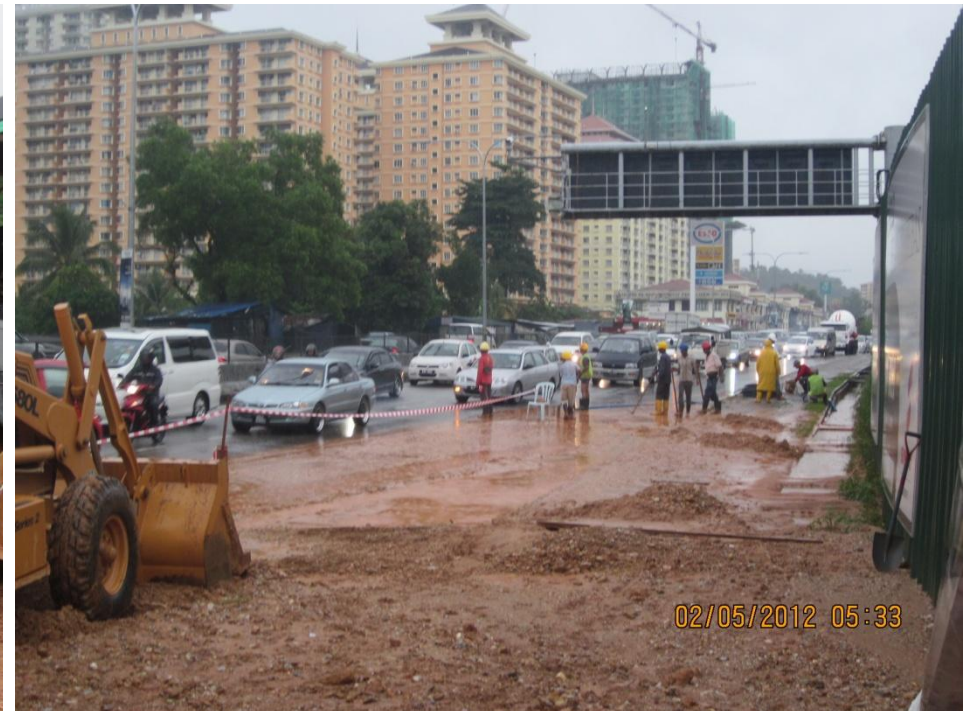
# Observe the tore fence and the quantity of earth eroded

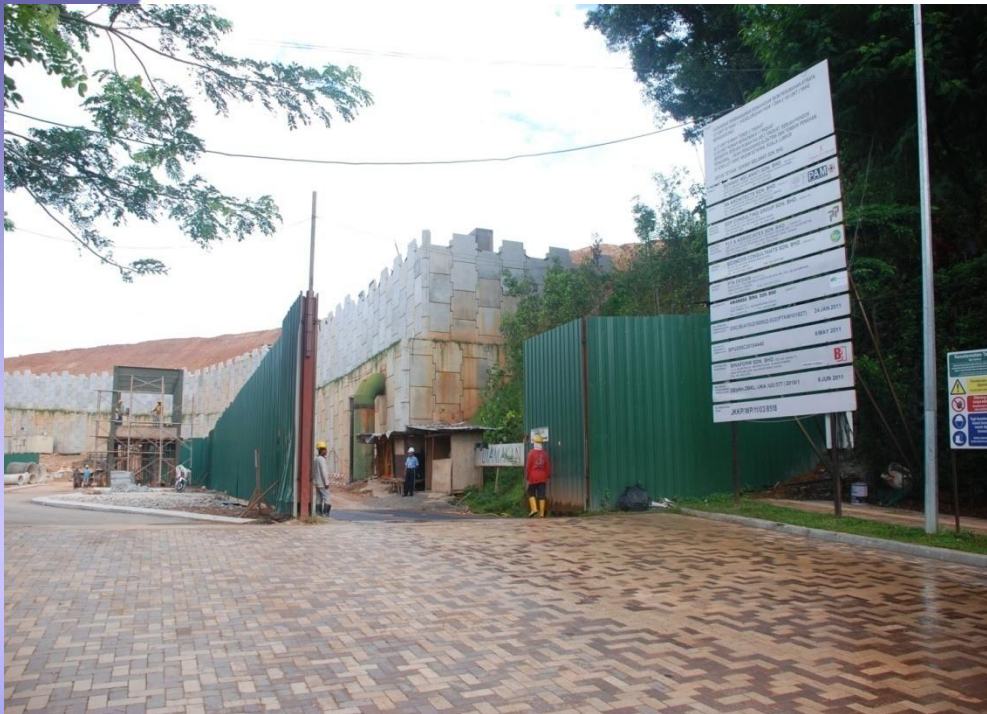
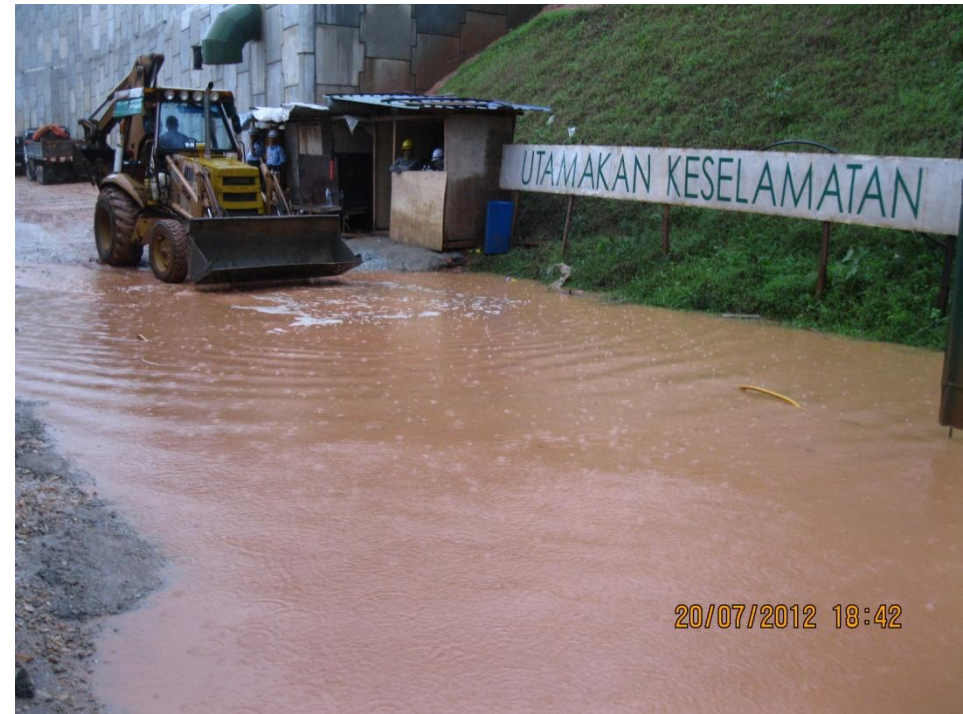
# Entrance to the Project Site is kept cleaned

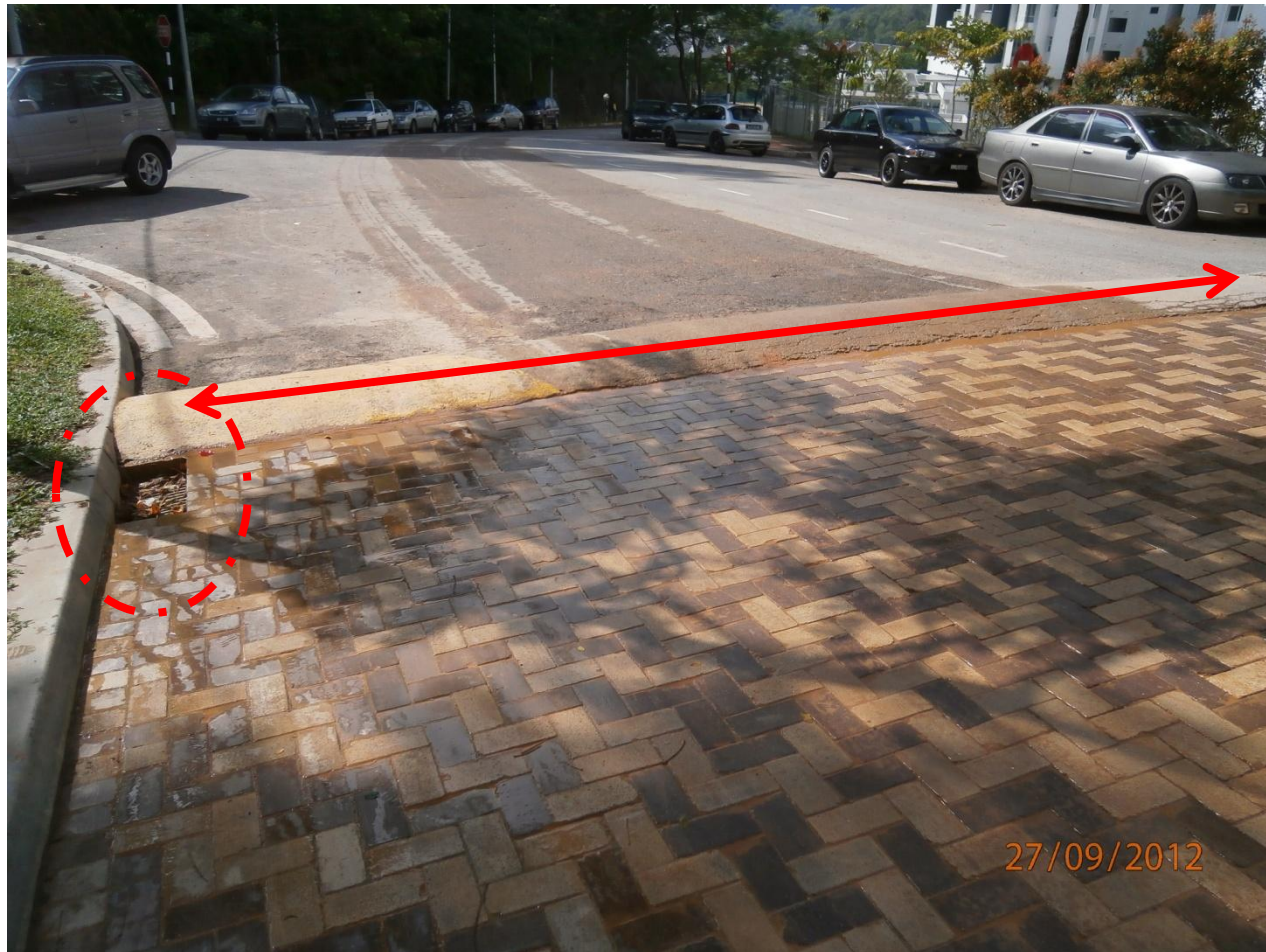
**Small sediment trap used as a secondary control after wash trough combined with hump/water bar prevent dirt water from flowing down the road surface.**

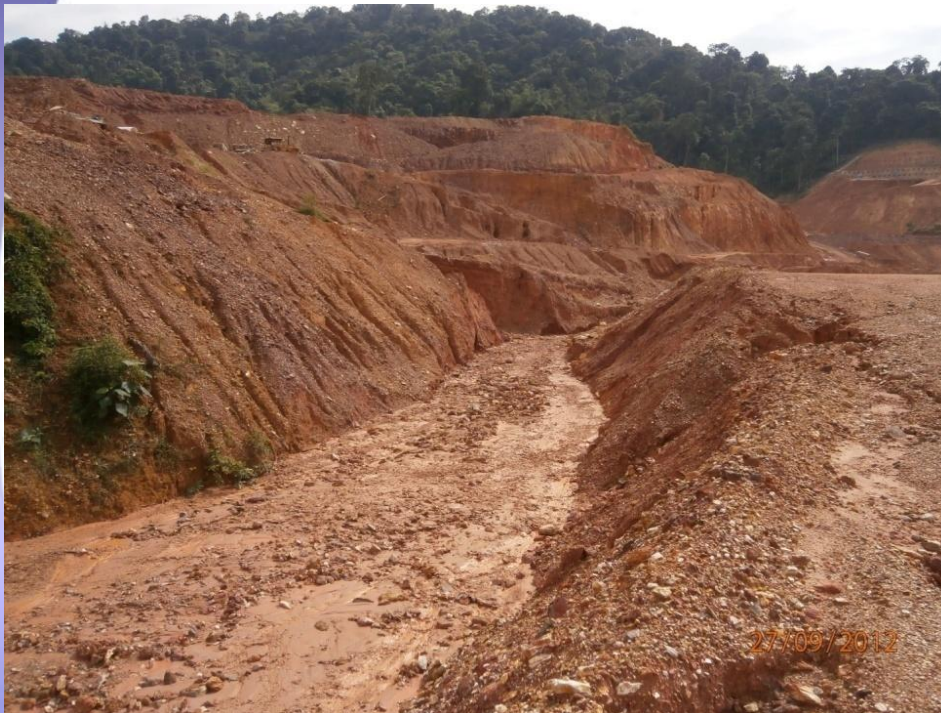
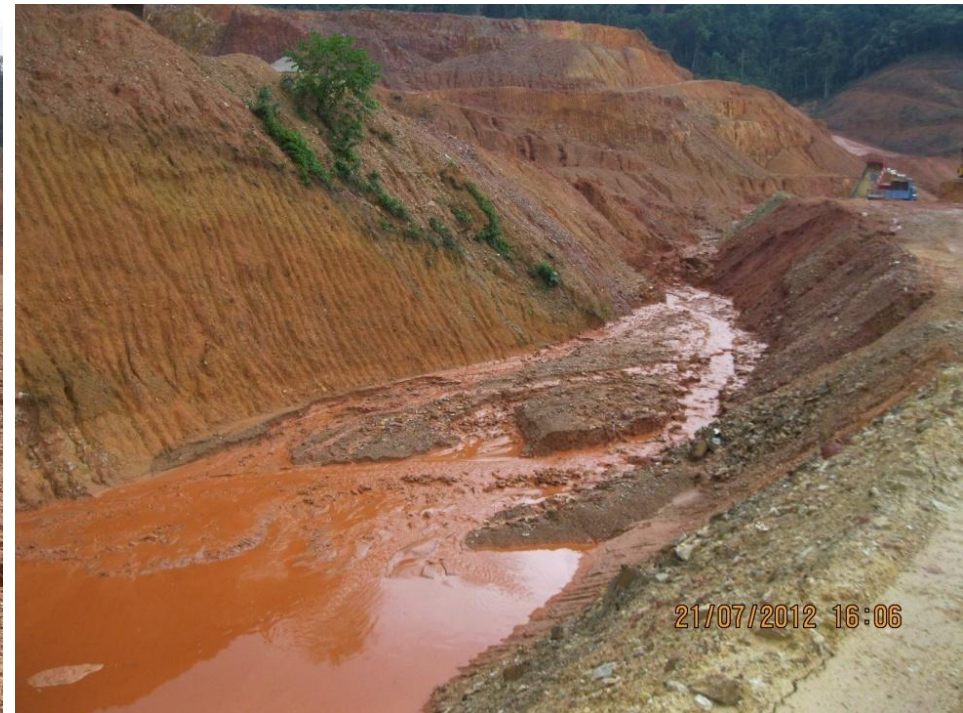
# Silted Drainageway Parcel 2

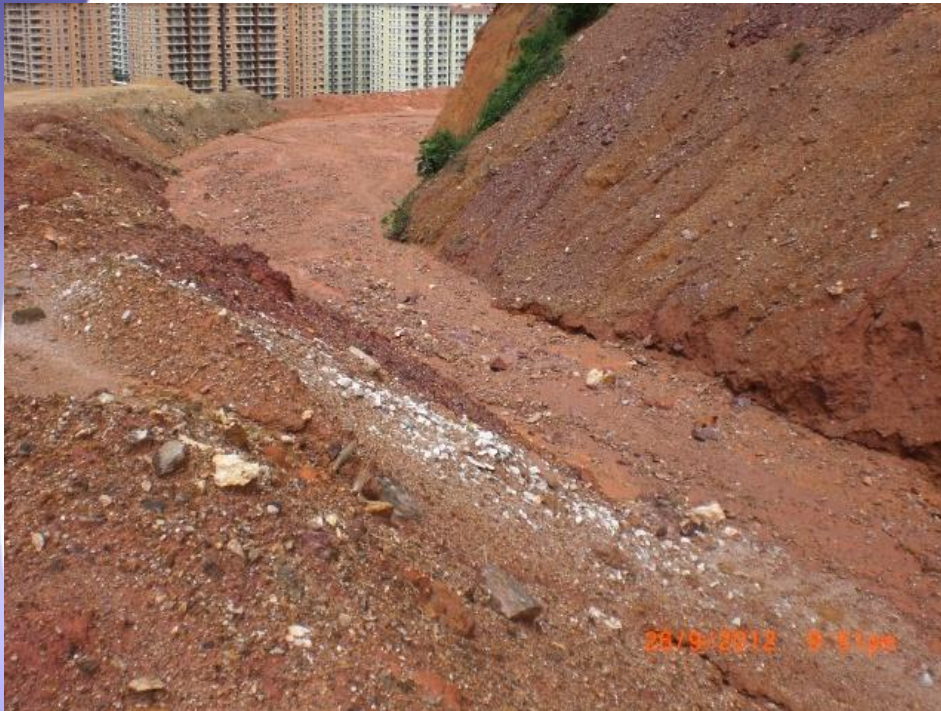
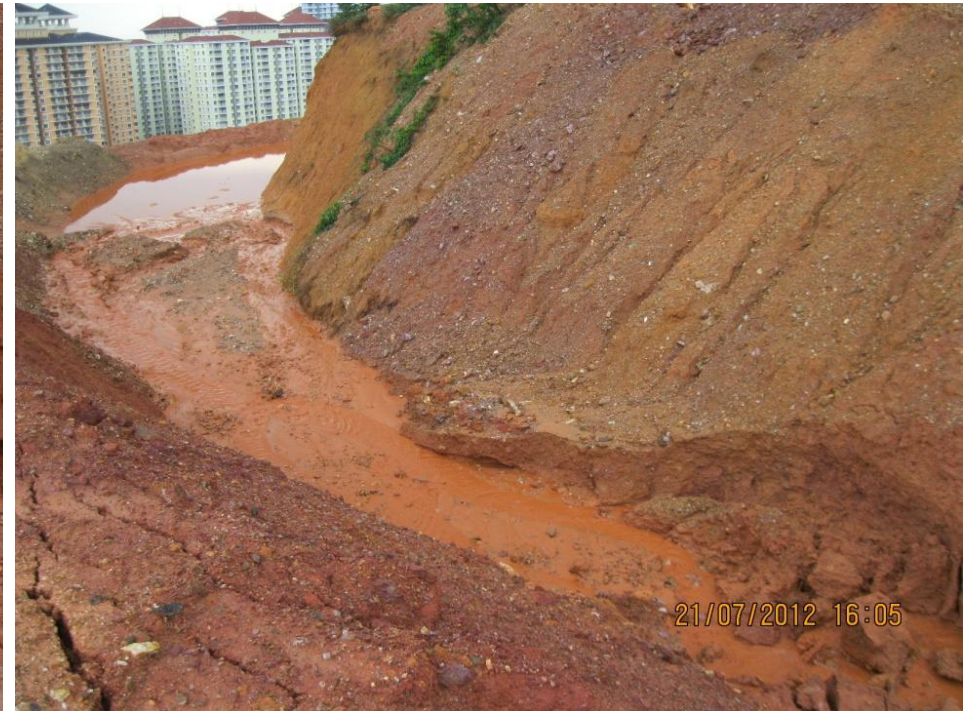
# Silted Drainageway Parcel 2

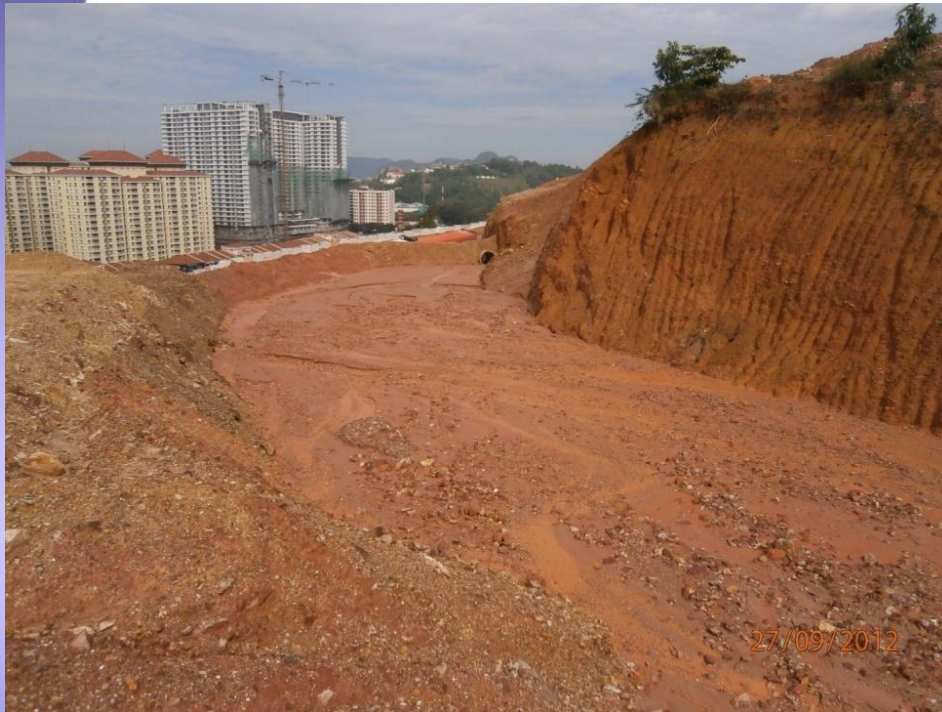
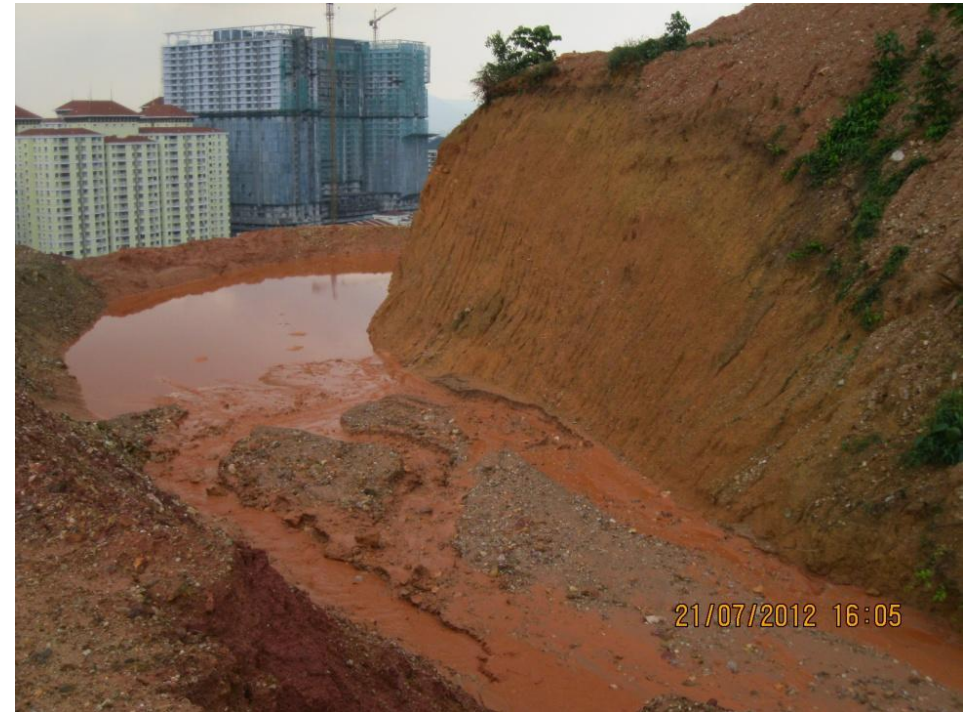
# Silted Drainageway Parcel 2

- ◆ Series of sediment trap/basin shall be constructed along the drainageway.
- ◆ Erosion and sediment control measures around this catchments area must be thoroughly revised and applied accordingly.

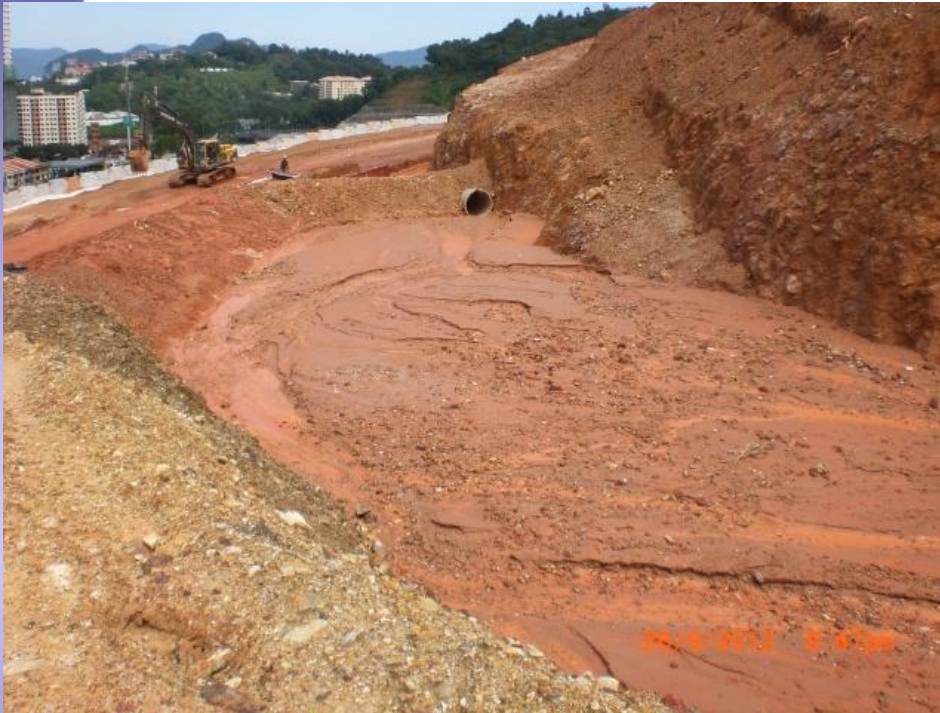
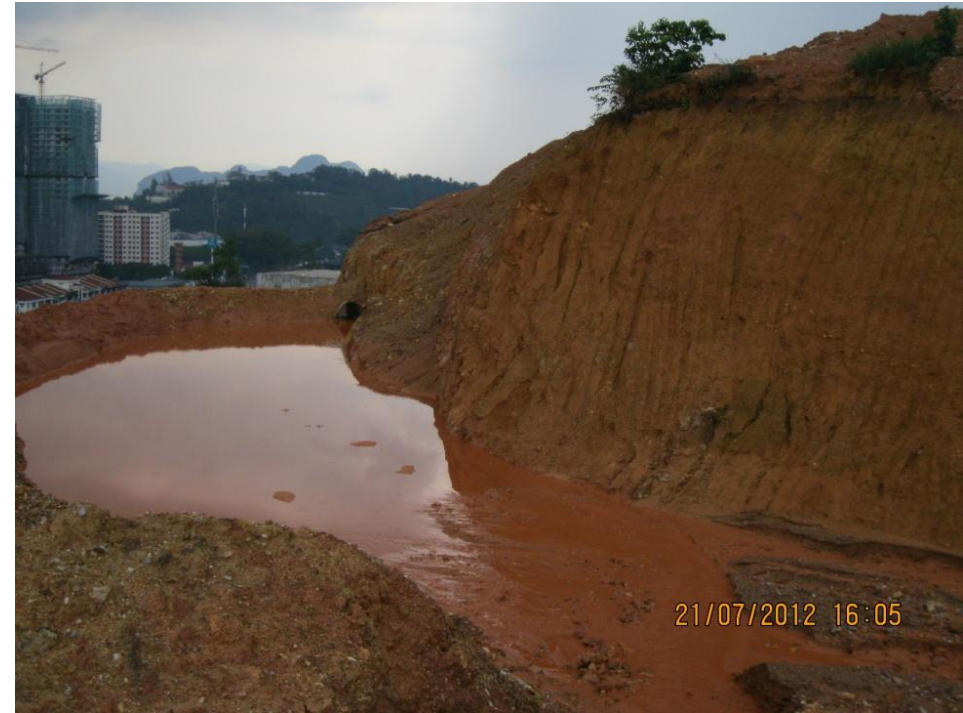
# Silted Drainageway Parcel 2. End point of drainageway been constructed earthen dam and with pipe outlet point.

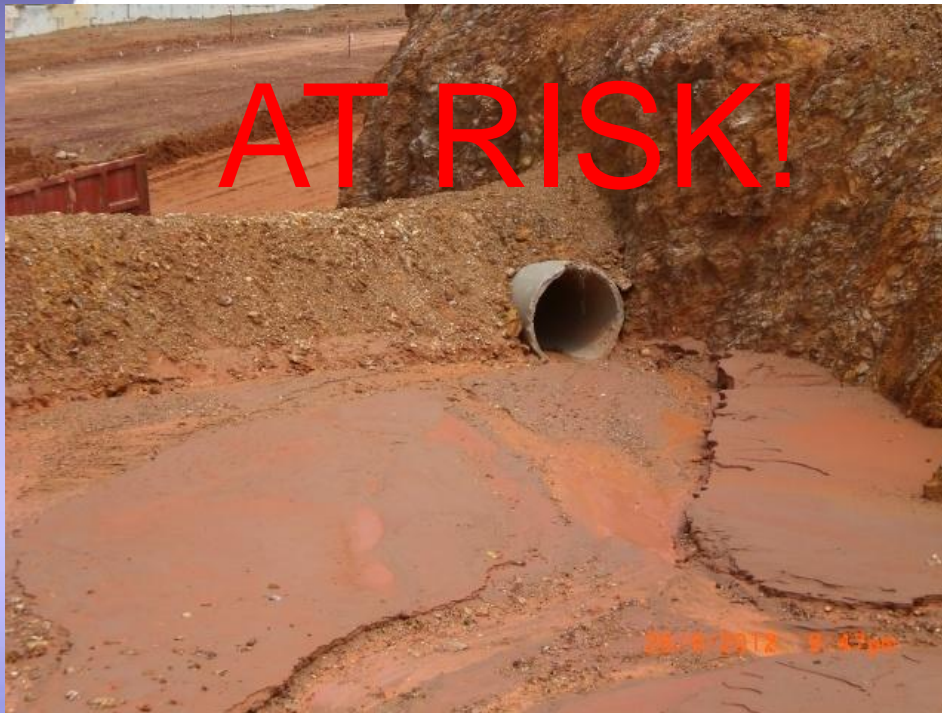
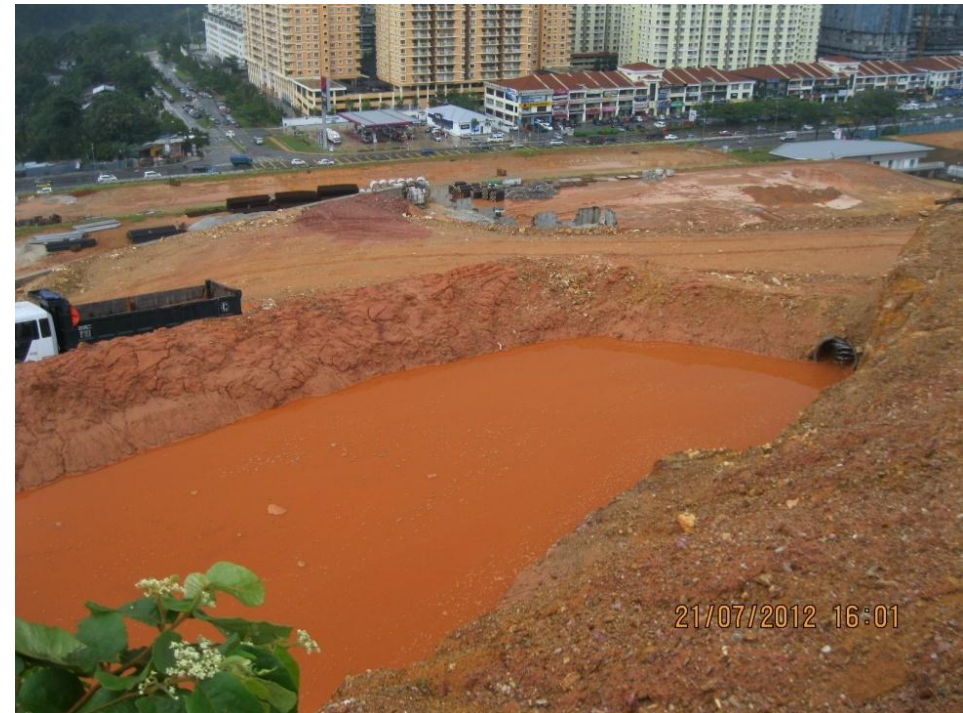
# Without proper structure and maintenance, this embankment may give way

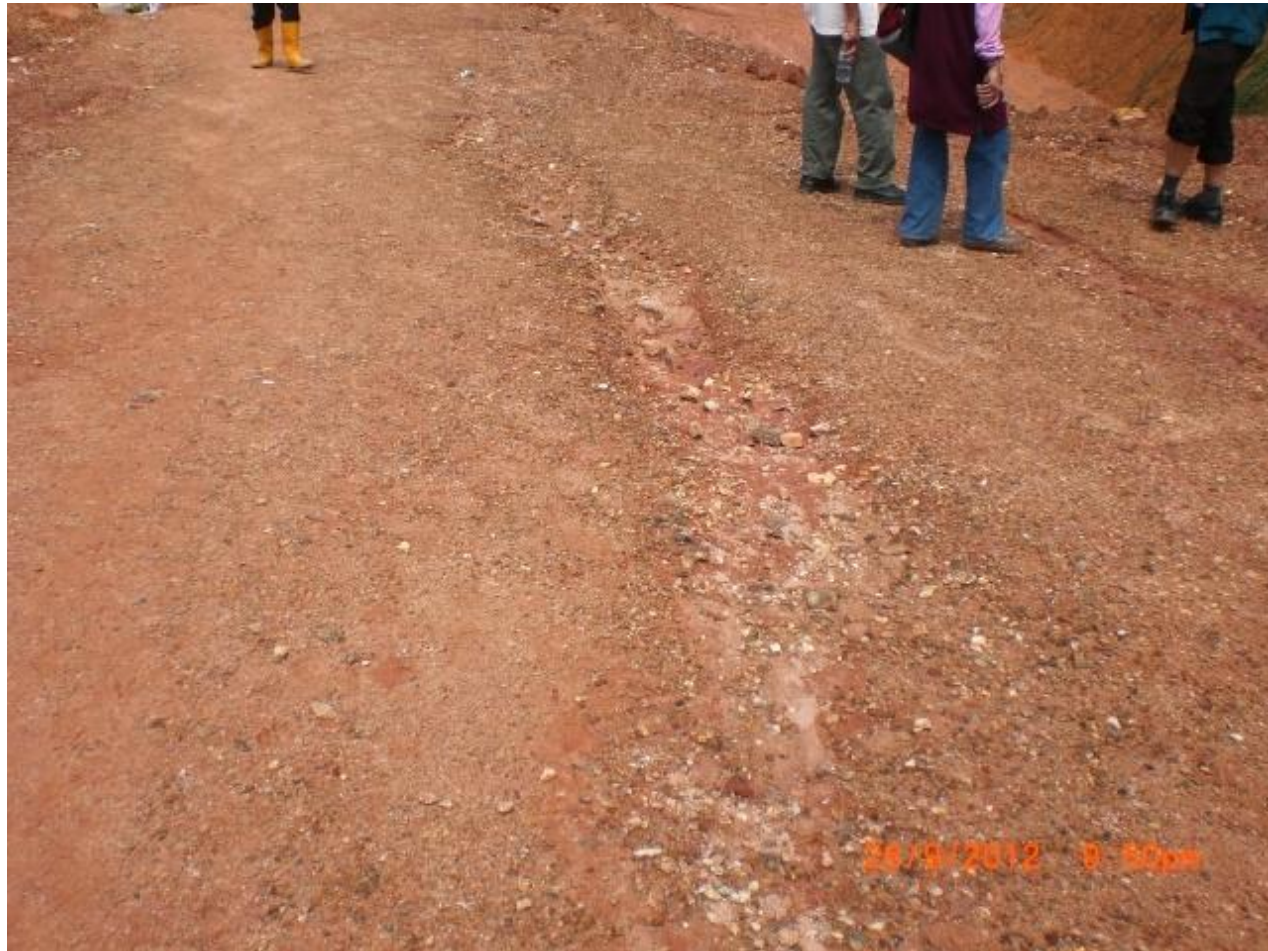
# Access Road

- ◆ Indicate unmanaged runoff flow.
- ◆ Use the maximum extent of runoff BMPs and wherever required apply temporary cover.

◆ EIA-4-08
