**Program Latihan Penguatkuasaan Untuk  
Pegawai JPS Bagi Pelaksanaan Perintah  
Kualiti Alam Sekeliling (Perwakilan Kuasa  
- Penyiasatan Ke Atas Kawalan Hakisan  
Dan Kelodakan)**

# BMPs INSPECTION

THE GOOD , THE BAD AND THE BMPs  
OPTION AND SELECTION

**Cad. Skim Perumahan 195 Unit Rumah Di Atas Lot  
30086 dan Lot 30087, Mukim Setapak, Kuala Lumpur  
oleh SUNWAY MELAWATI SDN BHD**

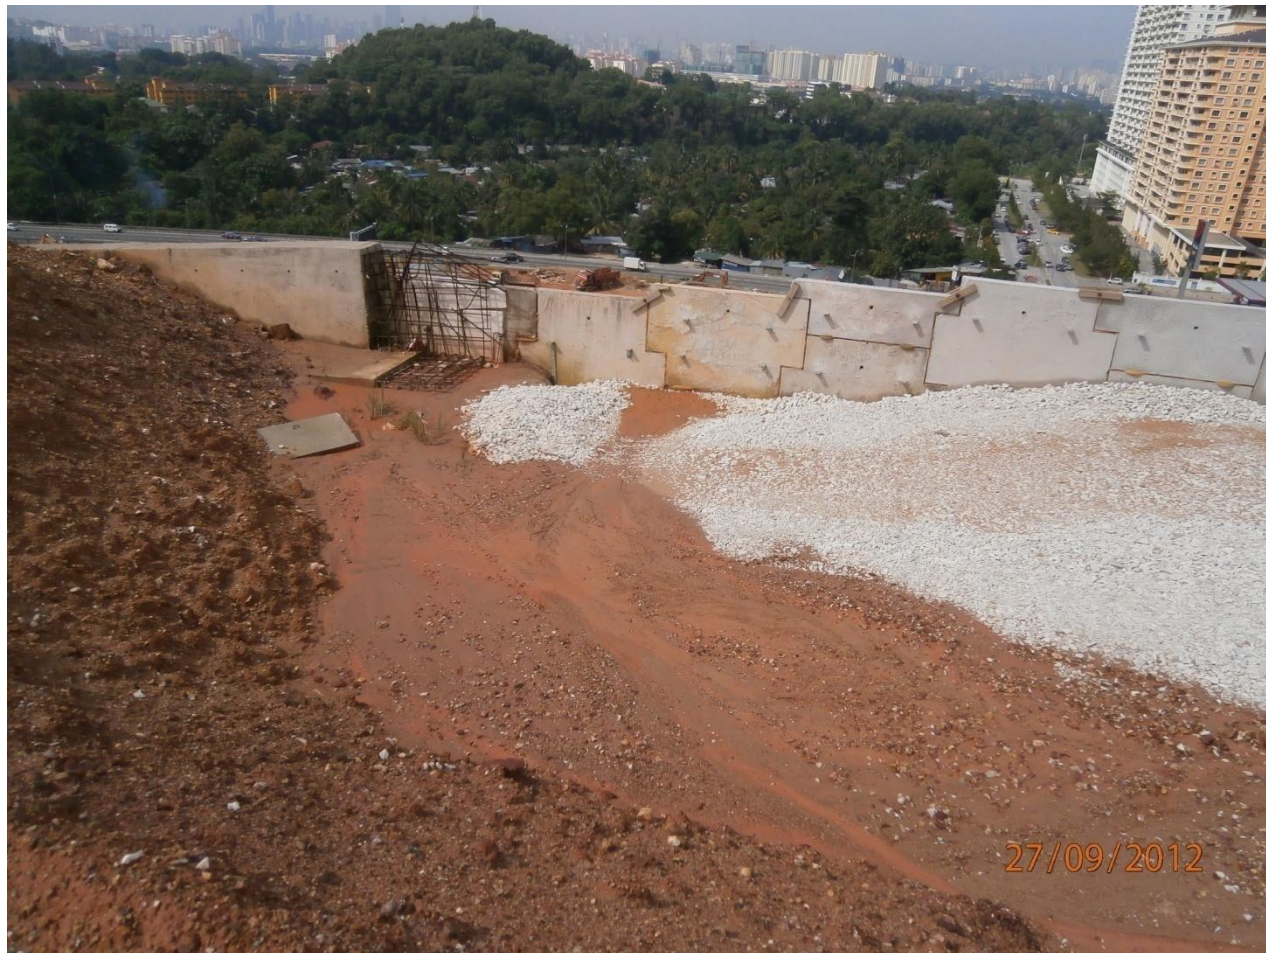
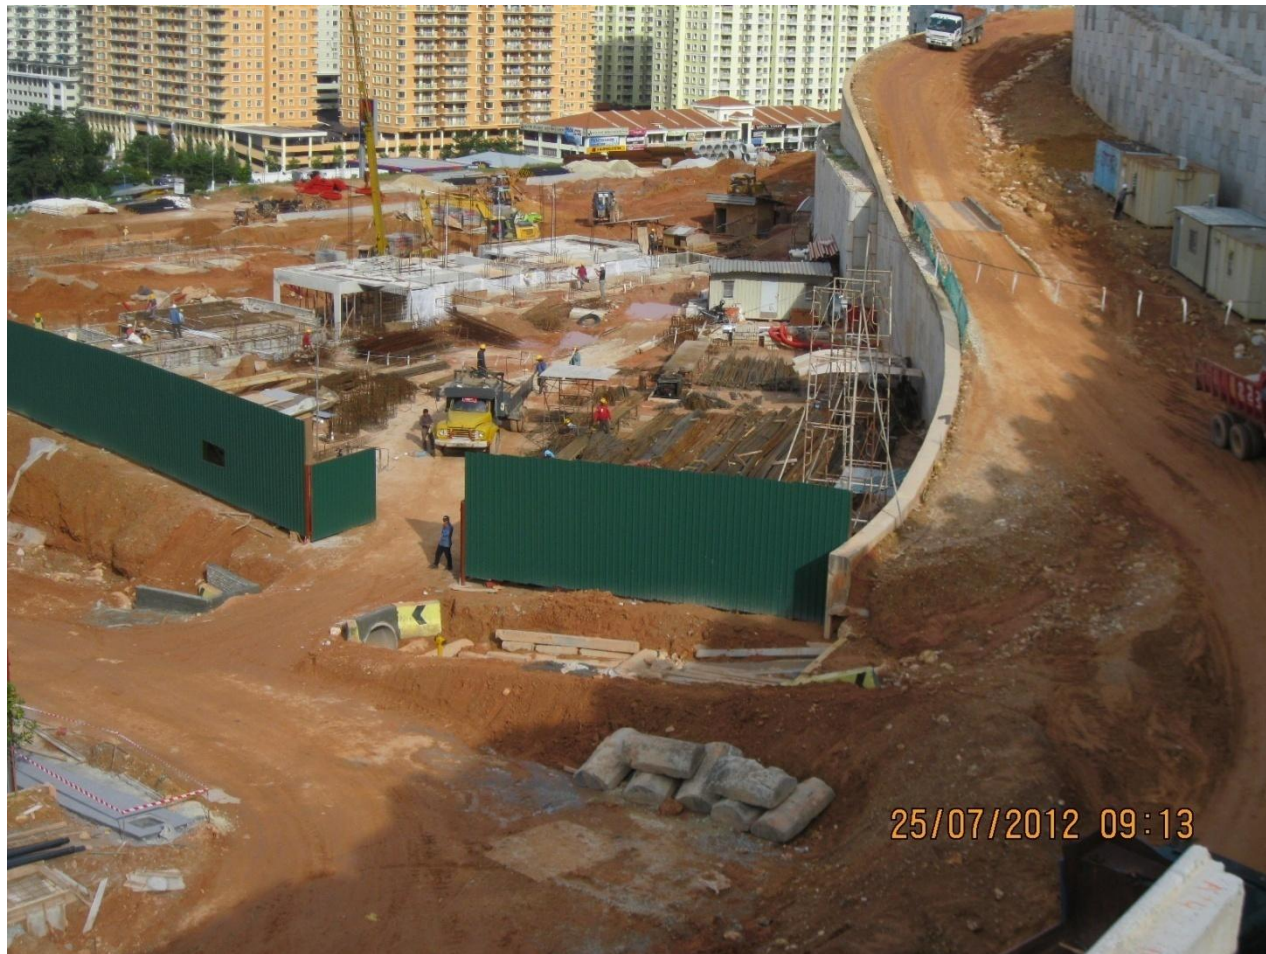
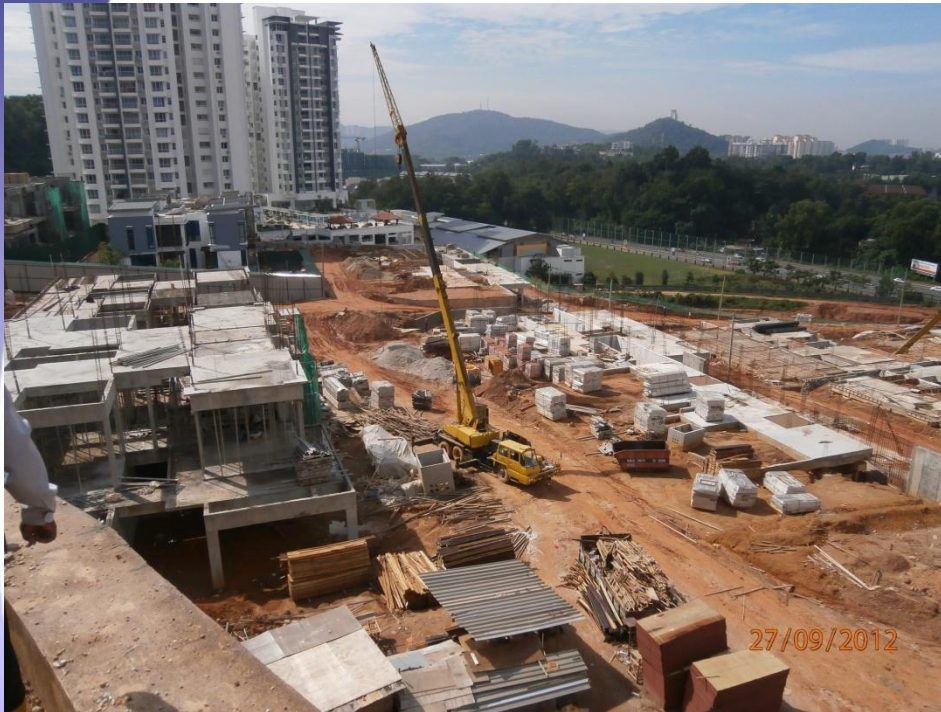
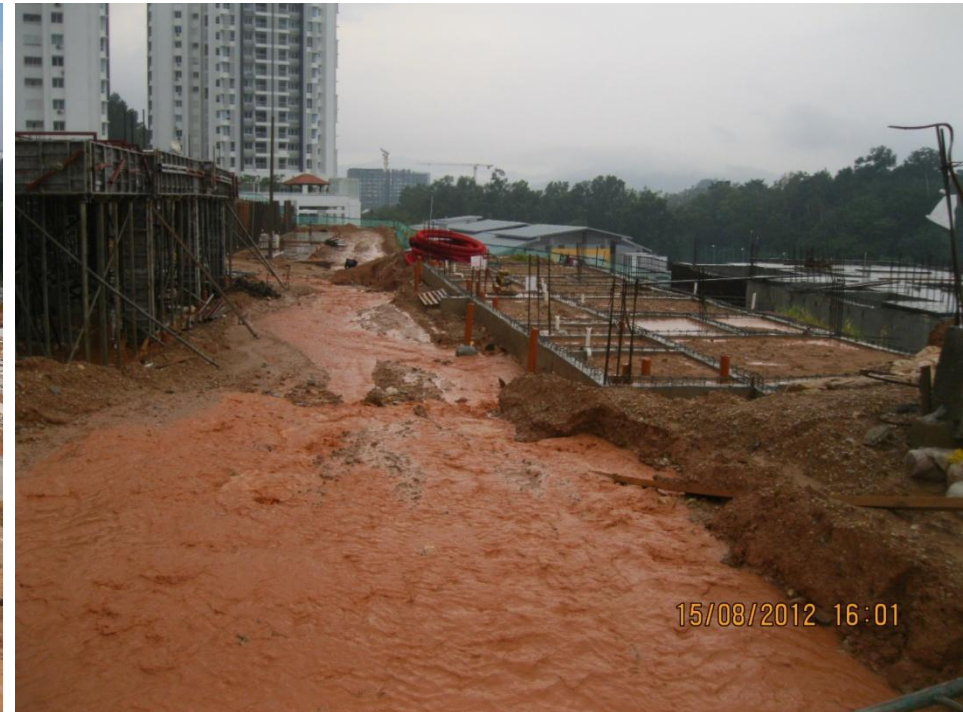
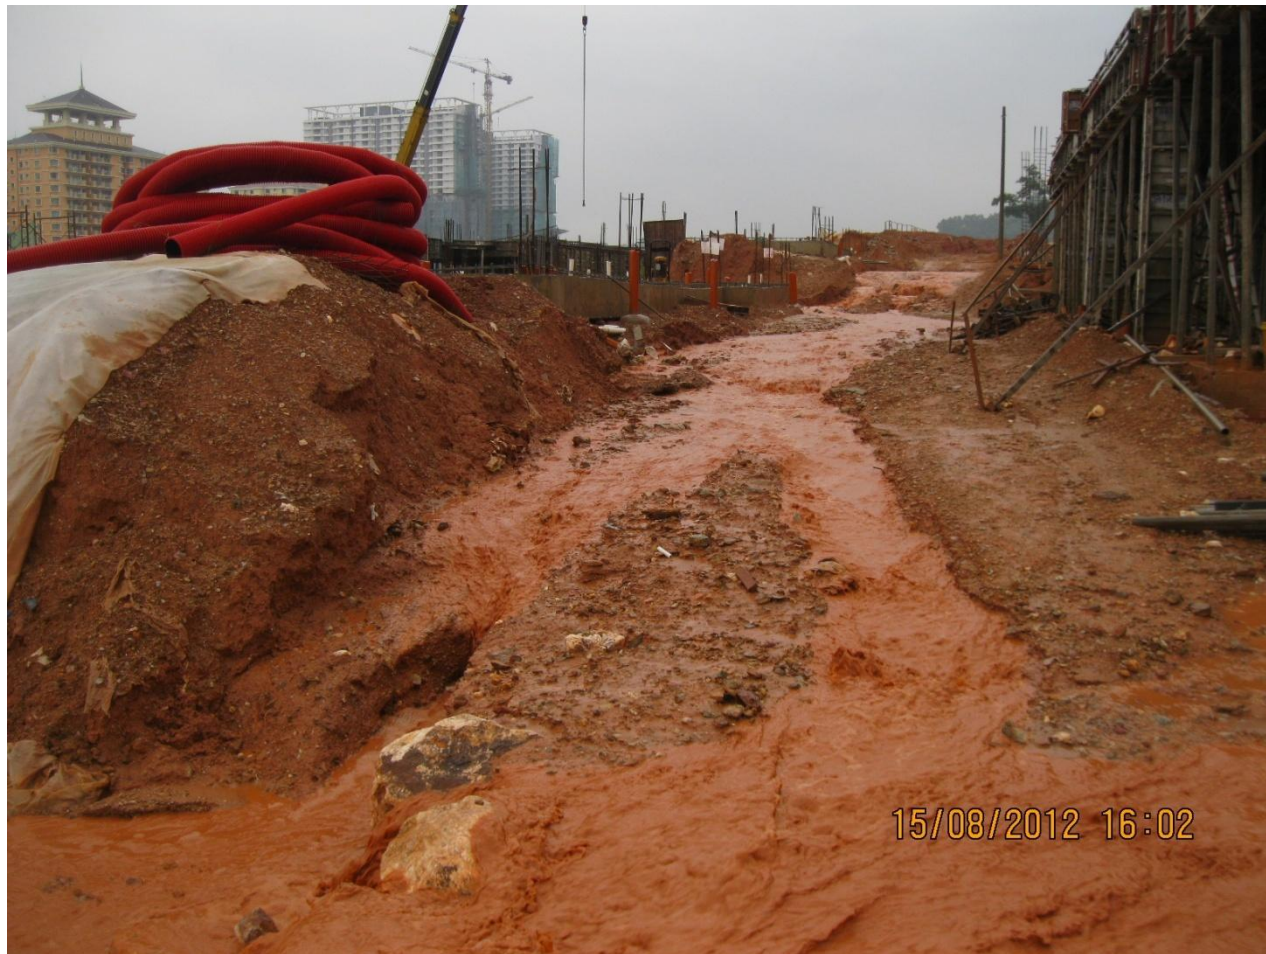
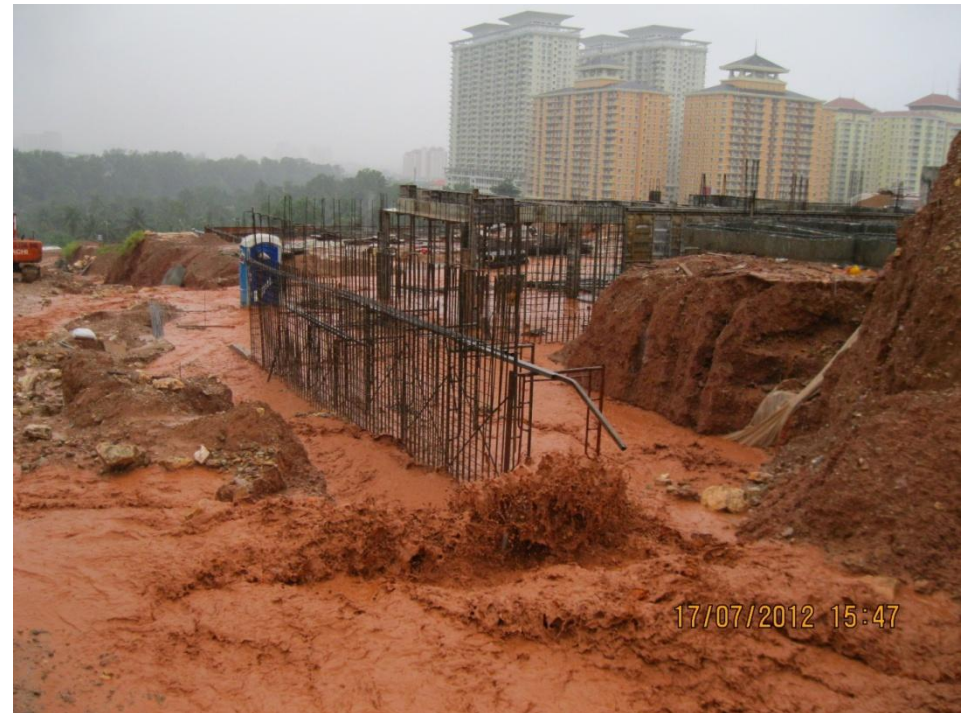
## Building Construction Area 2

- ◆ Indicate unmanaged runoff flow.
- ◆ Use the maximum extent of runoff BMPs and wherever required apply temporary cover.

◆ EIA-4-08

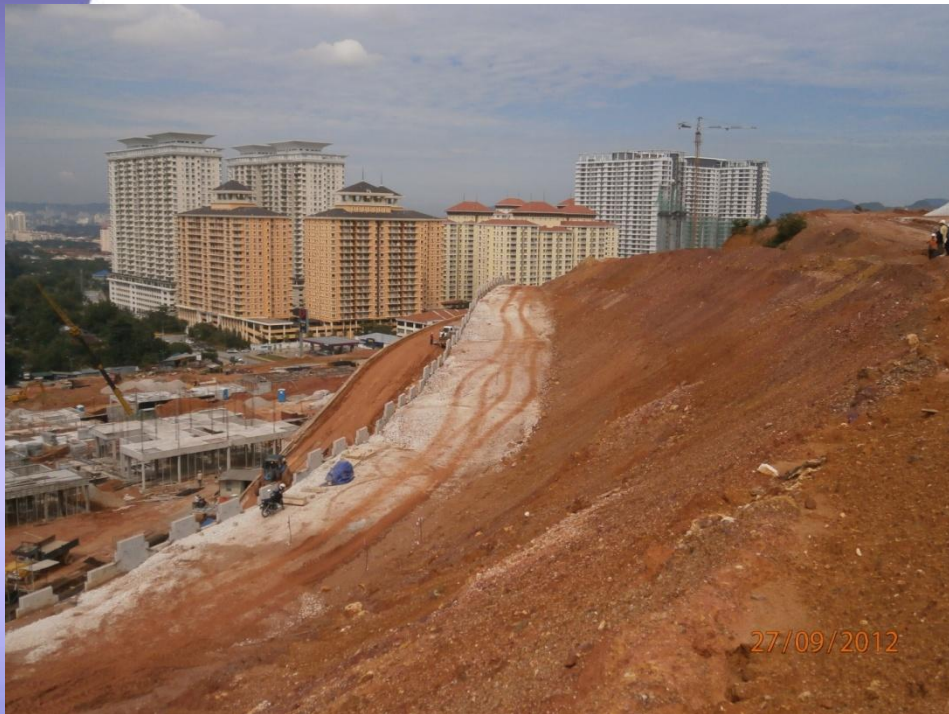
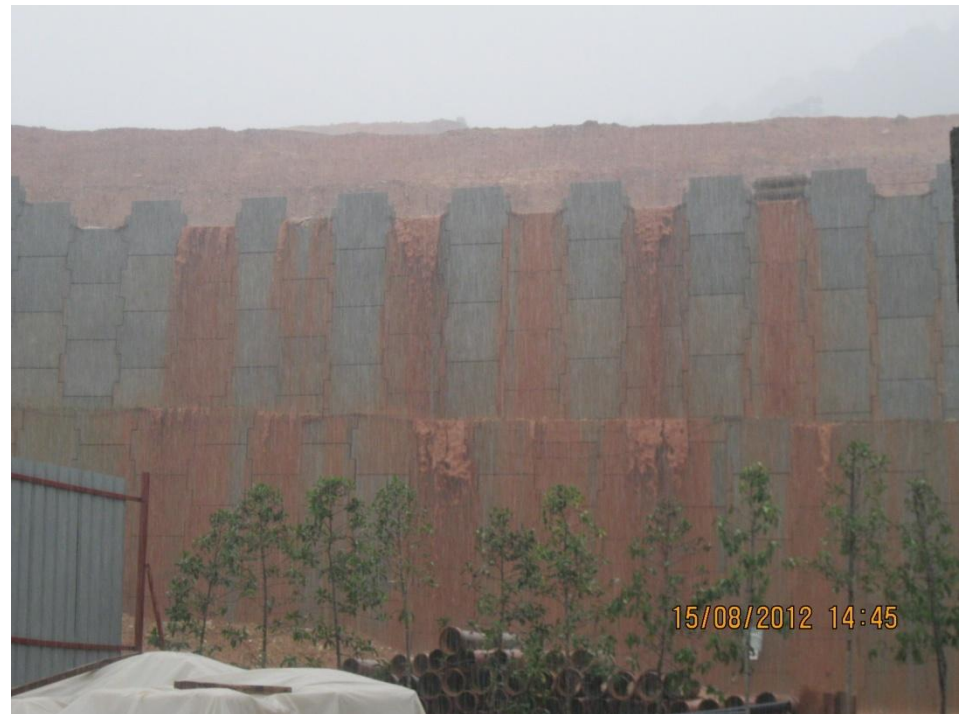
# Unprotected

- ◆ Slopes were not protected

- ◆ Cut and fill skills of slopes plays an important role in reducing the potential erosion problem. To complete certain cut/fill slope may take month, so method used such as terraces, benches and rounding the edge of the unfinished cutting of the most upslope shall reduce the vulnerability of the slope surface.
- ◆ Application of runoff BMPs such as temporary earth, interceptor, toe, cut-off and berms drains is mandatory in dealing with slopes formation process. Incomplete slopes formation that left exposed of more than 2 weeks shall be temporarily covered.

- ◆ EIA 4-08
- ◆ Notice S31

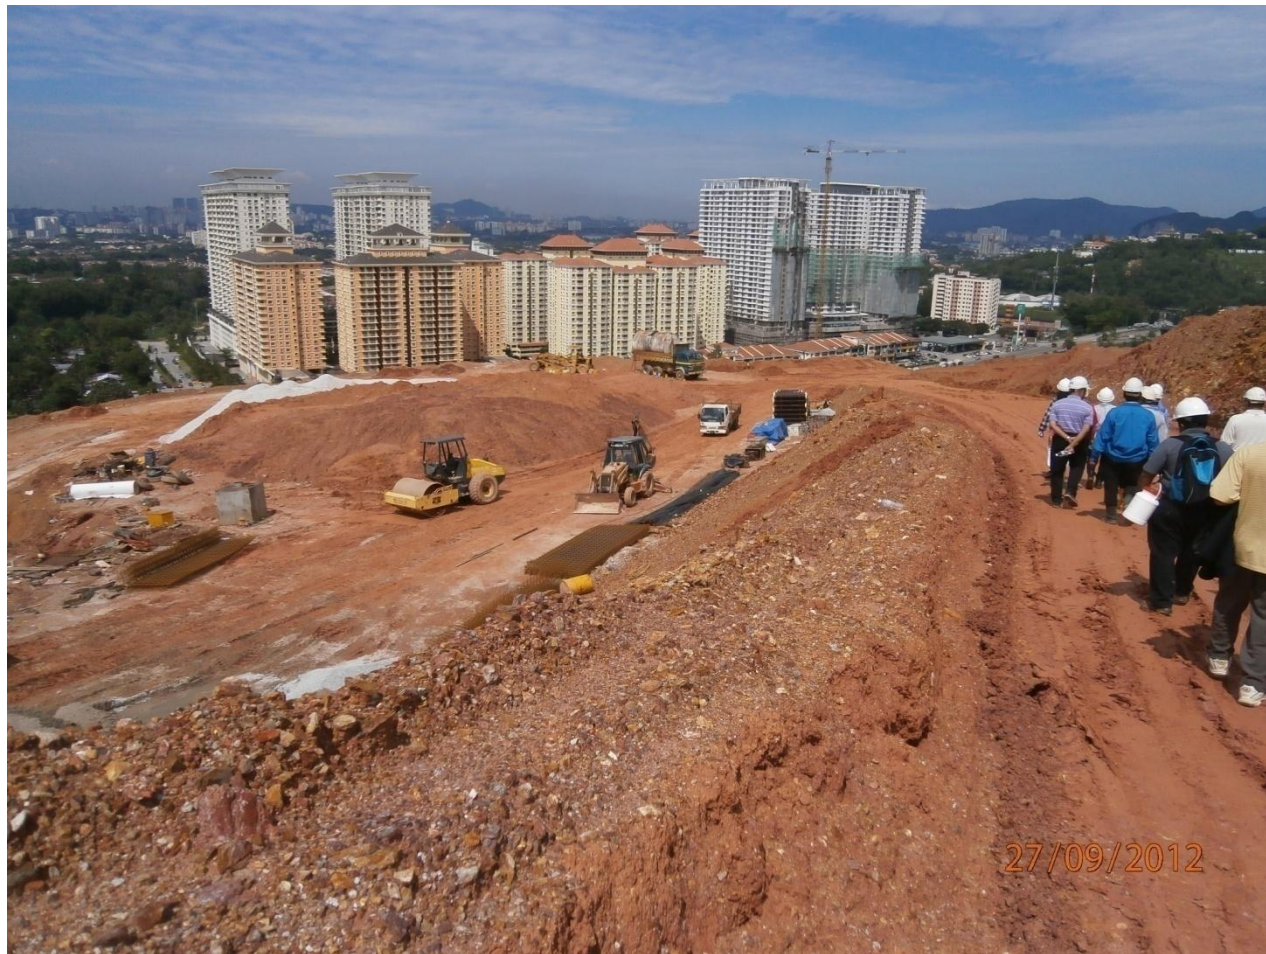
# Almost all of the active construction area left unprotected

- ◆ Not a single effort to temporarily cover with seeding or hydroseed seen around this project area particularly active or changing site elevation and condition.

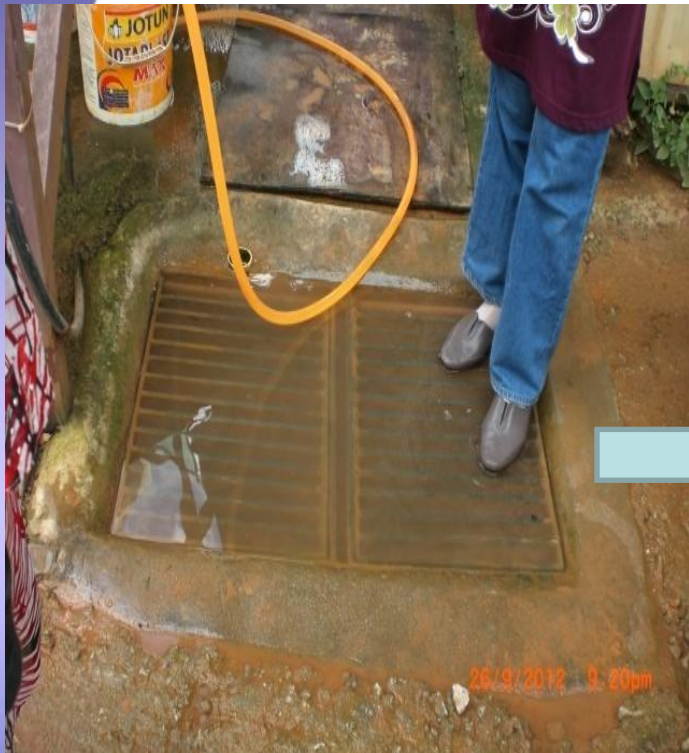
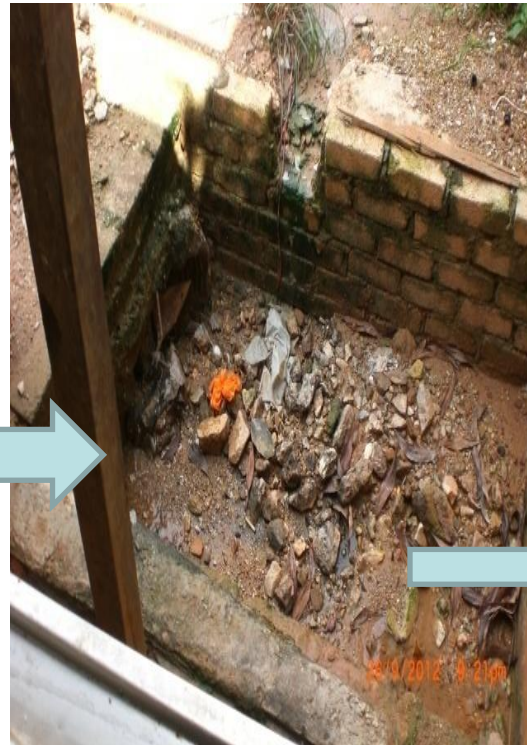
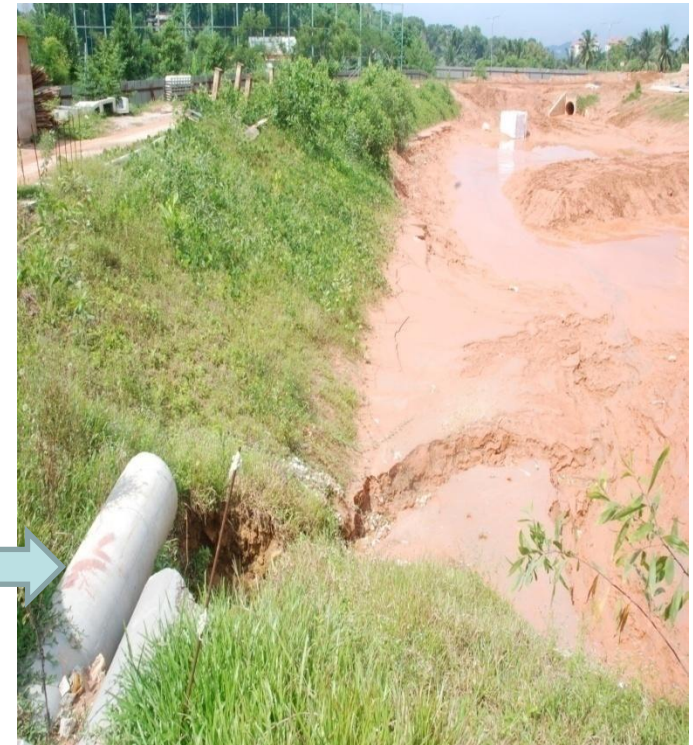
# Dirt washed water facility drains into SB 1

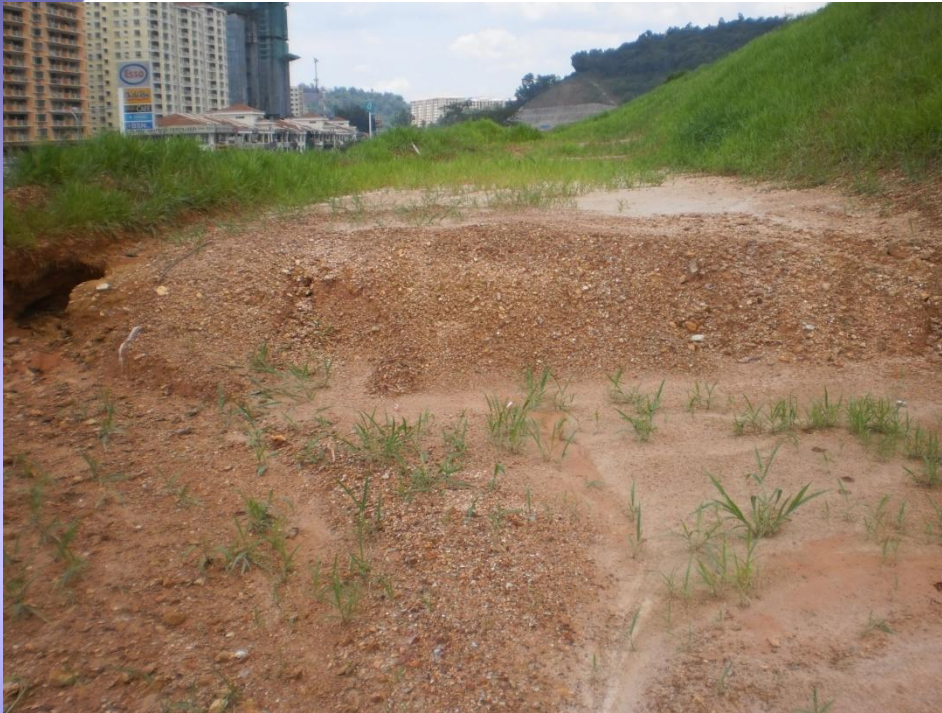
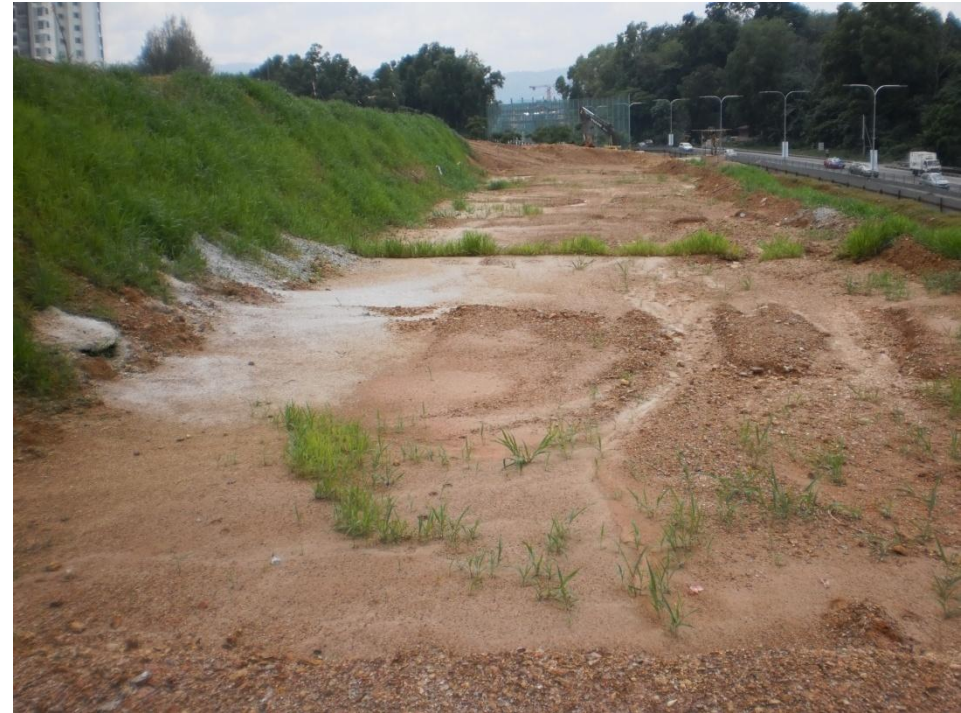
# HYDROSEEDING

**Not seen other than slopes along the southwest side of the project site parallel to MRR2 highway.**

- ◆ Temporary Hydroseeding should have been applied to all of the critical slopes nevertheless it may be complete or not.

- ◆ Implemented properly and functioning.
- ◆ EIA-3-08.

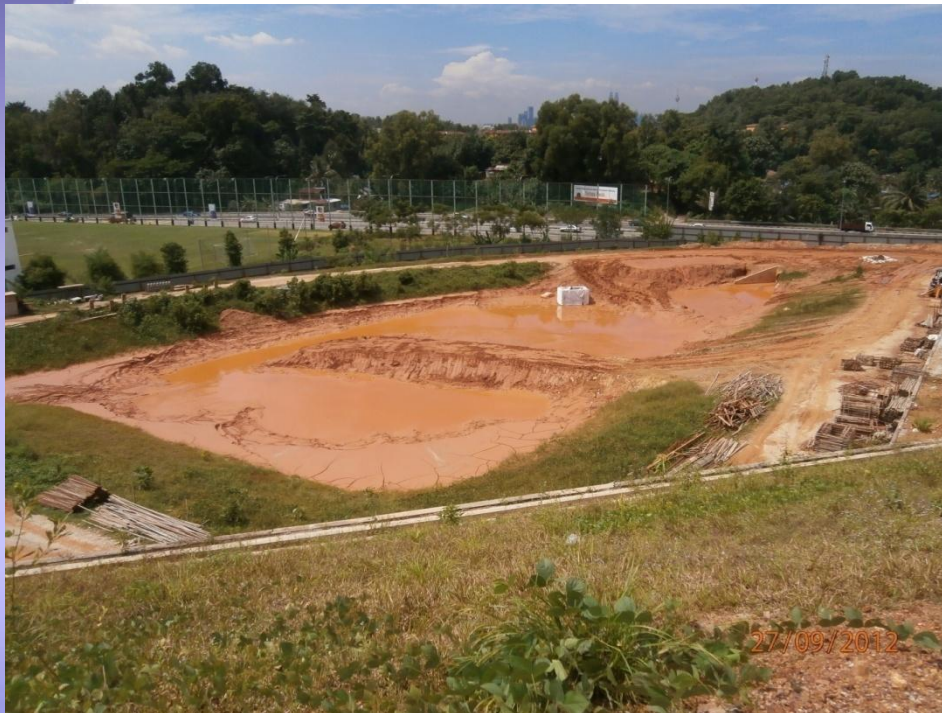
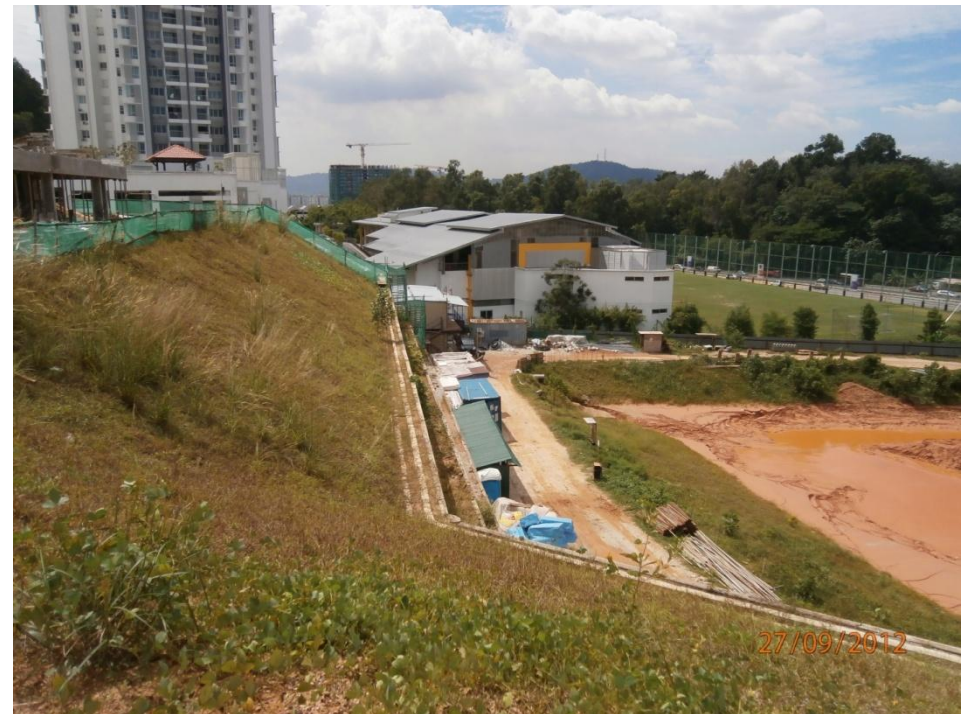
# Sediment Basin Embankment and Side-slope well turfed

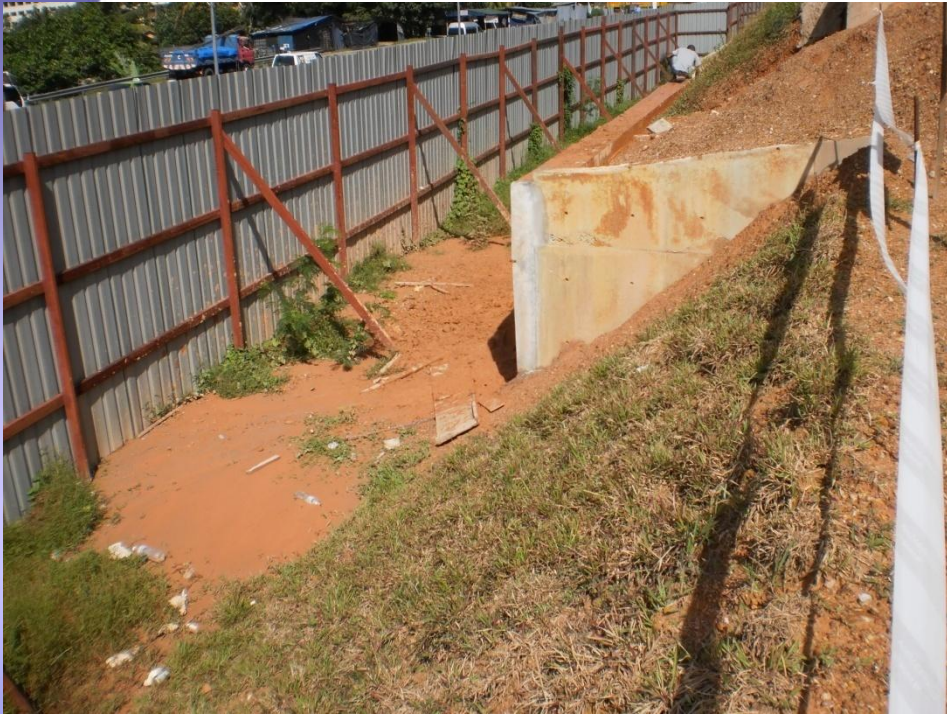
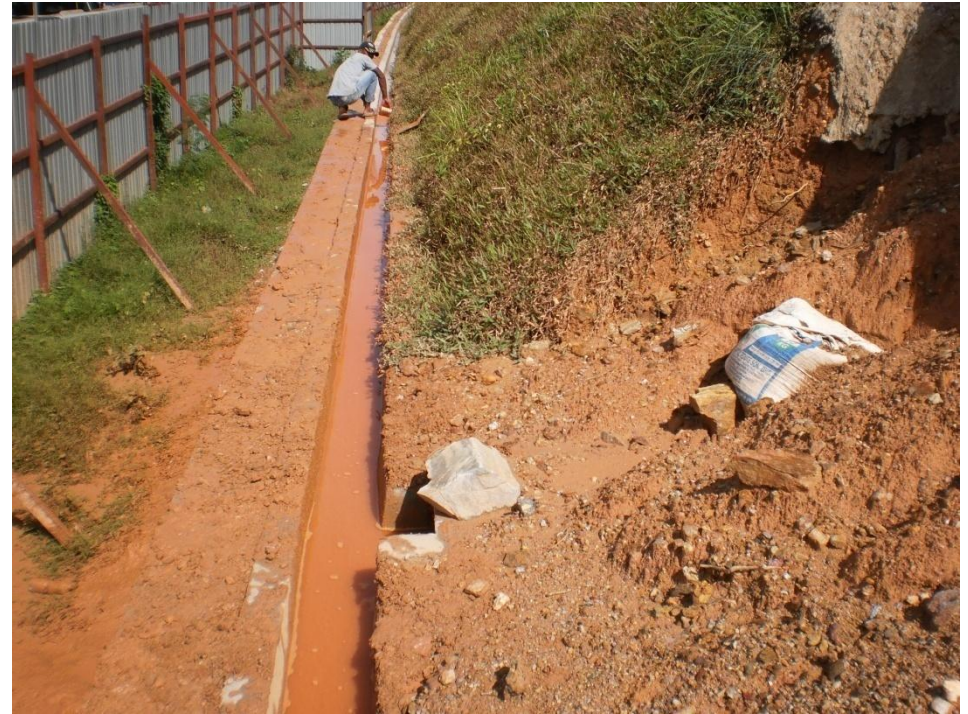
Other areas are not seen, except around the perimeter along the MRR2 highway.

- ◆ Must be applied immediately upon completion of slopes and any other unattended flat surface areas.

- ◆ Nicely done and functioning.
- ◆ EIA-3-08

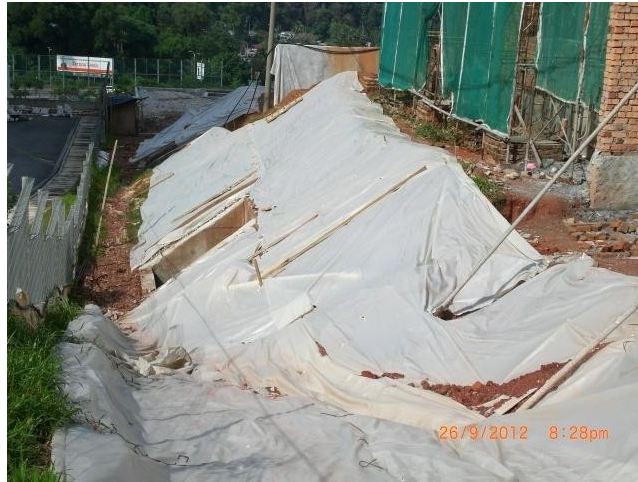
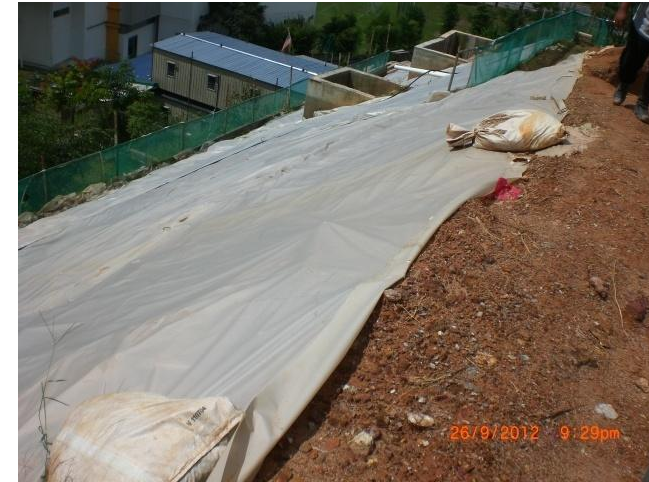
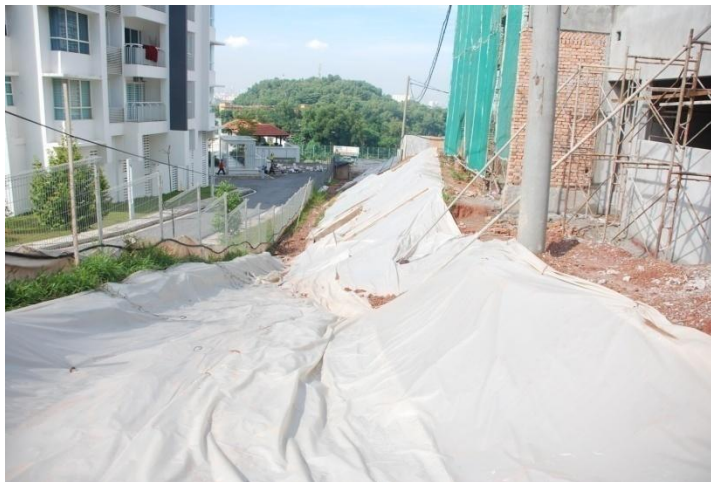
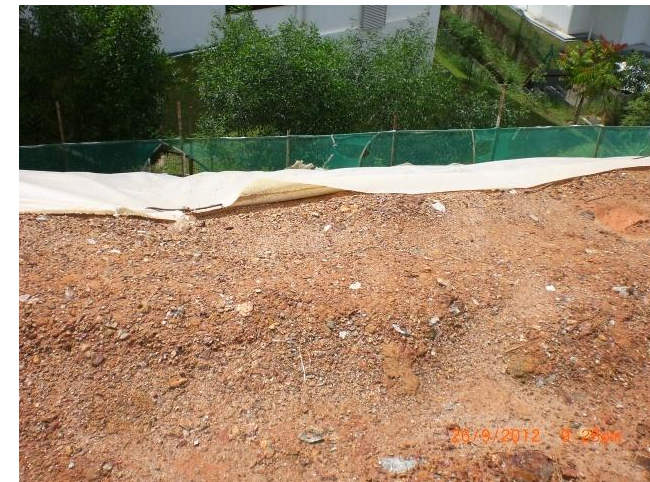
# Being informed that this low quality plastic sheet can only last for one month

## Parcel 2: The only slope temporarily covered with low quality plastic sheet

- The many exposed slopes around the site, only two slopes have been covered with plastic sheet.
- Low quality material.
- Installation not to the standard and specification such as sheet was not staked, no lengthwise and crosswise overlapped at edge, not trench and extend at top and bottom of slope.

- Tore sheets were not replaced.

- ◆ Use high quality plastic sheet.
- ◆ Shall follow standard and specification.
- ◆ EIA 3-08

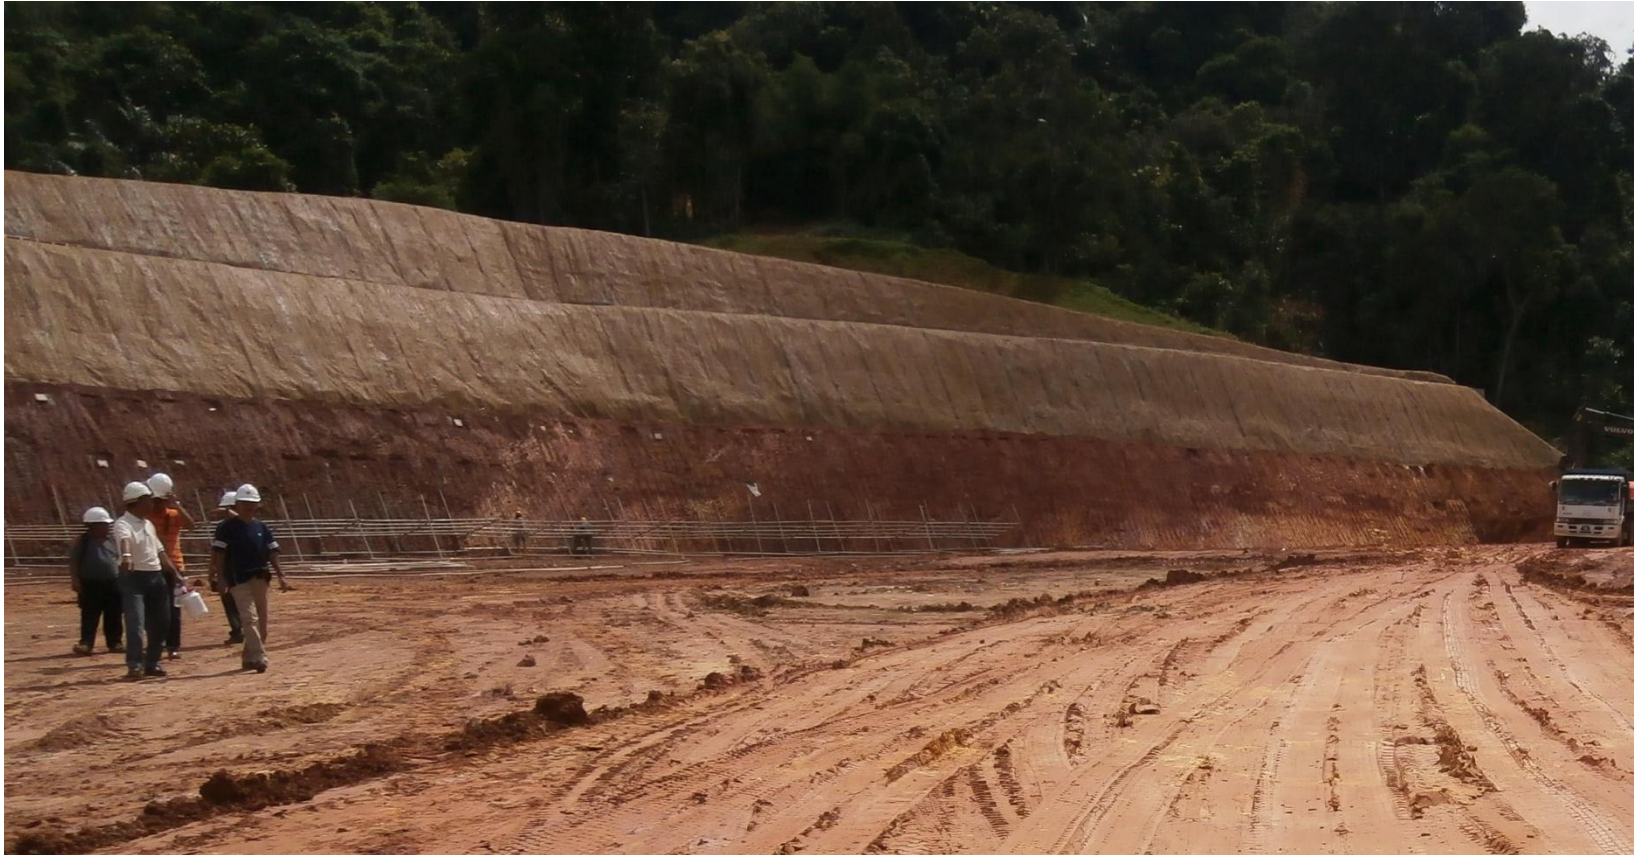
# Matting

- ◆ Installed at one slope location GPS:

- Material used was not made available by contractor.
- For the 1:1 slope, one must use high strength material combined with hydroseeding.

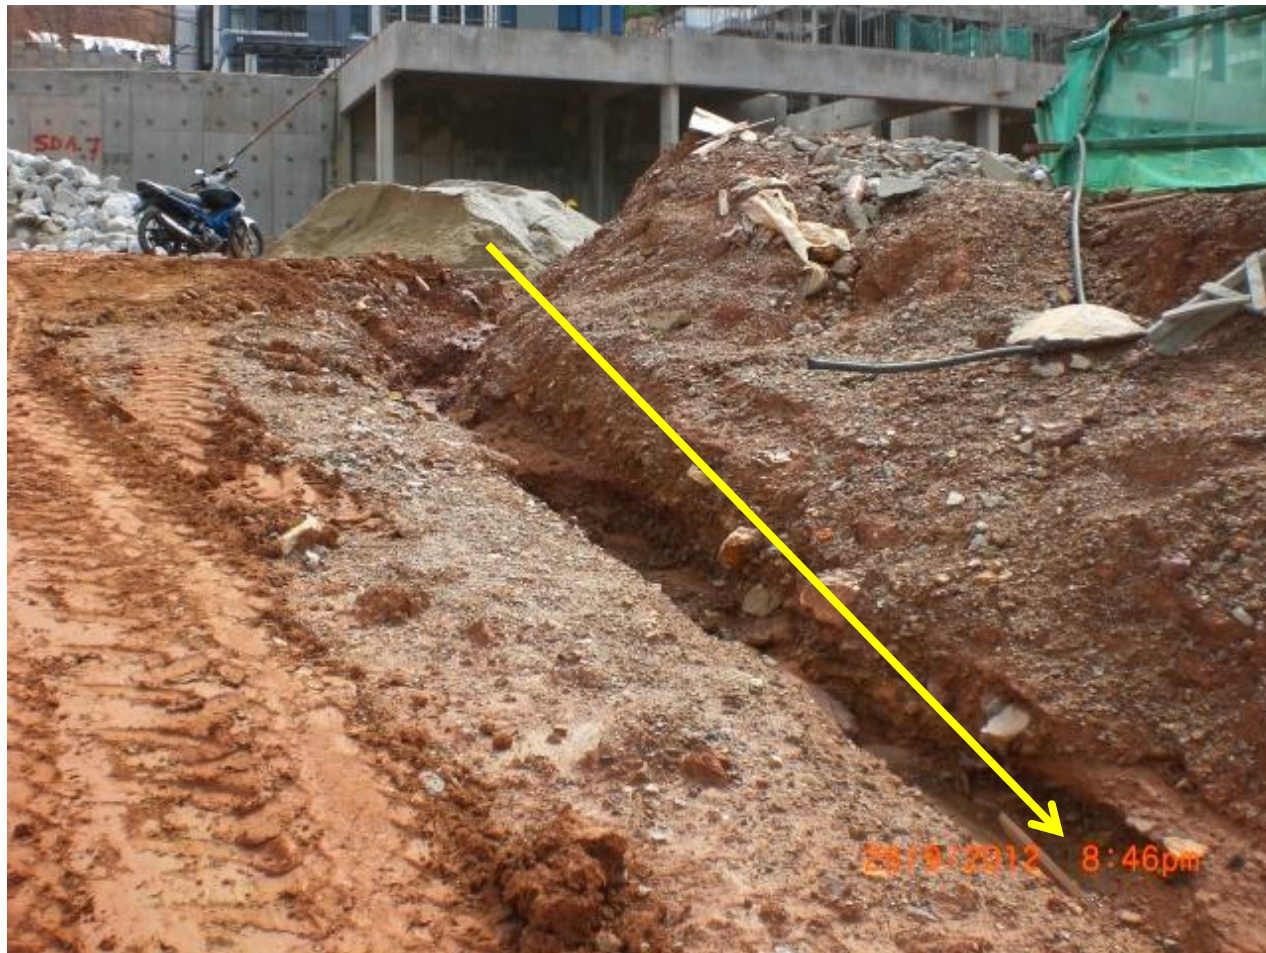
# Parcel 1: Earth drain (Access Rd 1) draining from Building Construction Area 1

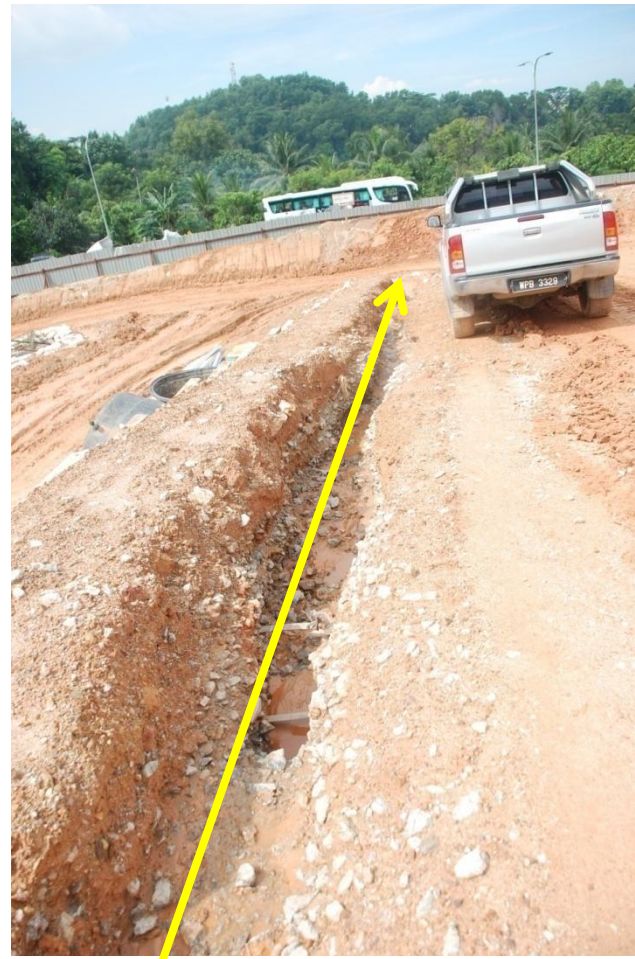
# Parcel 1: Earth drain (Access Rd 1) End Point

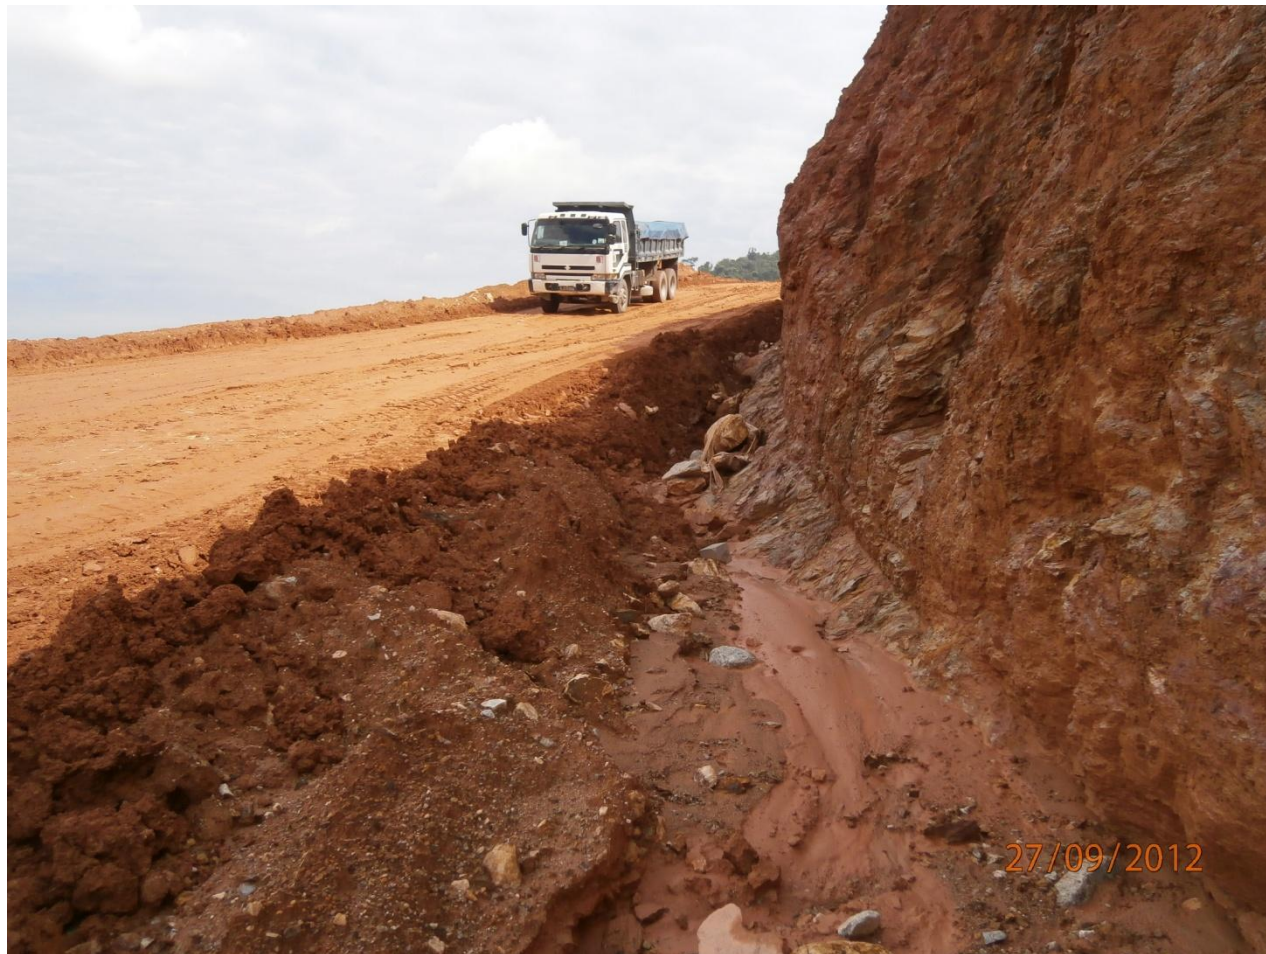
## Parcel 2: Earth drain

- ◆ Improperly done and evidence of overtopping as well as undermining of drain slope and bed.
- ◆ EIA-3-08

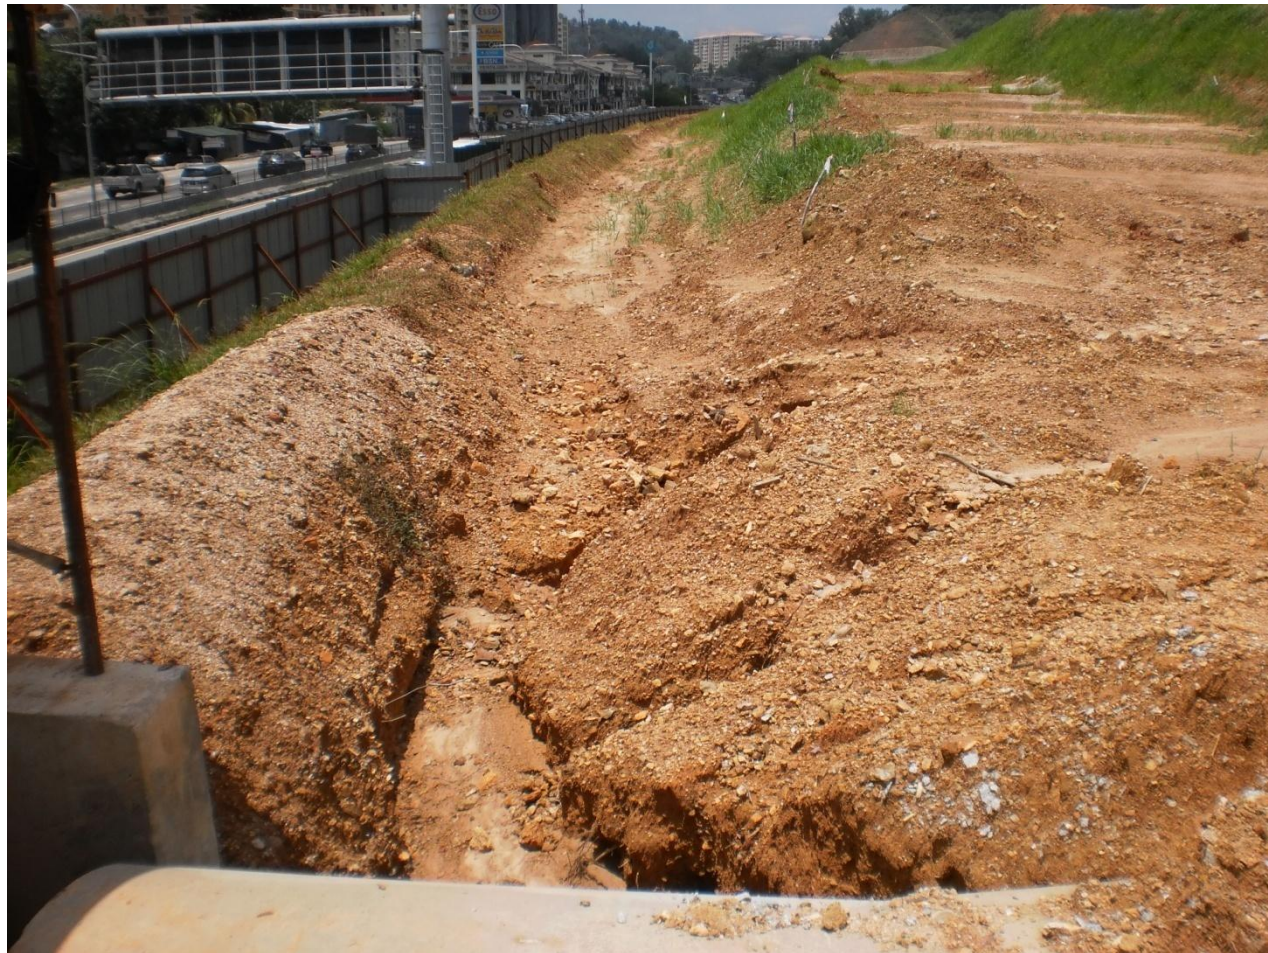
**Not seen other than slopes along the southwest side of the project site parallel to MRR2 highway.**

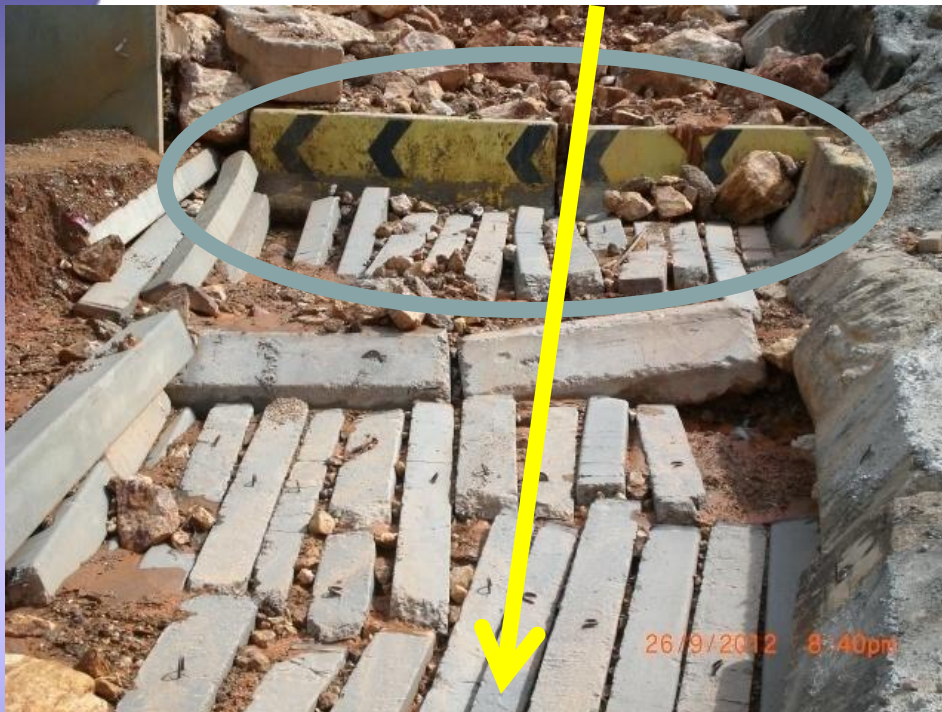
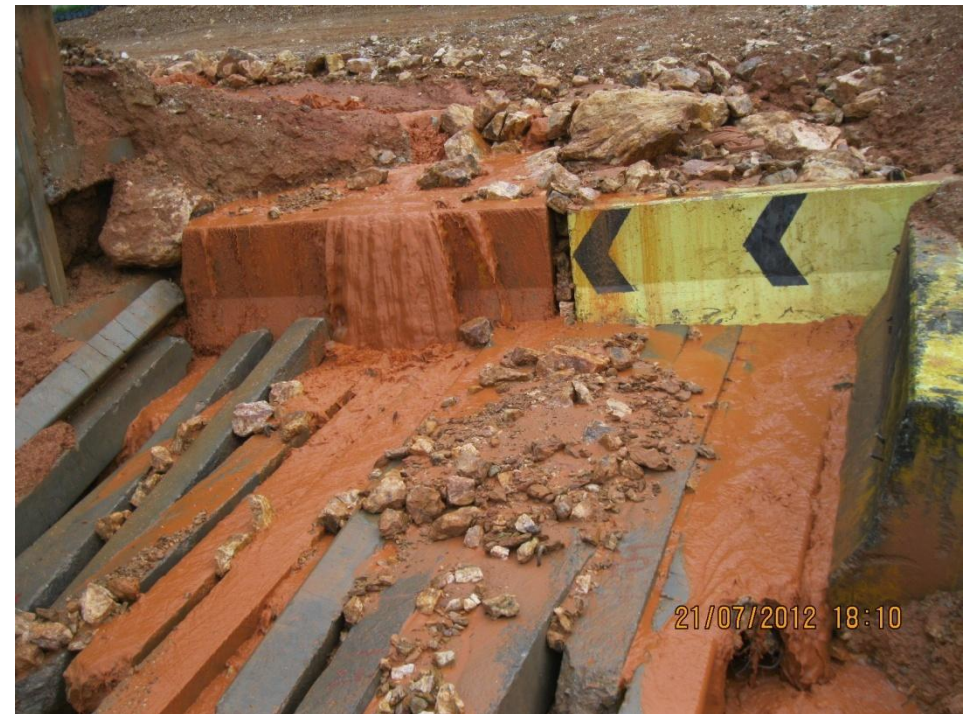
# Concrete dam (claimed as Check Dam)
