**Program Latihan Penguatkuasaan Untuk  
Pegawai JPS Bagi Pelaksanaan Perintah  
Kualiti Alam Sekeliling (Perwakilan Kuasa  
- Penyiasatan Ke Atas Kawalan Hakisan  
Dan Kelodakan)**

# BMPs INSPECTION

THE GOOD , THE BAD AND THE BMPs  
OPTION AND SELECTION

**Cad. Skim Perumahan 195 Unit Rumah Di Atas Lot  
30086 dan Lot 30087, Mukim Setapak, Kuala Lumpur  
oleh SUNWAY MELAWATI SDN BHD**

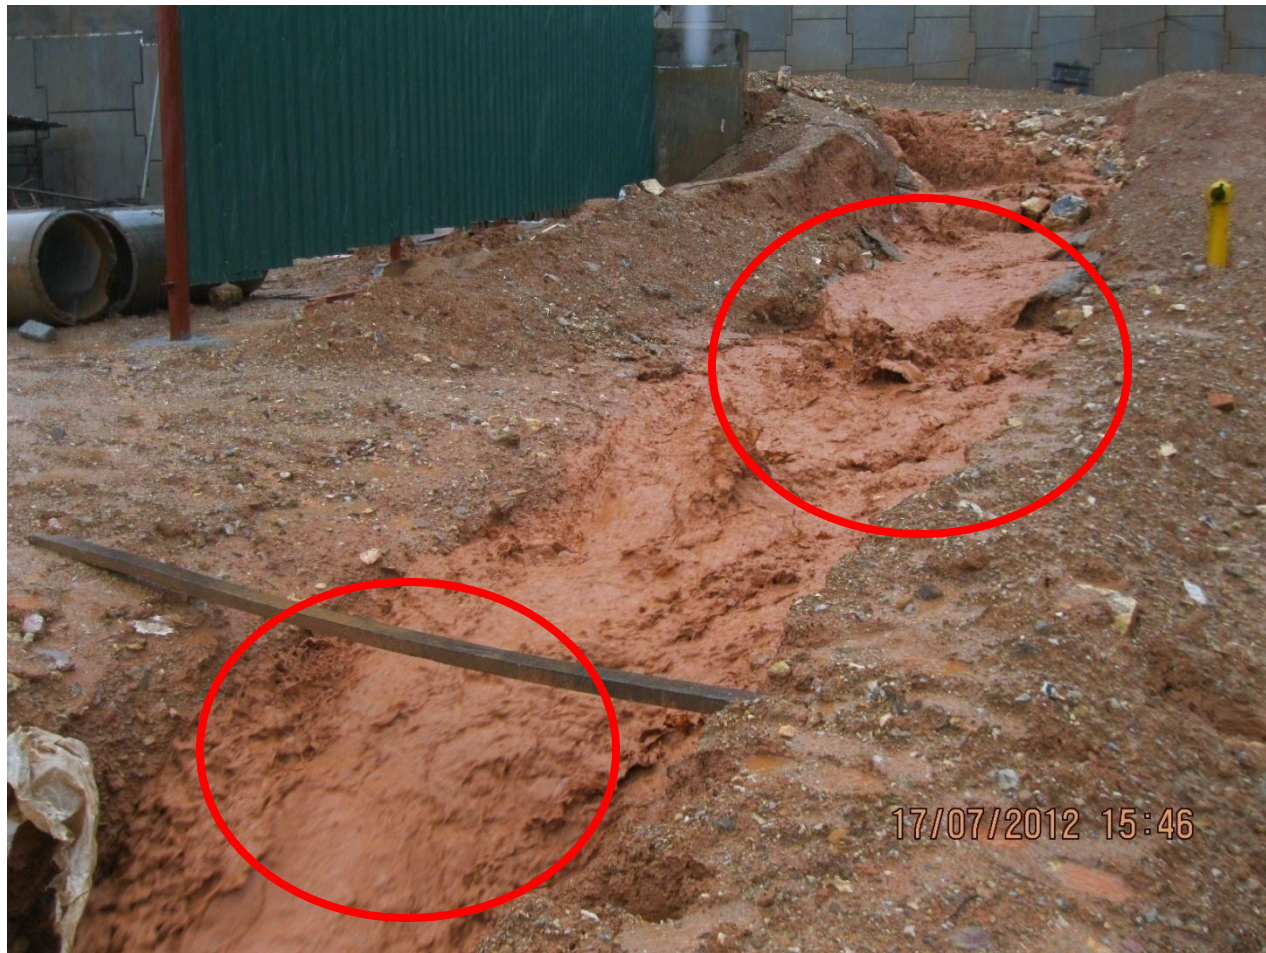
# Overtopping culvert crossing

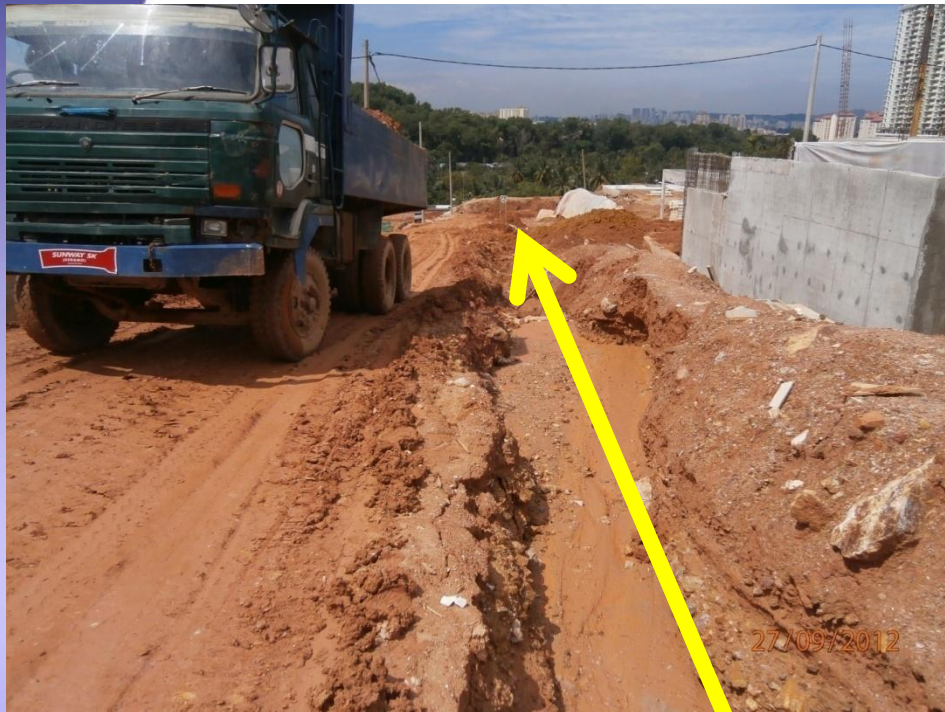
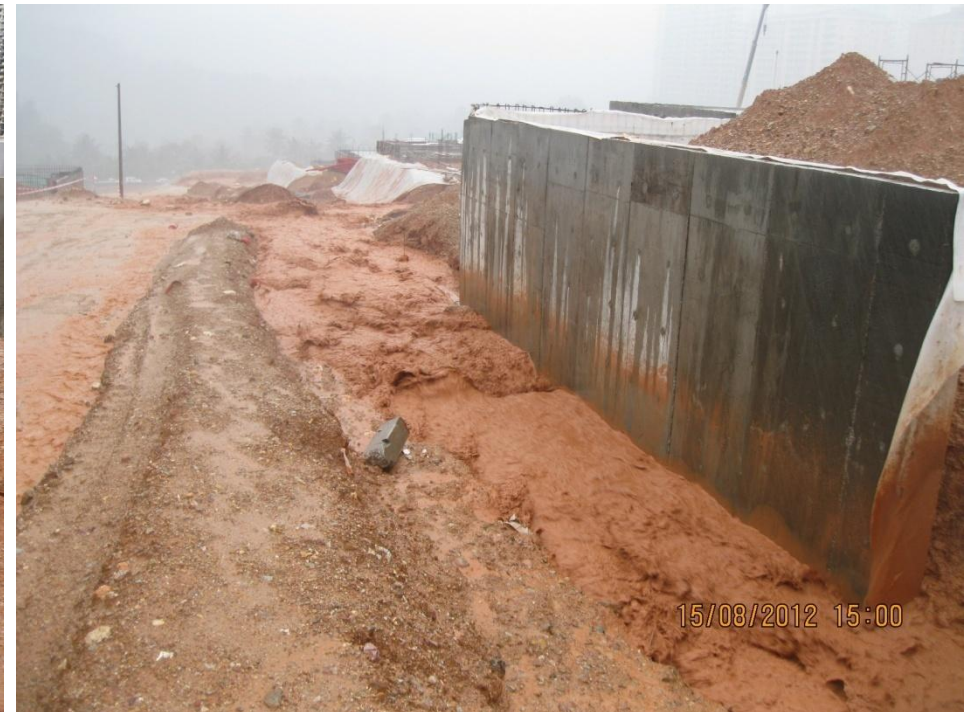
# Further downstream without lining

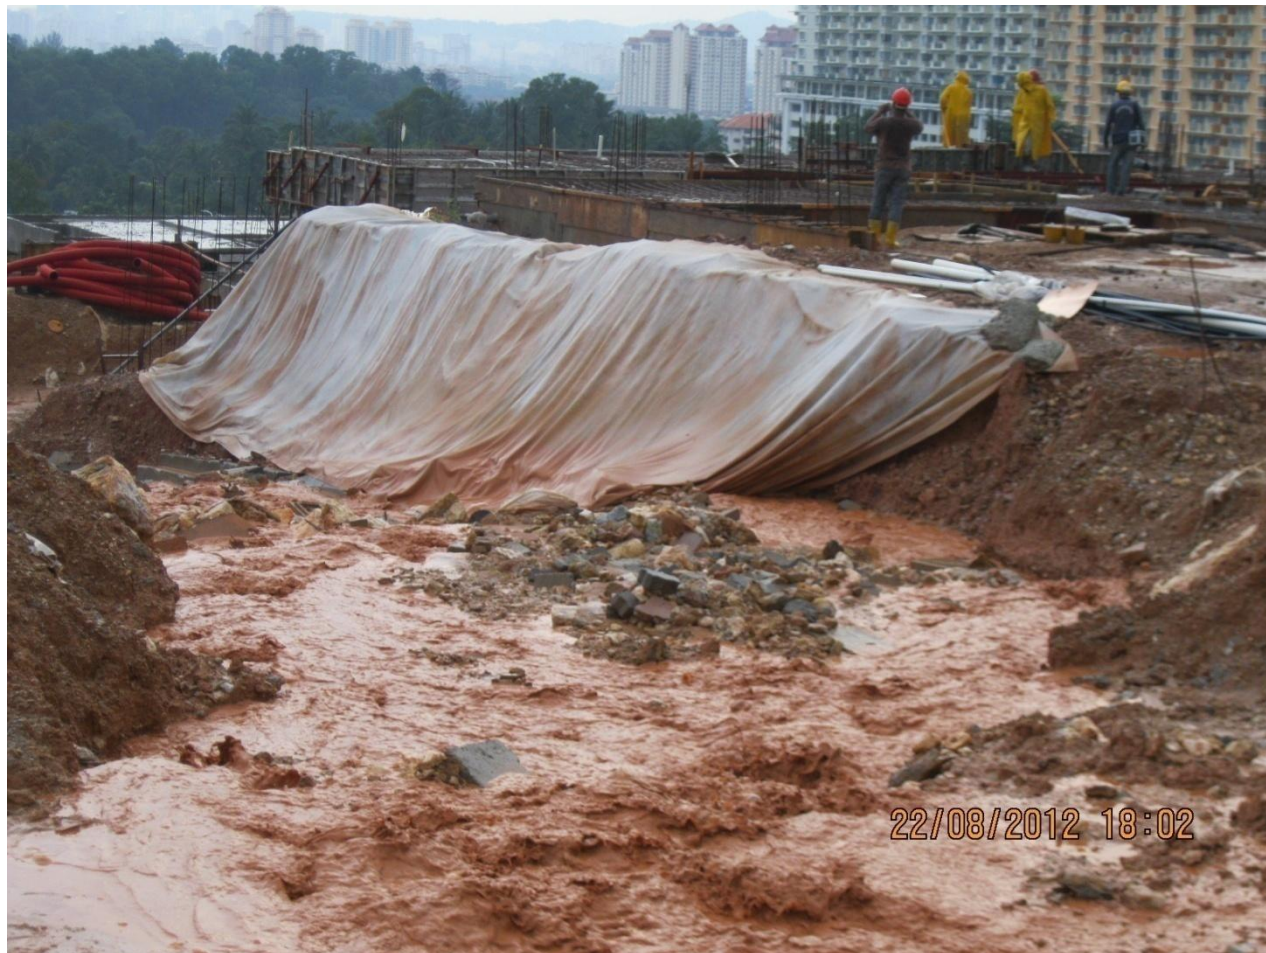
# Eroded channel bank

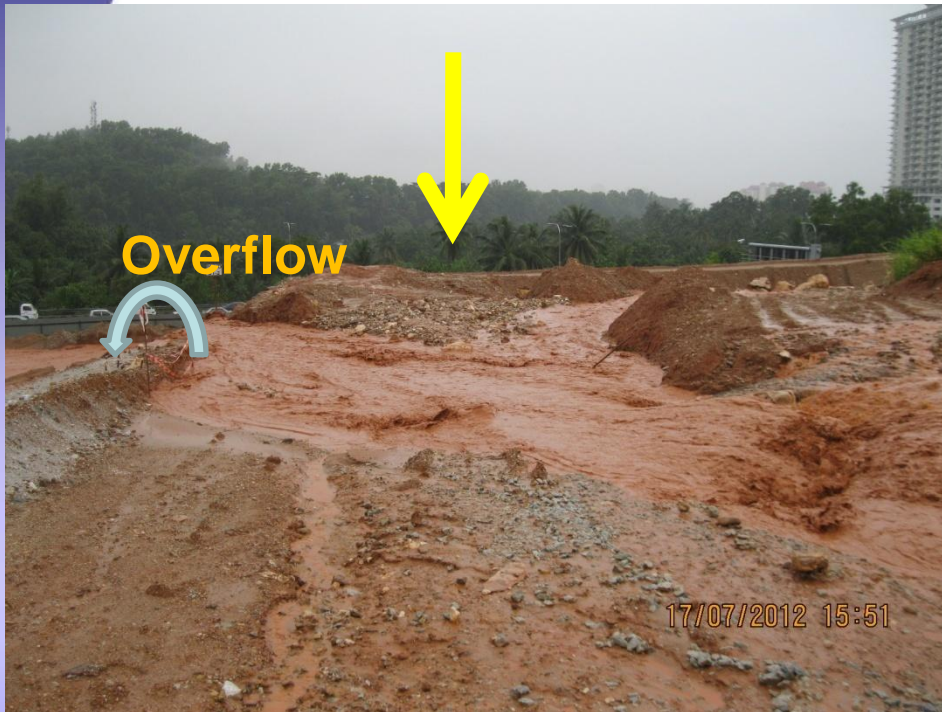
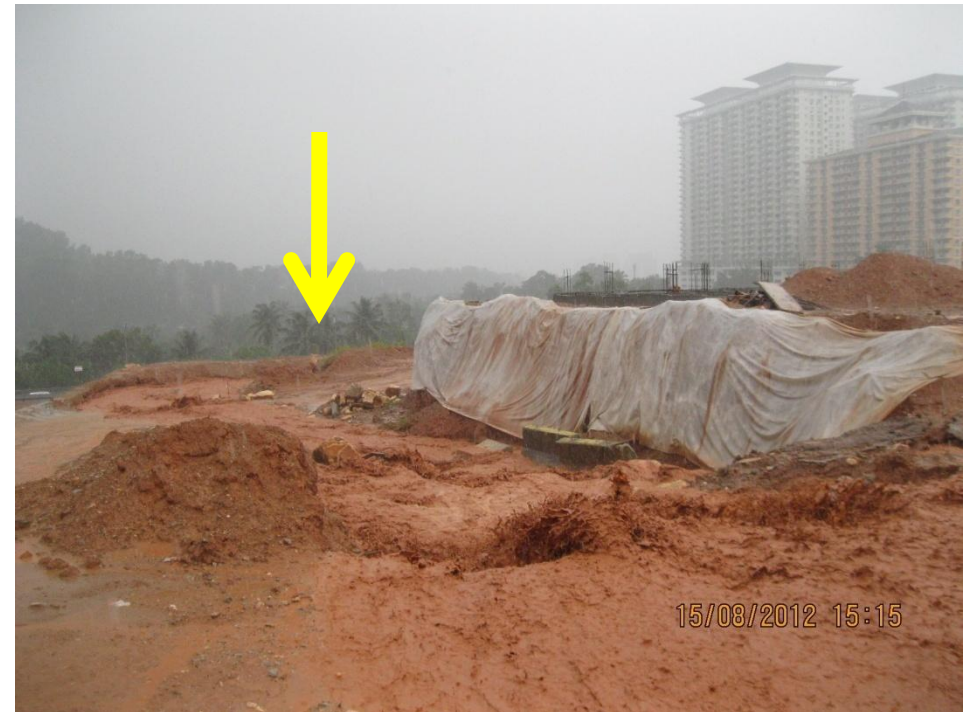
# Diversion Channel drain to SB2

- ◆ Diversion Channel drain runoff from Parcel 2 uphill and along site boundary at perimeter along MRR2

- ◆ Improperly done and evidence of overtopping as well as undermining of drain slope and bed.
- ◆ [EIA-3-08](#)

- ◆ Follow strictly standards and specifications been set.

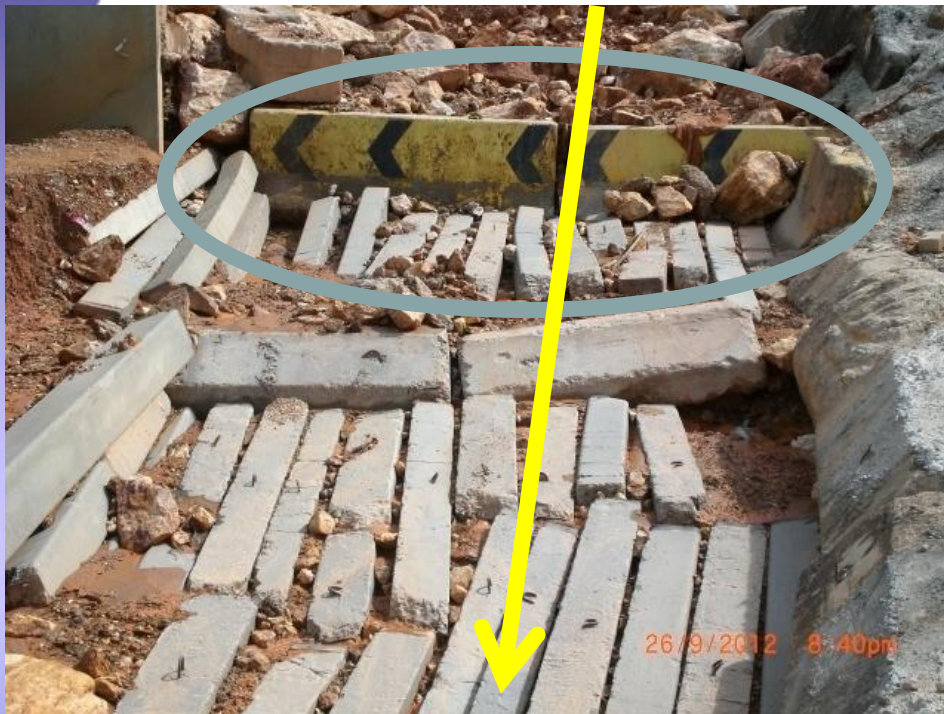
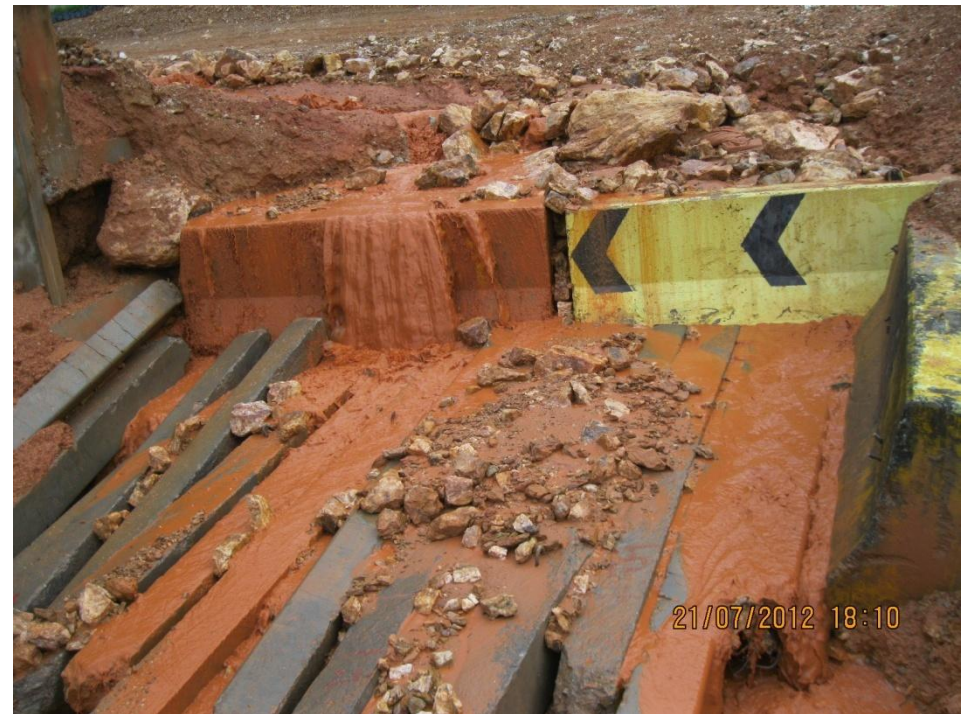
# Concrete dam (claimed as Check Dam)

- ◆ Consider not done or installed.
- ◆ EIA-3-08

- ◆ Follow strictly standards and specifications been set.

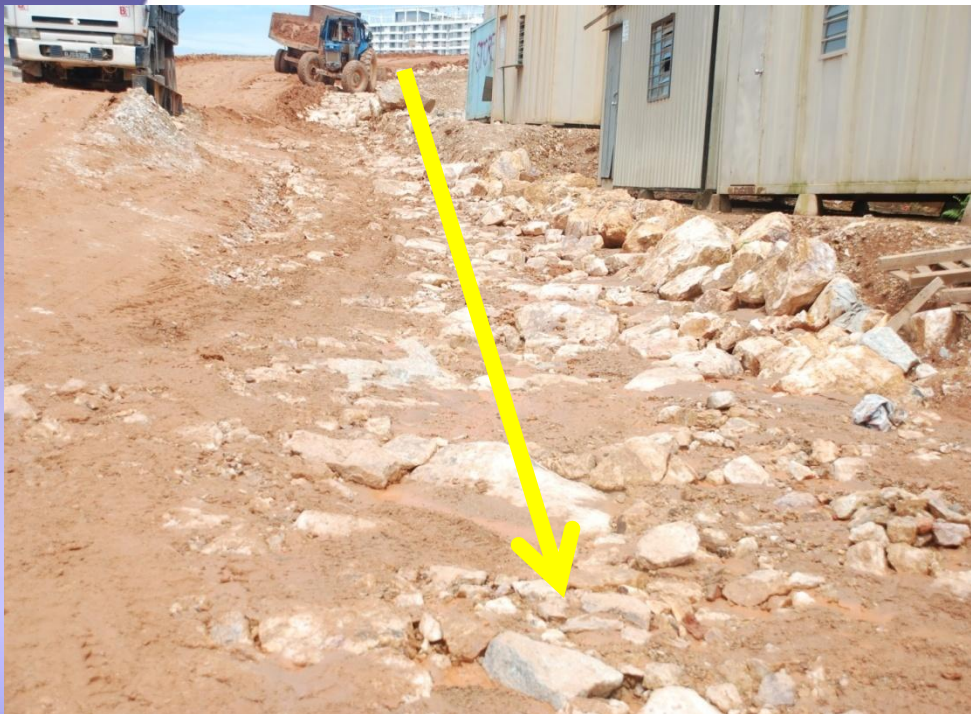
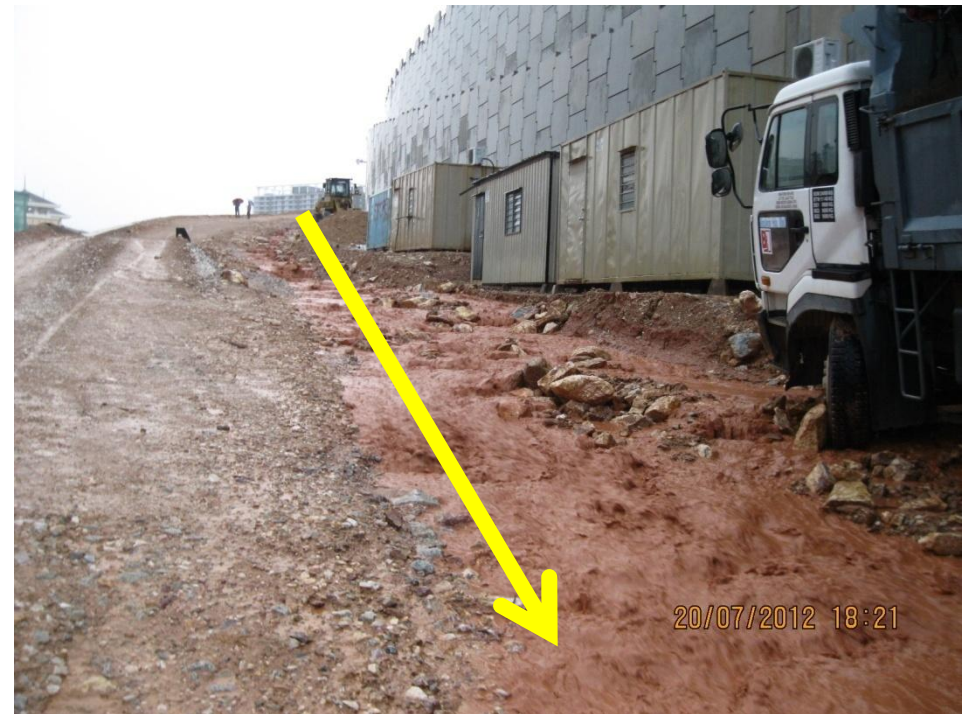
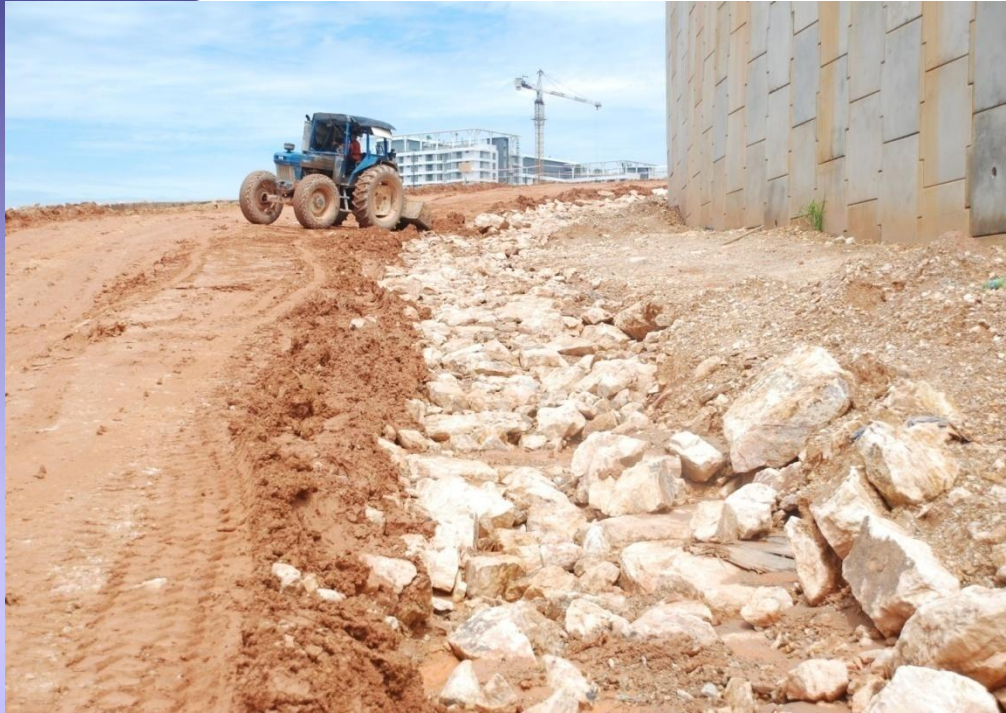
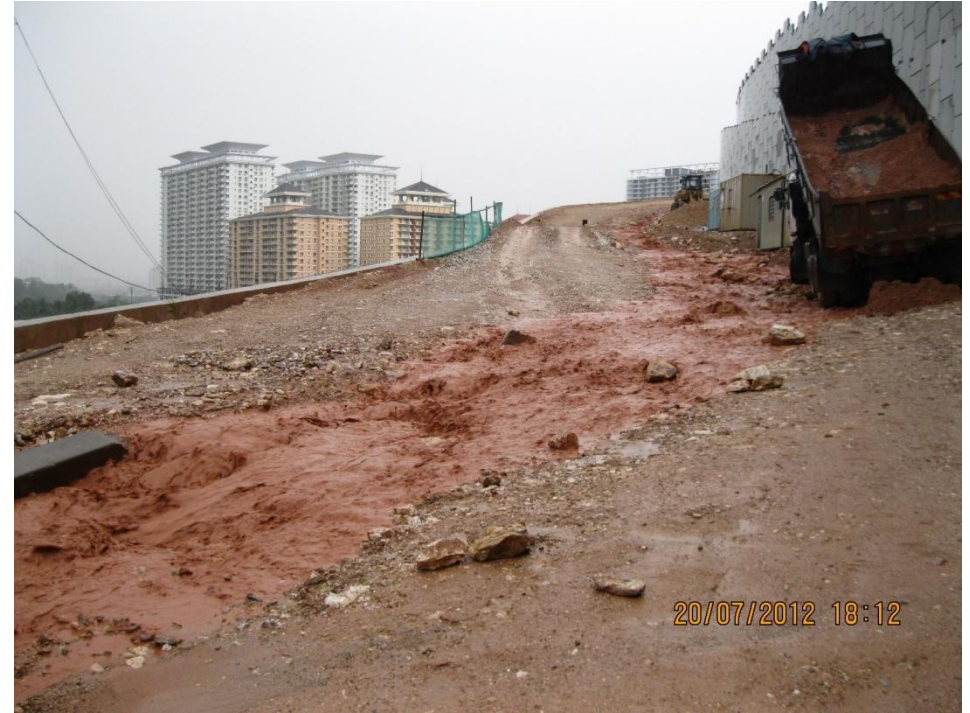
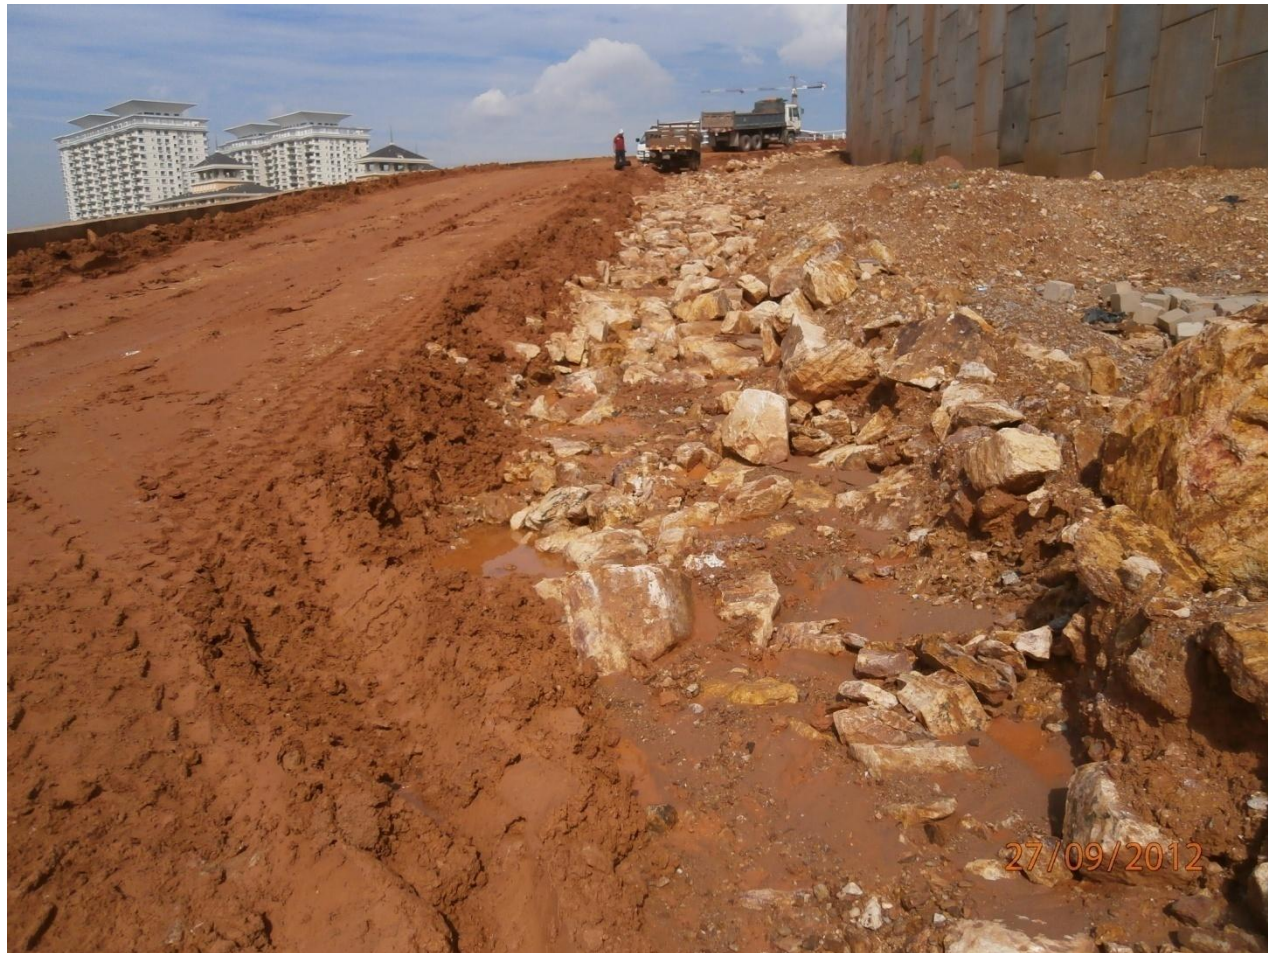
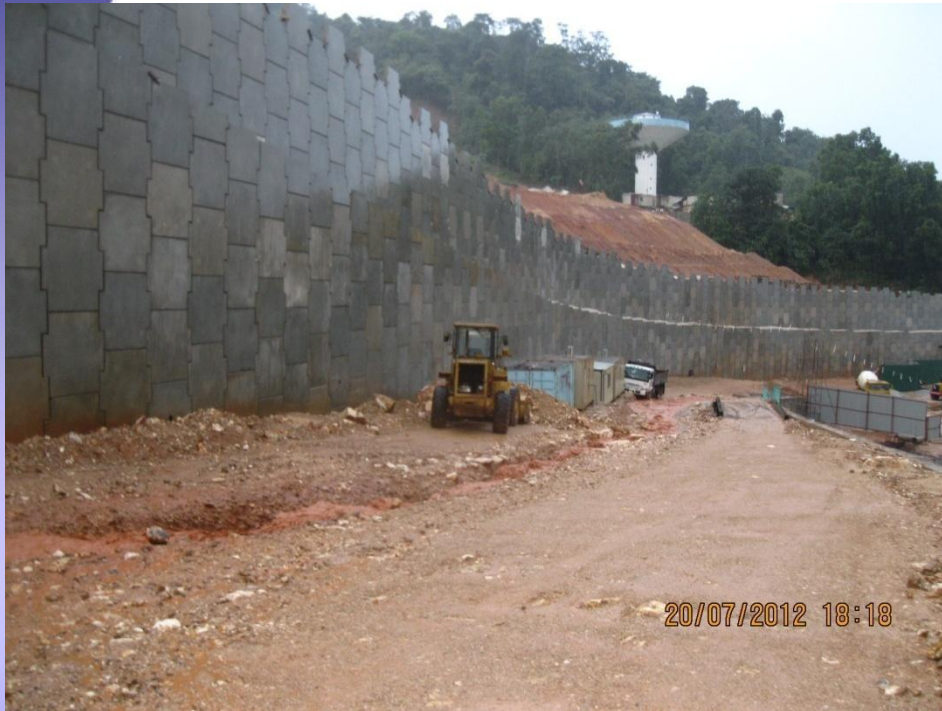
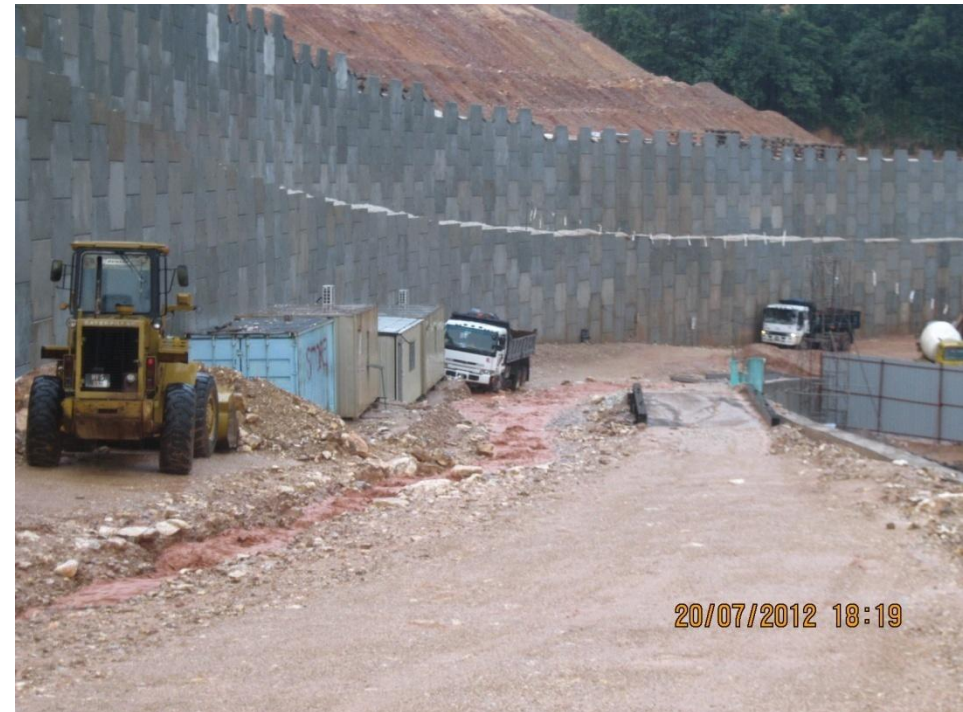
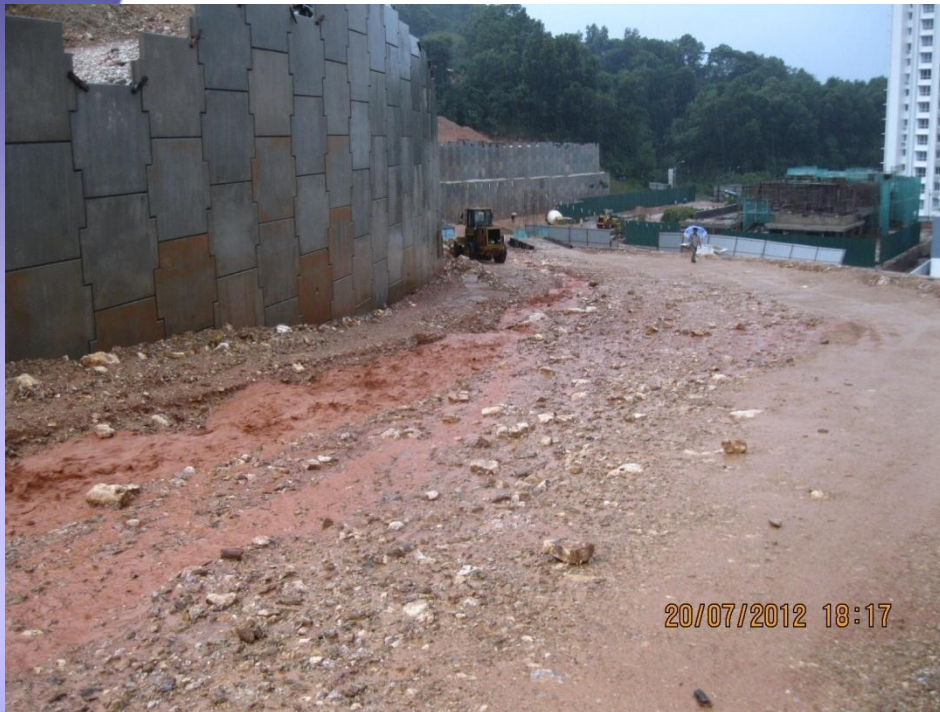
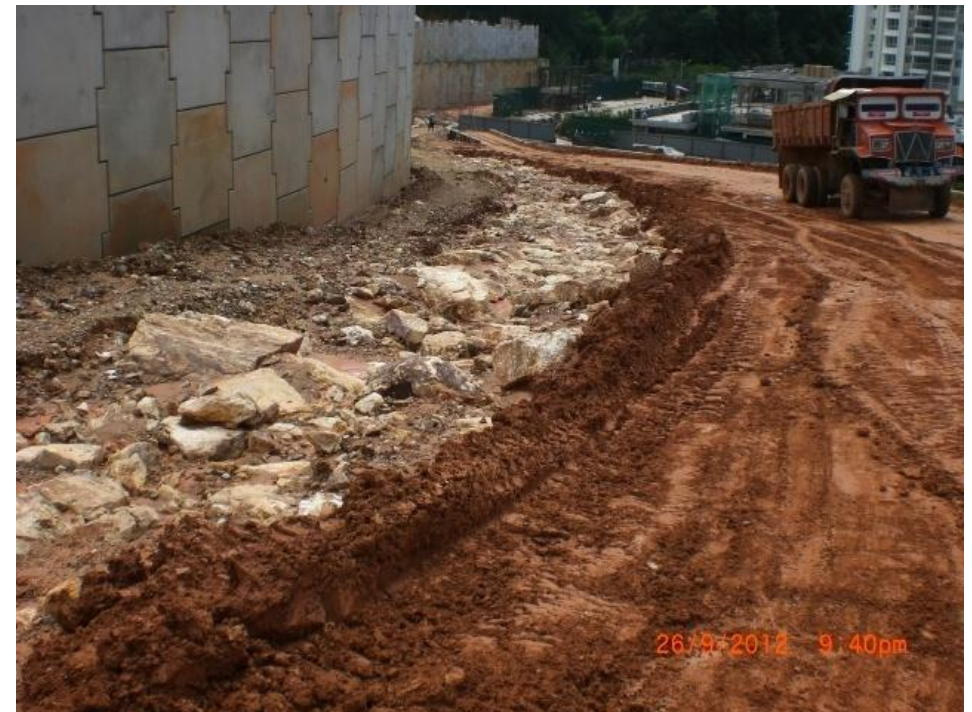
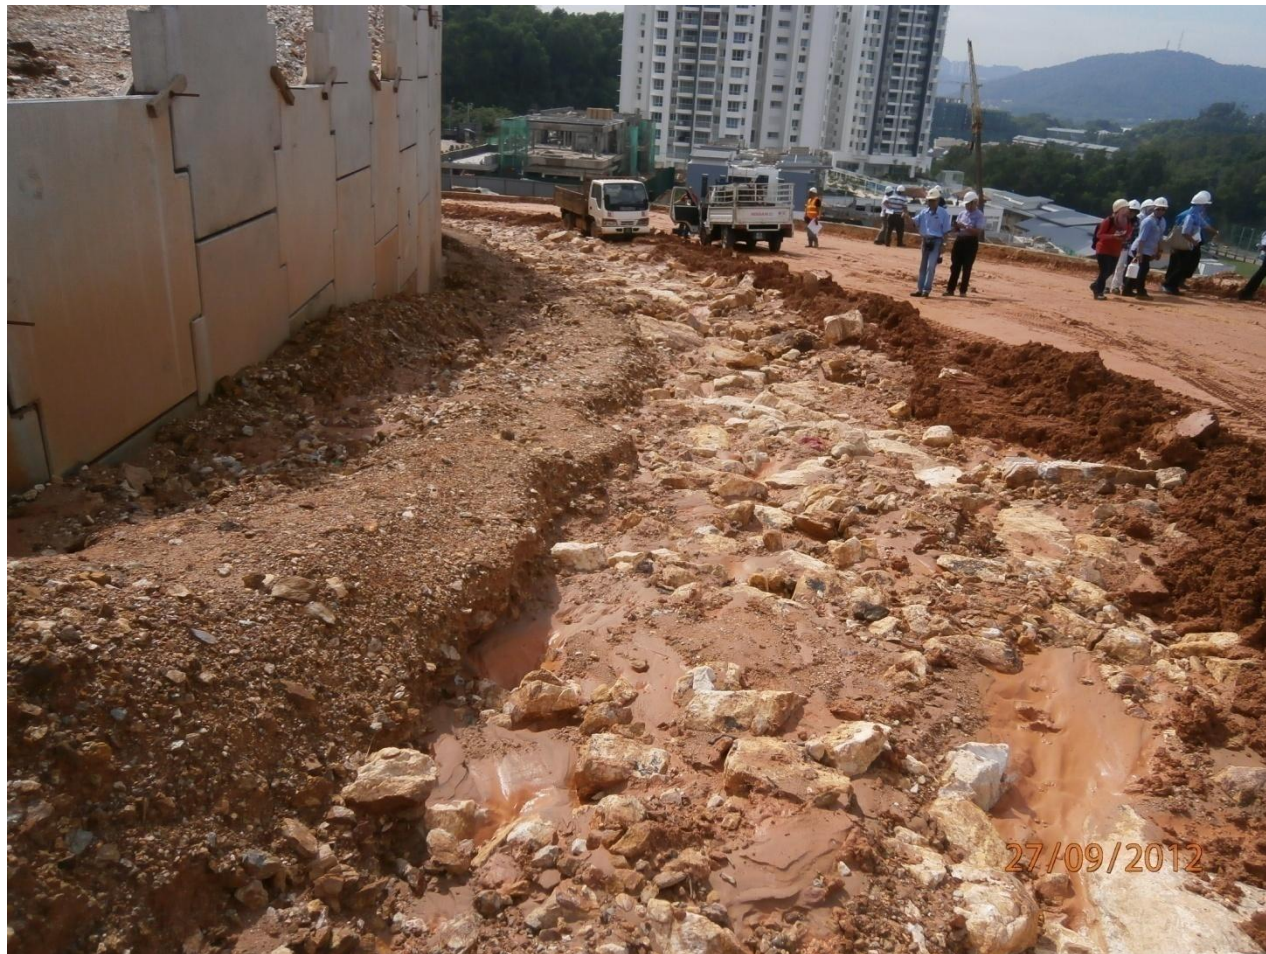
- ◆ Installation not according to standards and specifications.
- ◆ EIA-3-08

- ◆ Follow strictly standards and specifications been set.

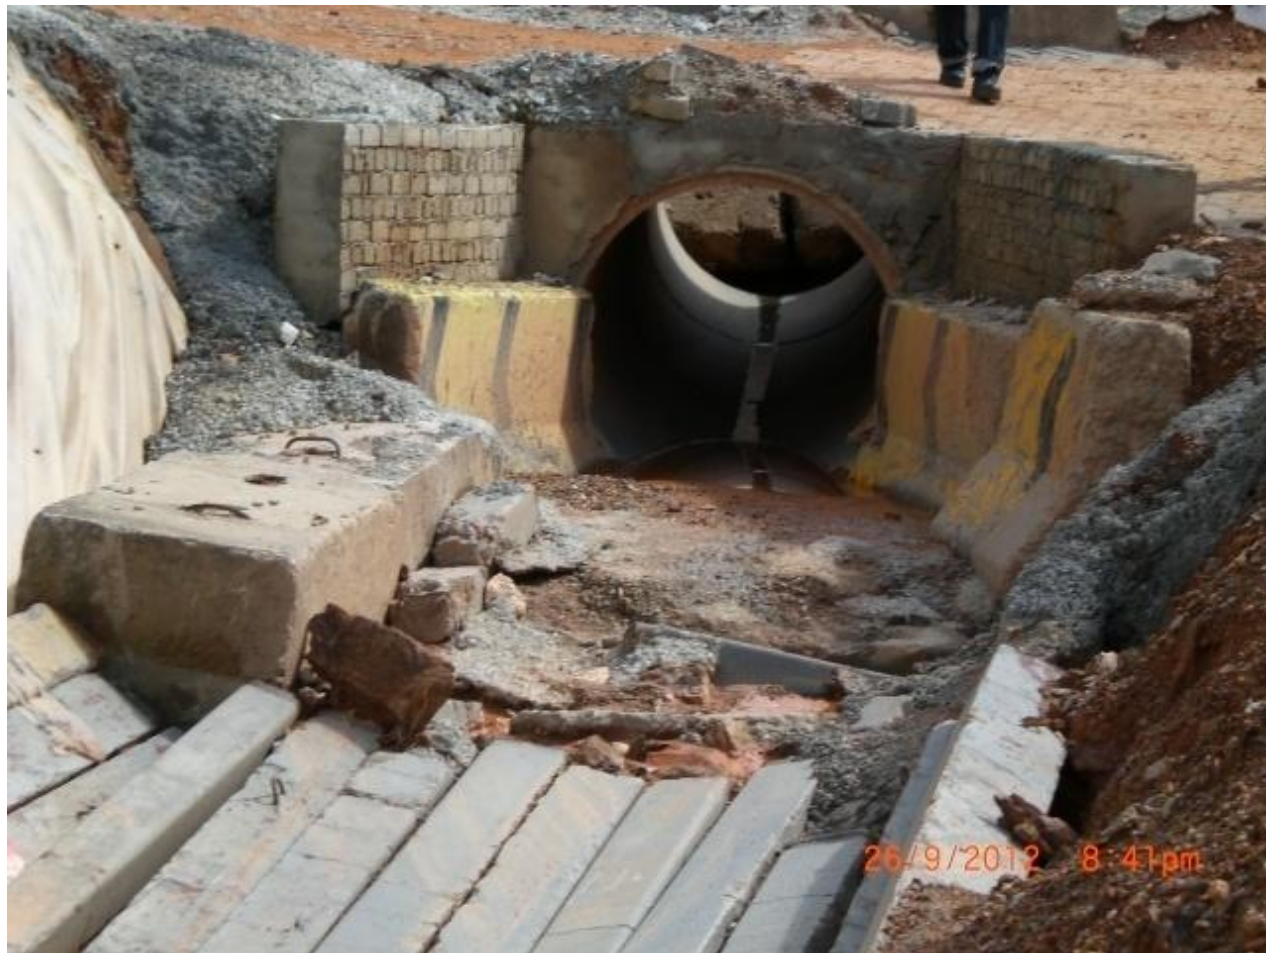
## No outlet protection around culvert

- ◆ Installation not according to standards and specifications.
- ◆ EIA-3-08

- ◆ Shall follow standards and specifications been set.

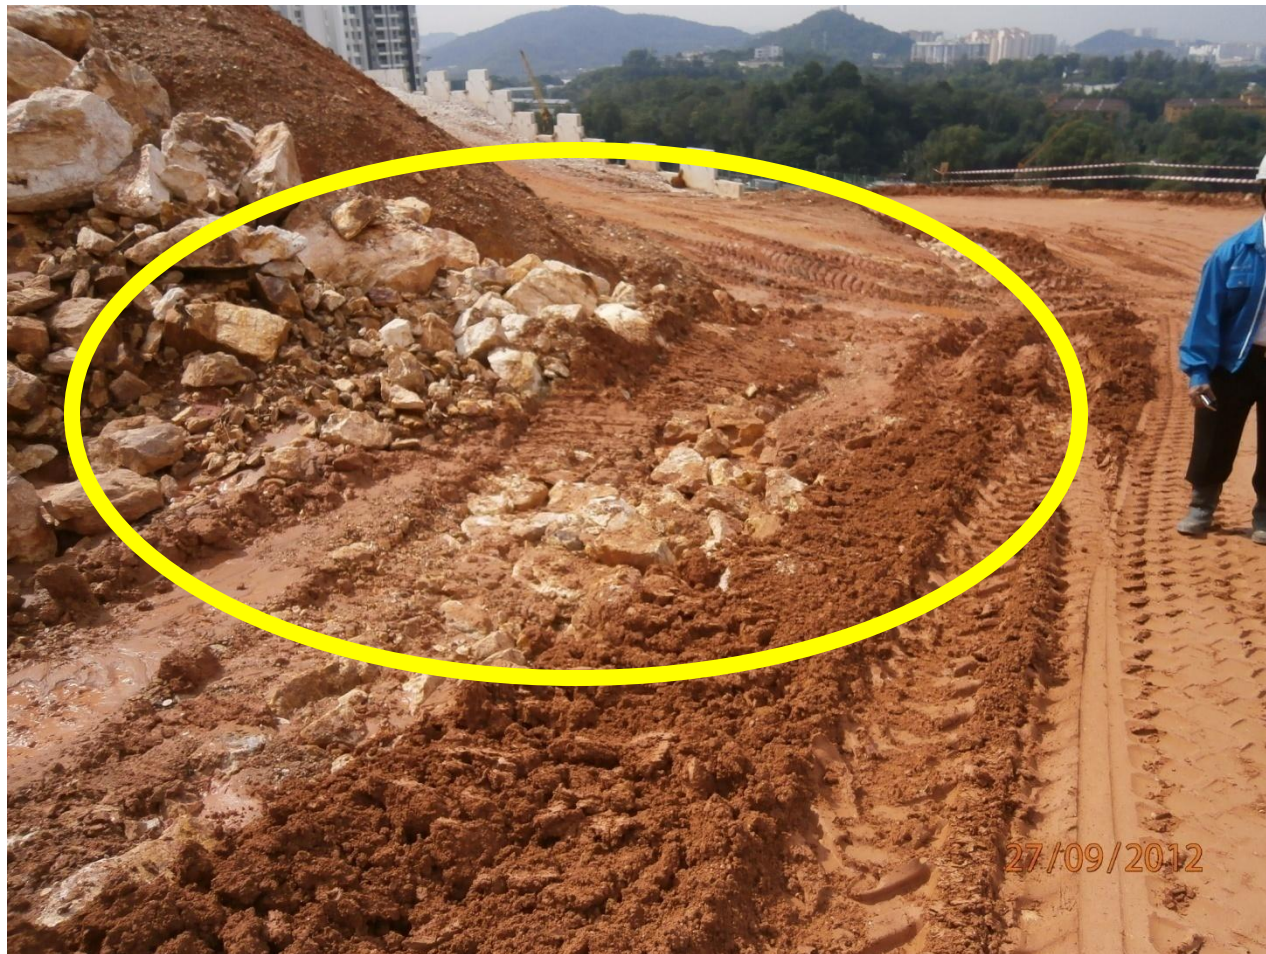
## Discharge not conveyed properly downstream (Must extend apron)

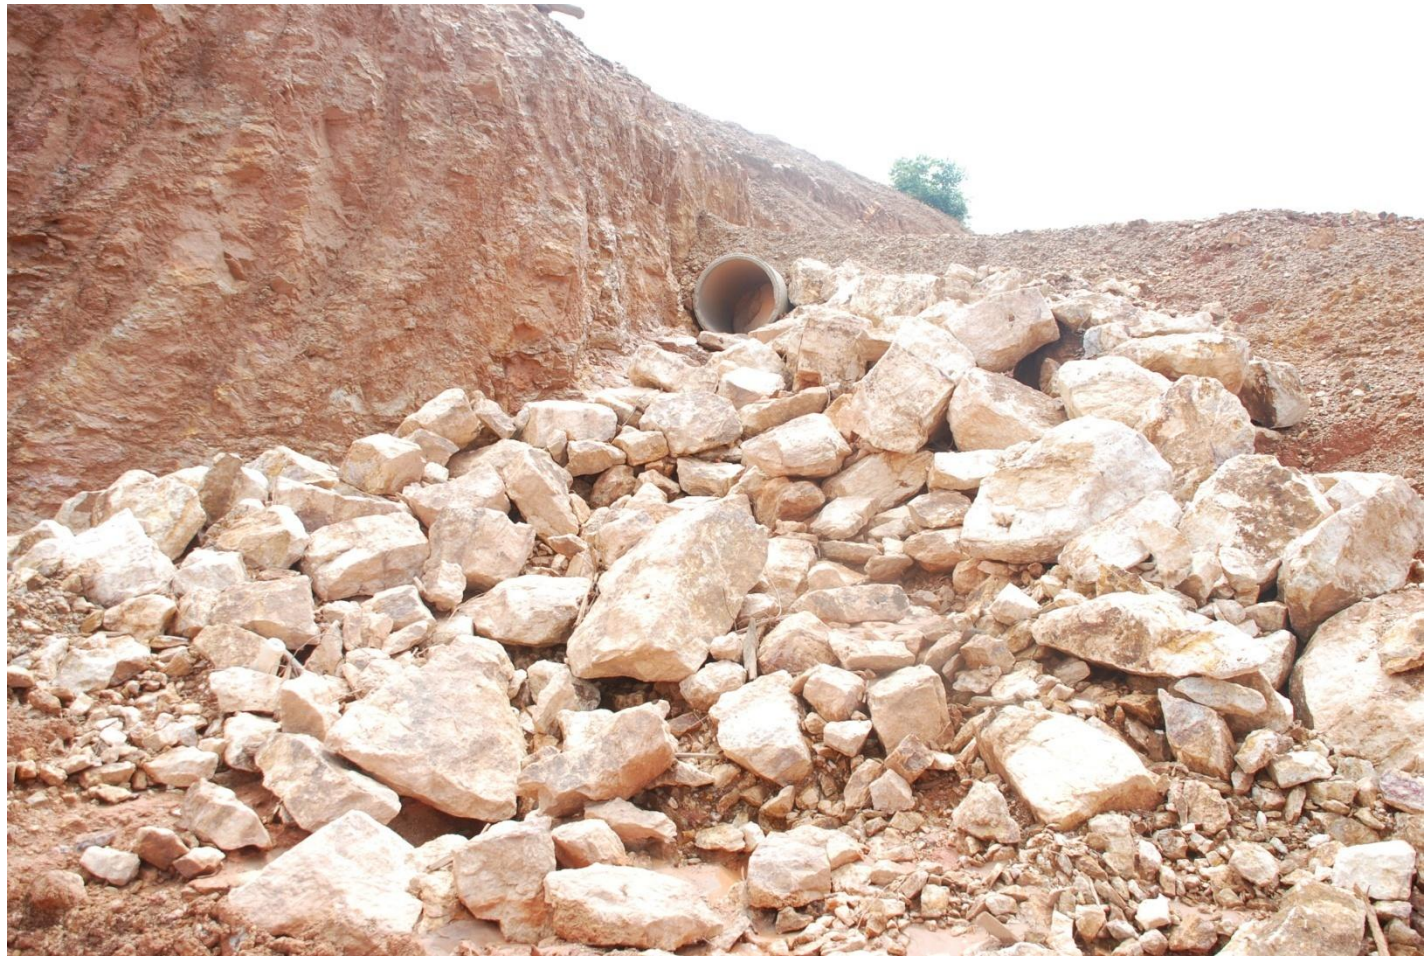
# Dissipater

- ◆ Installation not according to standards and specifications.
- ◆ EIA-3-08

- ◆ Shall follow standards and specifications been set.

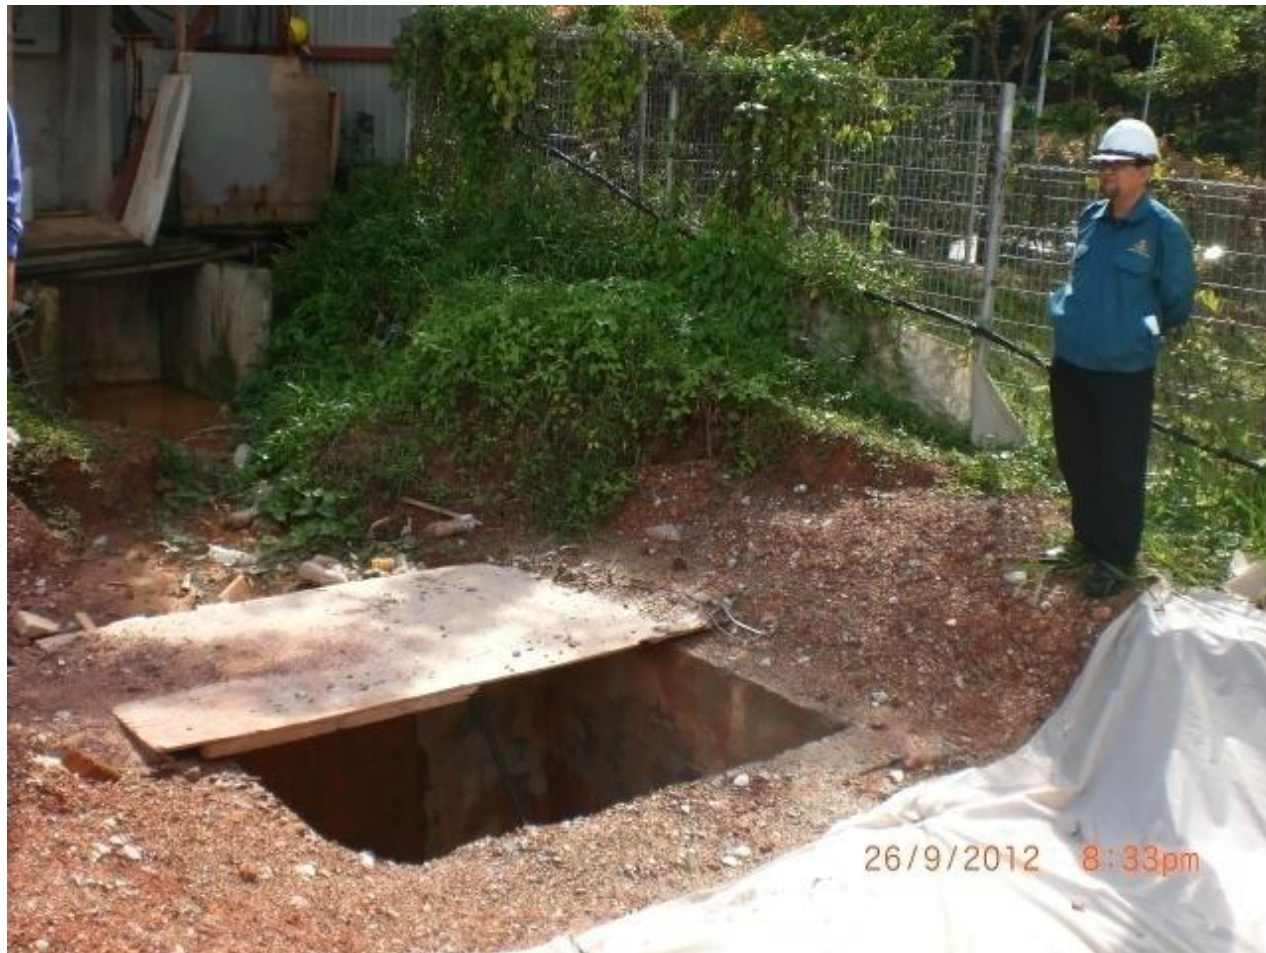
# No Storm Drain Inlet Protection

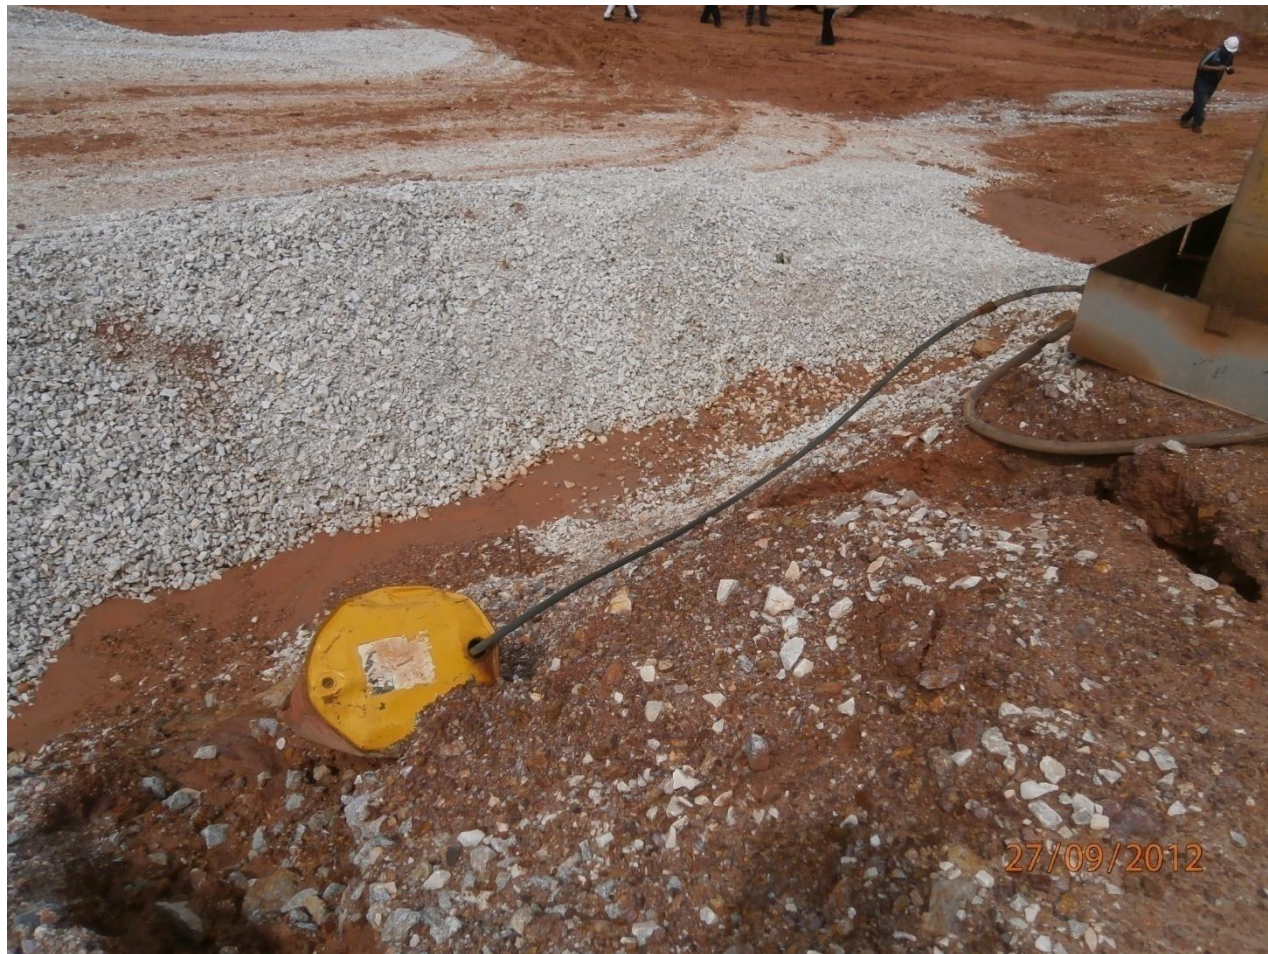
## Stabilized surface with crusher run

- ◆ Compaction
- ◆ Stabilized surface with crusher run at the access track of material storage area.

- ◆ Earth compaction serves a good method of soil stabilization but tends to promote runoff volume due to impervious surface. Proper roadside drain and diverter should be constructed to avoid free flow and standing water that may rut the surface and induce erosion during heavy vehicles movement.

- ◆ Smooth compaction road surface shall be provided with roadside drain and runoff diverter or water bar.
- ◆ [EIA-3-08](#)

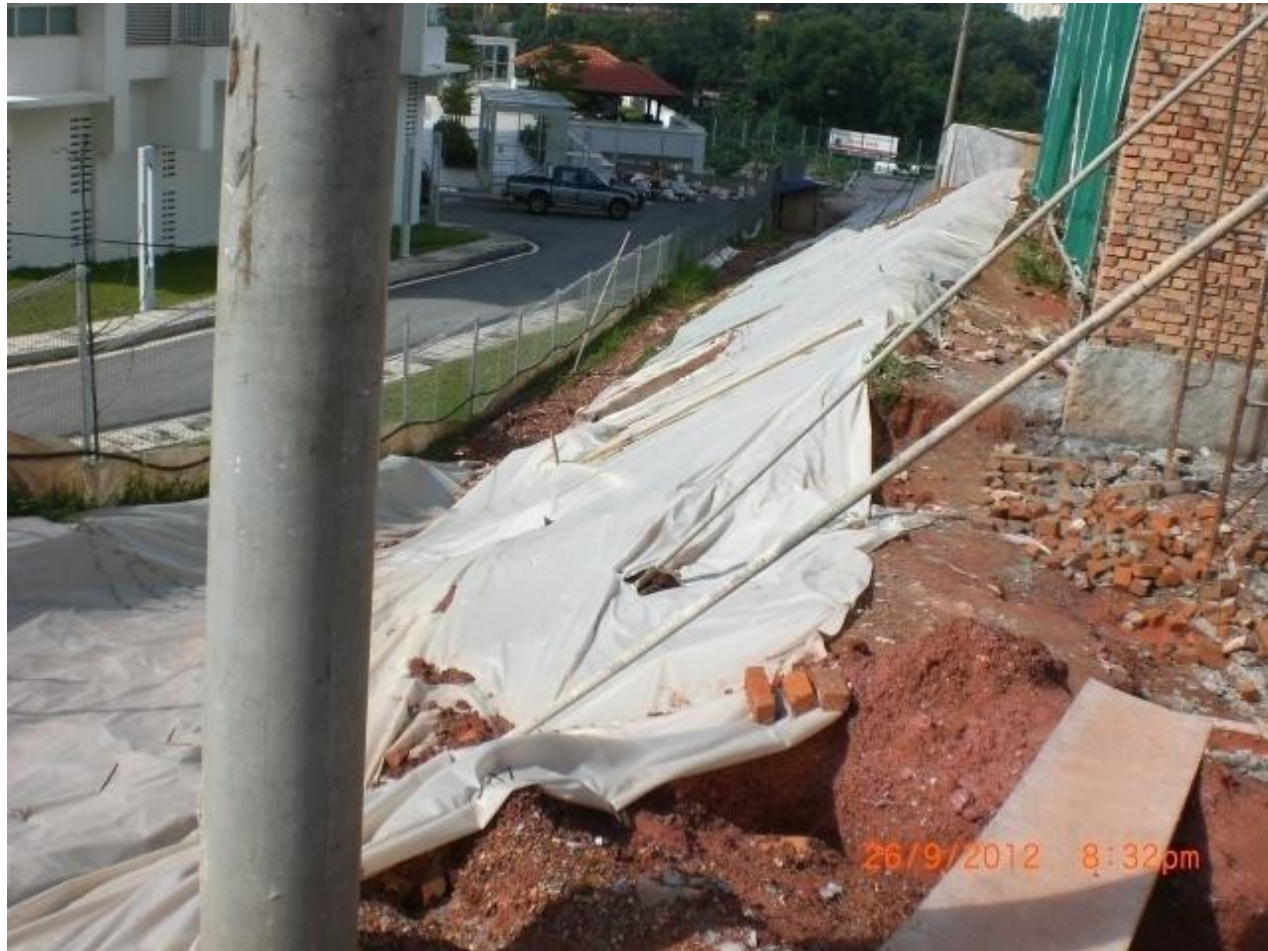
## Silt Fence – the only 50 metres installed

- ◆ Silt Fence – the only 50 metres installed.

- ◆ Shall follow standards and specifications been set.
- ◆ Many potential location at the site should be applied especially the site boundary at perimeter along MRR2 highway as suggested in the ESCP.

- ◆ Shall follow standards and specifications been set.
- ◆ EIA-3-08
