**Program Latihan Penguatkuasaan Untuk  
Pegawai JPS Bagi Pelaksanaan Perintah  
Kualiti Alam Sekeliling (Perwakilan Kuasa  
- Penyiasatan Ke Atas Kawalan Hakisan  
Dan Kelodakan)**

# BMPs INSPECTION

THE GOOD , THE BAD AND THE BMPs  
OPTION AND SELECTION

**Cad. Skim Perumahan 195 Unit Rumah Di Atas Lot  
30086 dan Lot 30087, Mukim Setapak, Kuala Lumpur  
oleh SUNWAY MELAWATI SDN BHD**

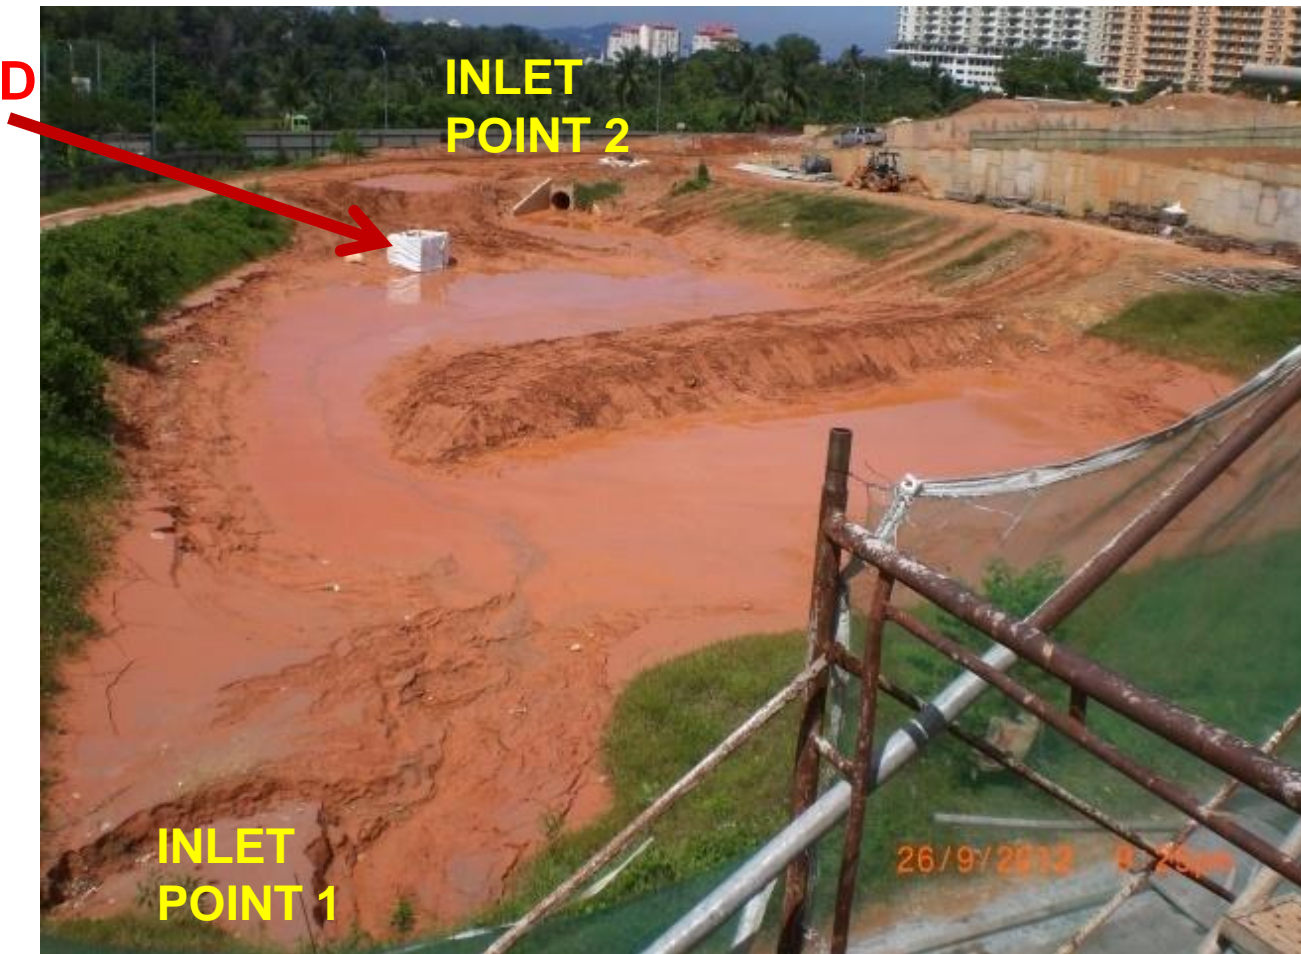
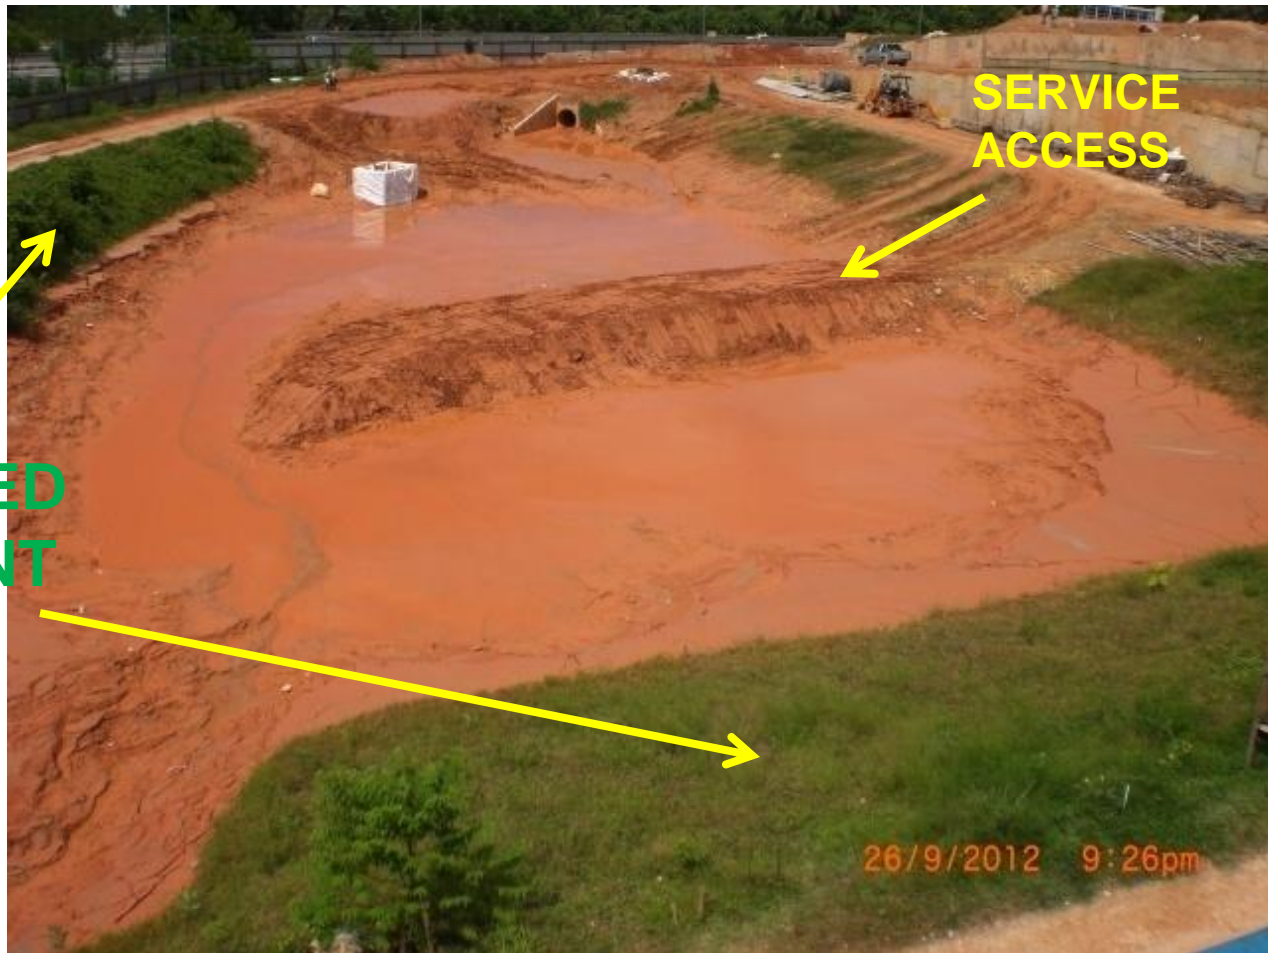
# Sediment Basin 1

**RISER  
COVERED  
WITH  
FABRIC**

**GOOD TURFED  
EMBANKMENT**

- ◆ Shall follow standards and specifications been set.
- ◆ Overload or under capacity.
- ◆ Construct many more.
- ◆ Establish forebay and baffles.
- ◆ Make use of PAM.

- ◆ Shall follow standards and specifications been set.
- ◆ EIA-3-08

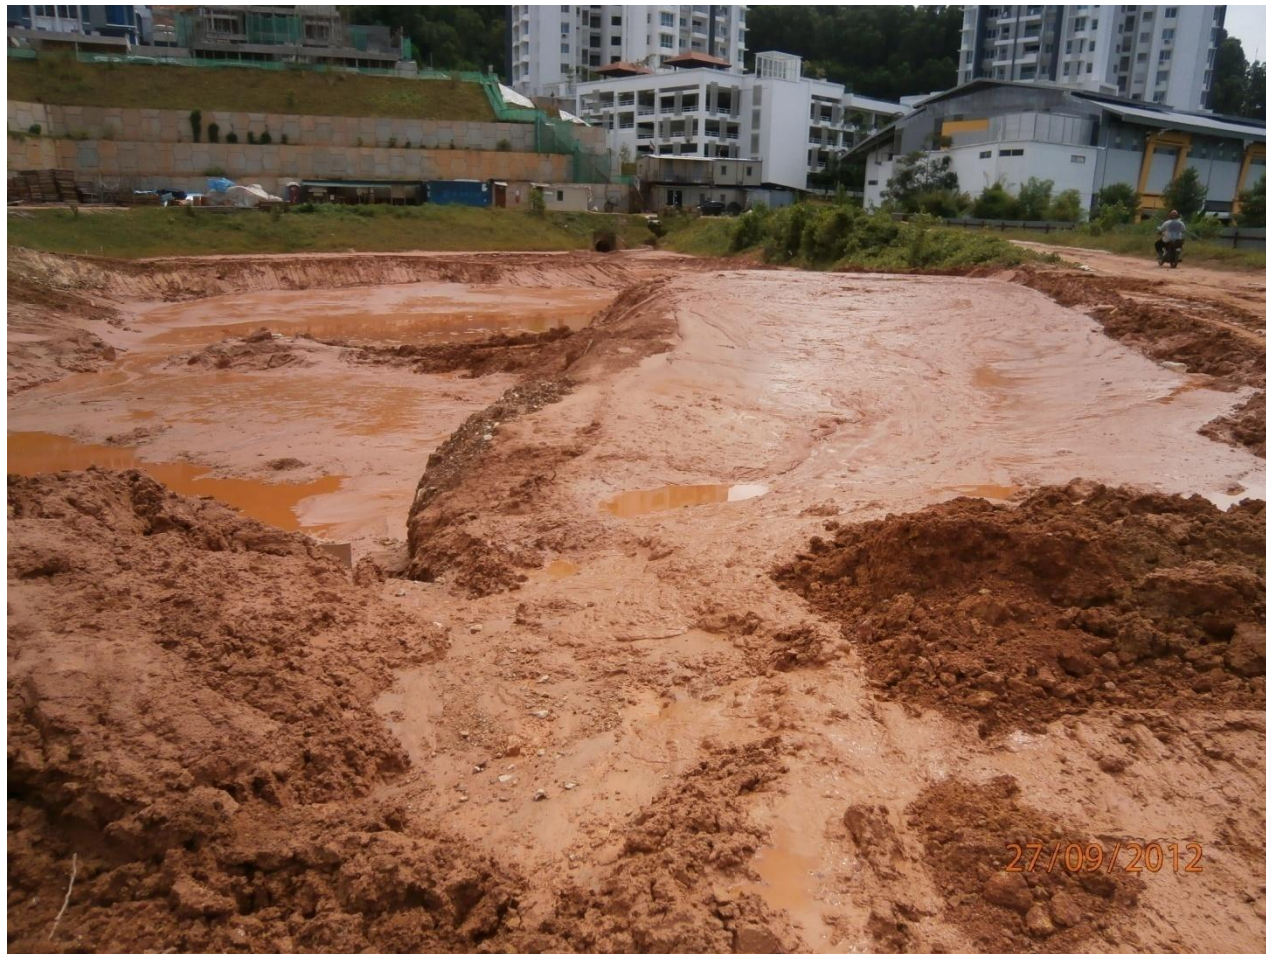
# De-silting material dumped beside the pond

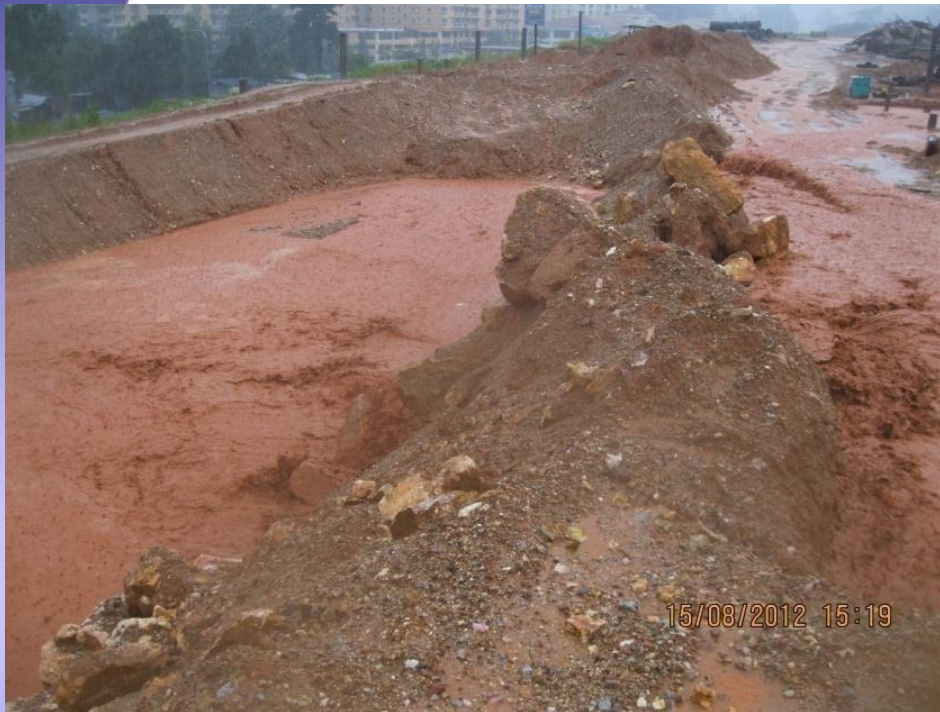
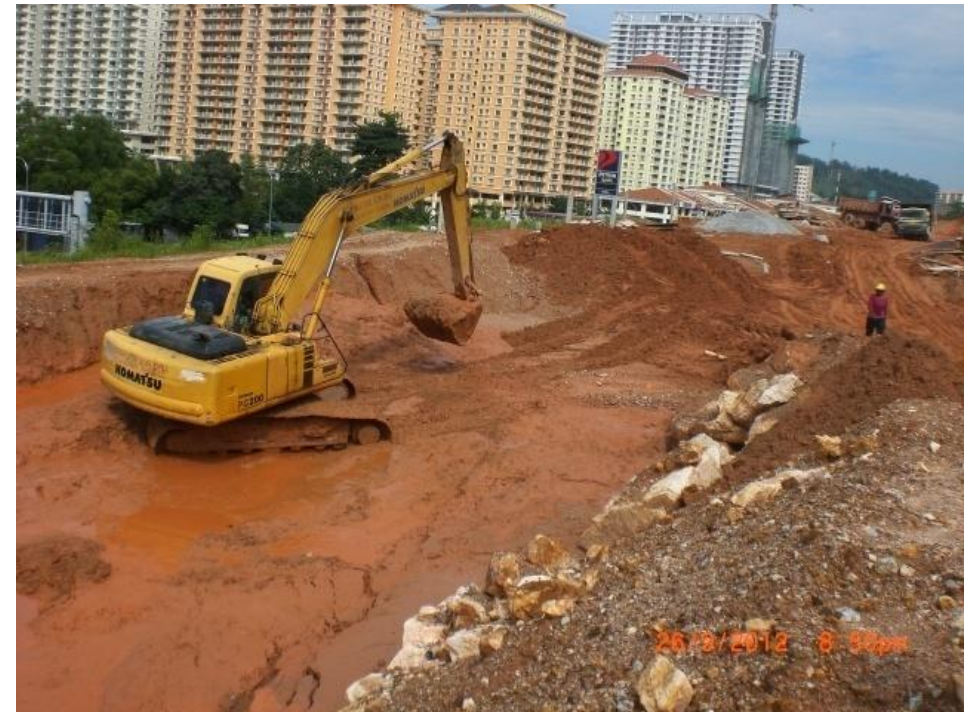
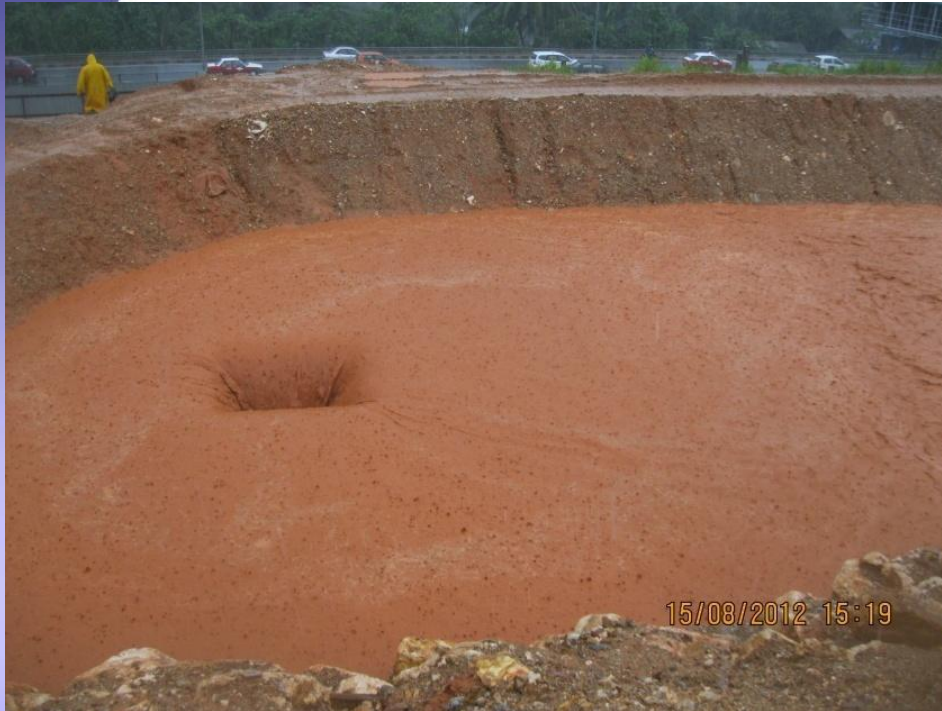
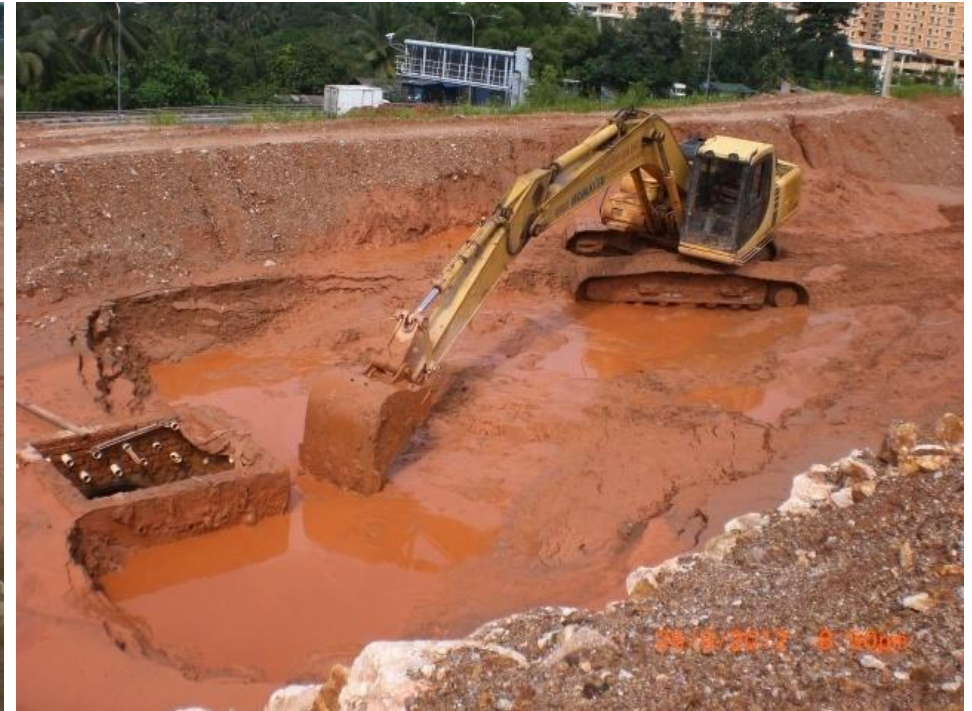
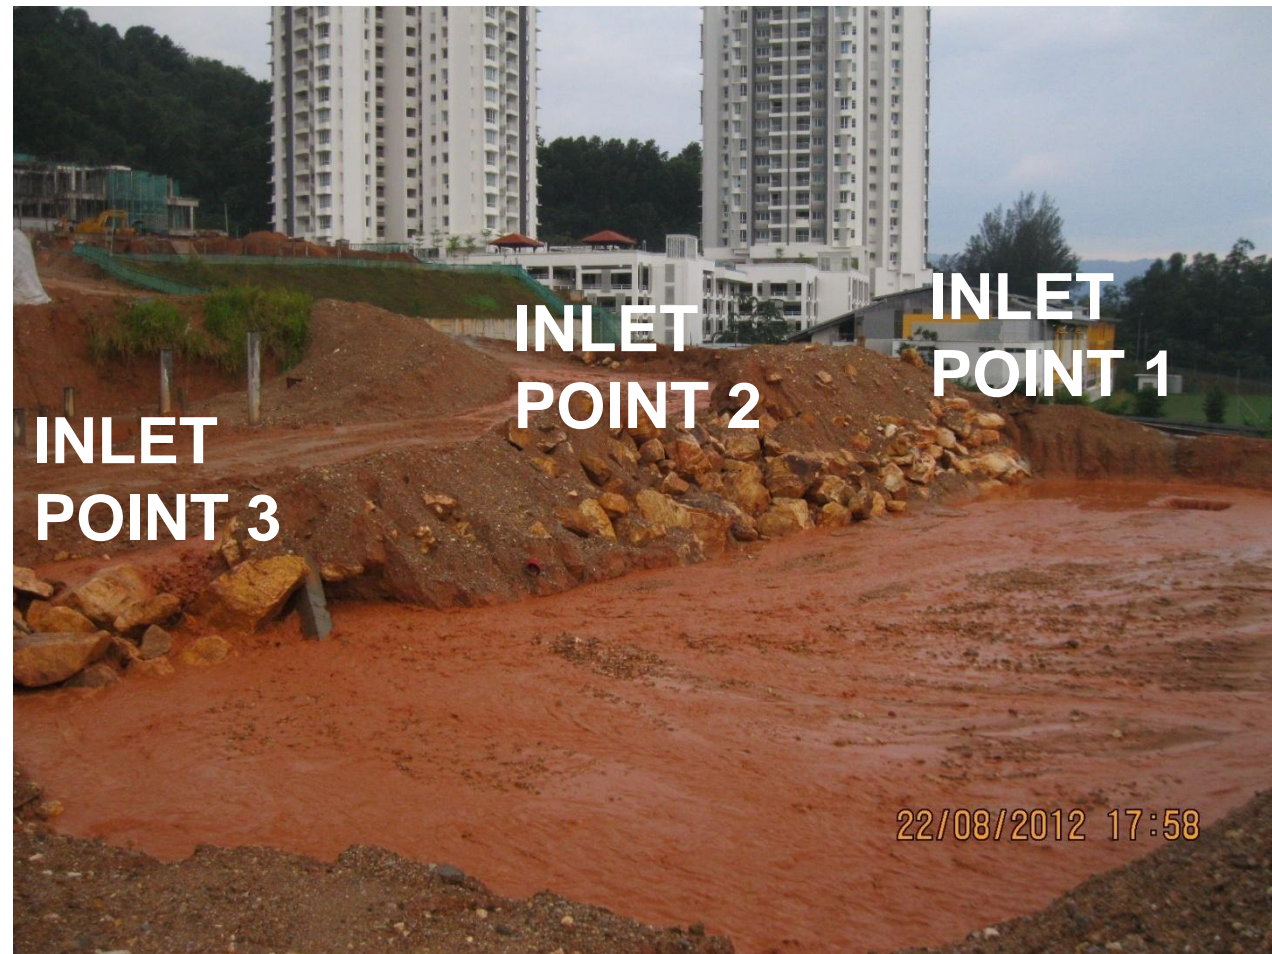
## Sediment Basin 2

- ◆ Shall follow standards and specifications been set.
- ◆ Overload or under capacity.
- ◆ Construct many more.
- ◆ Establish forebay and baffles.
- ◆ Make use of PAM.

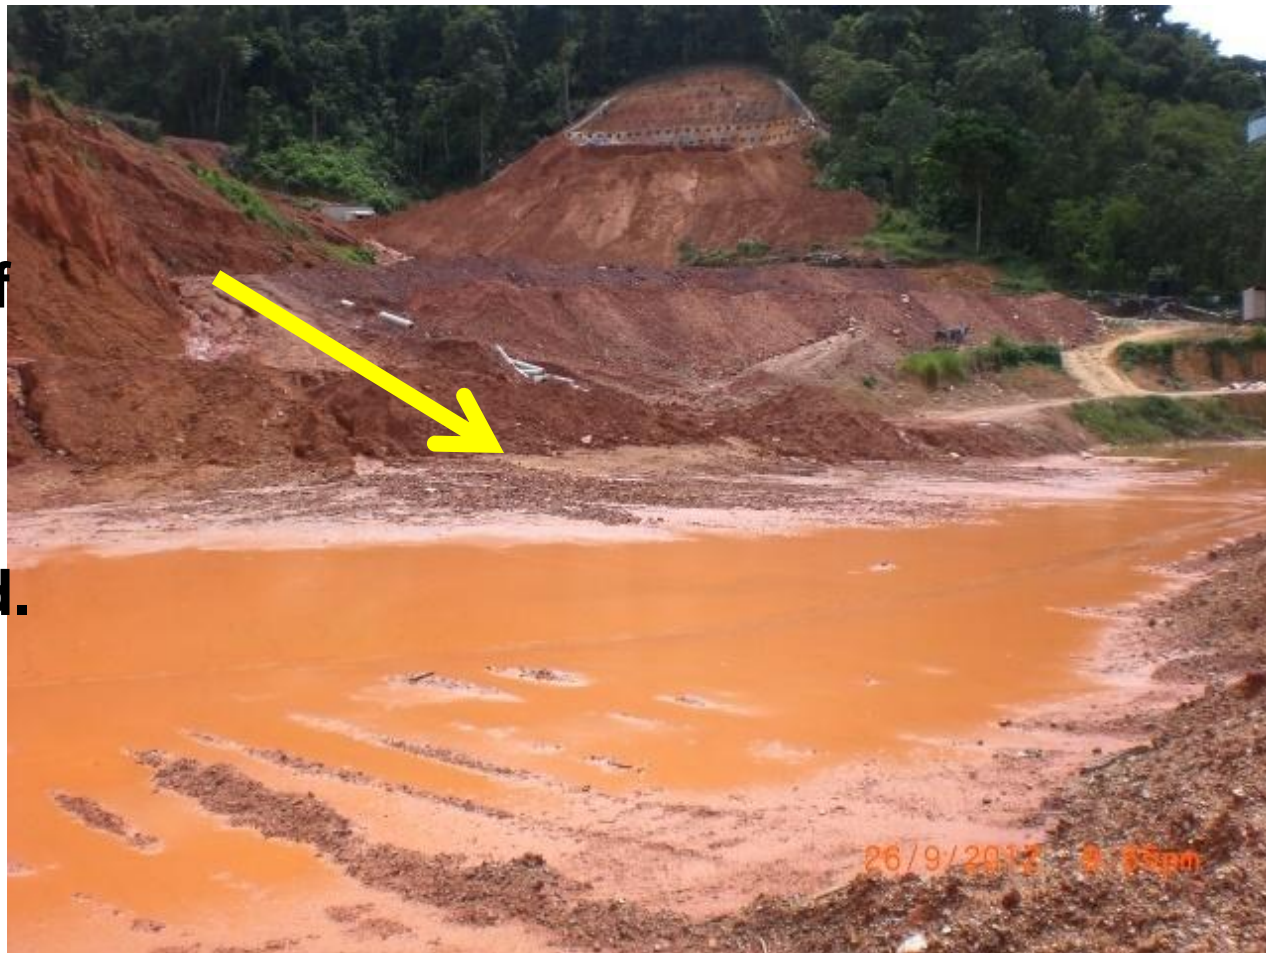
## Sediment Basin 3

Evidently direct sediment-laden runoff flows down steep sloping access road.

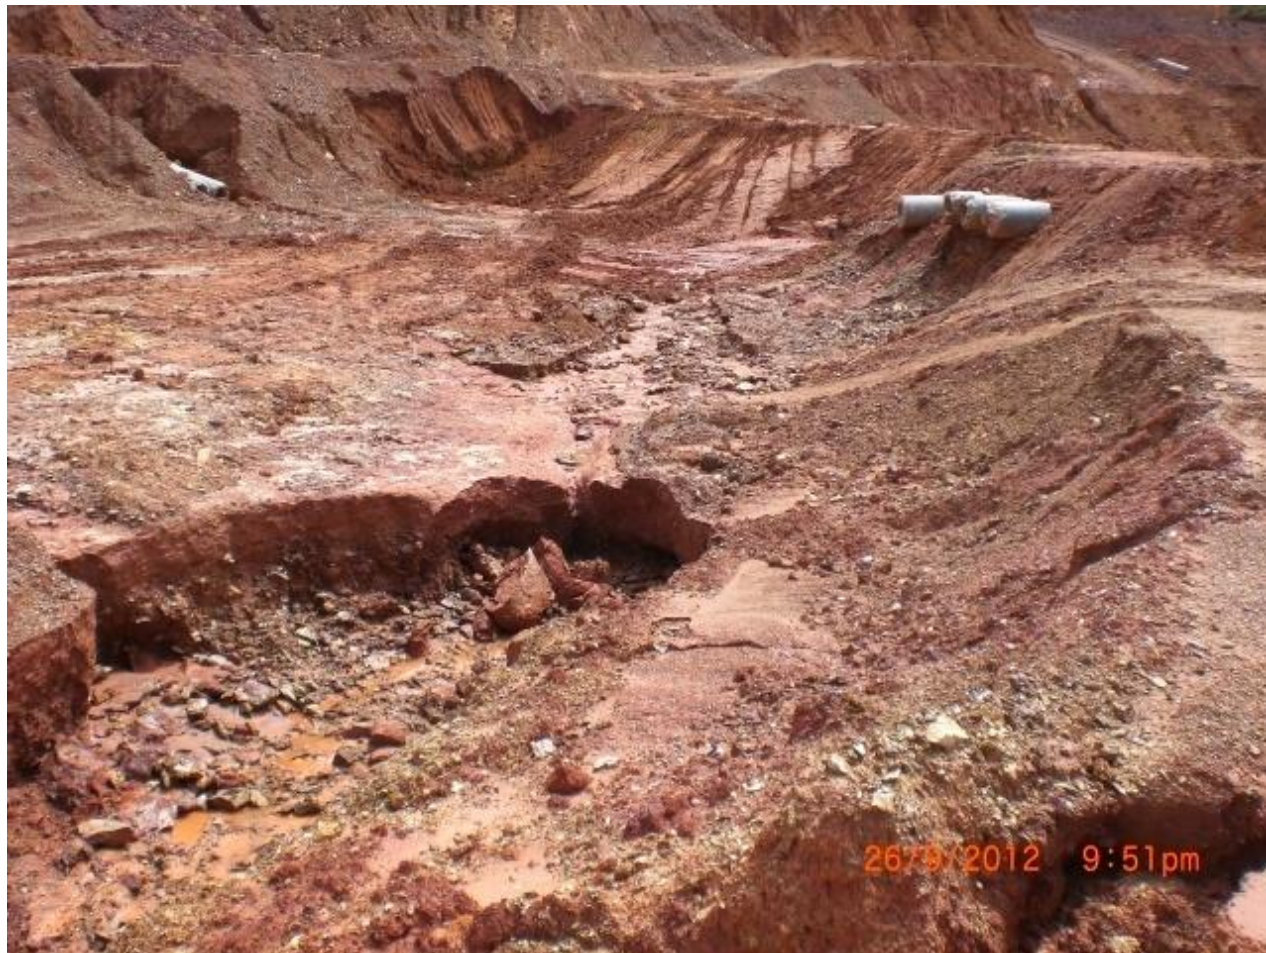
## A suitable location to construct additional sediment basin after SB3

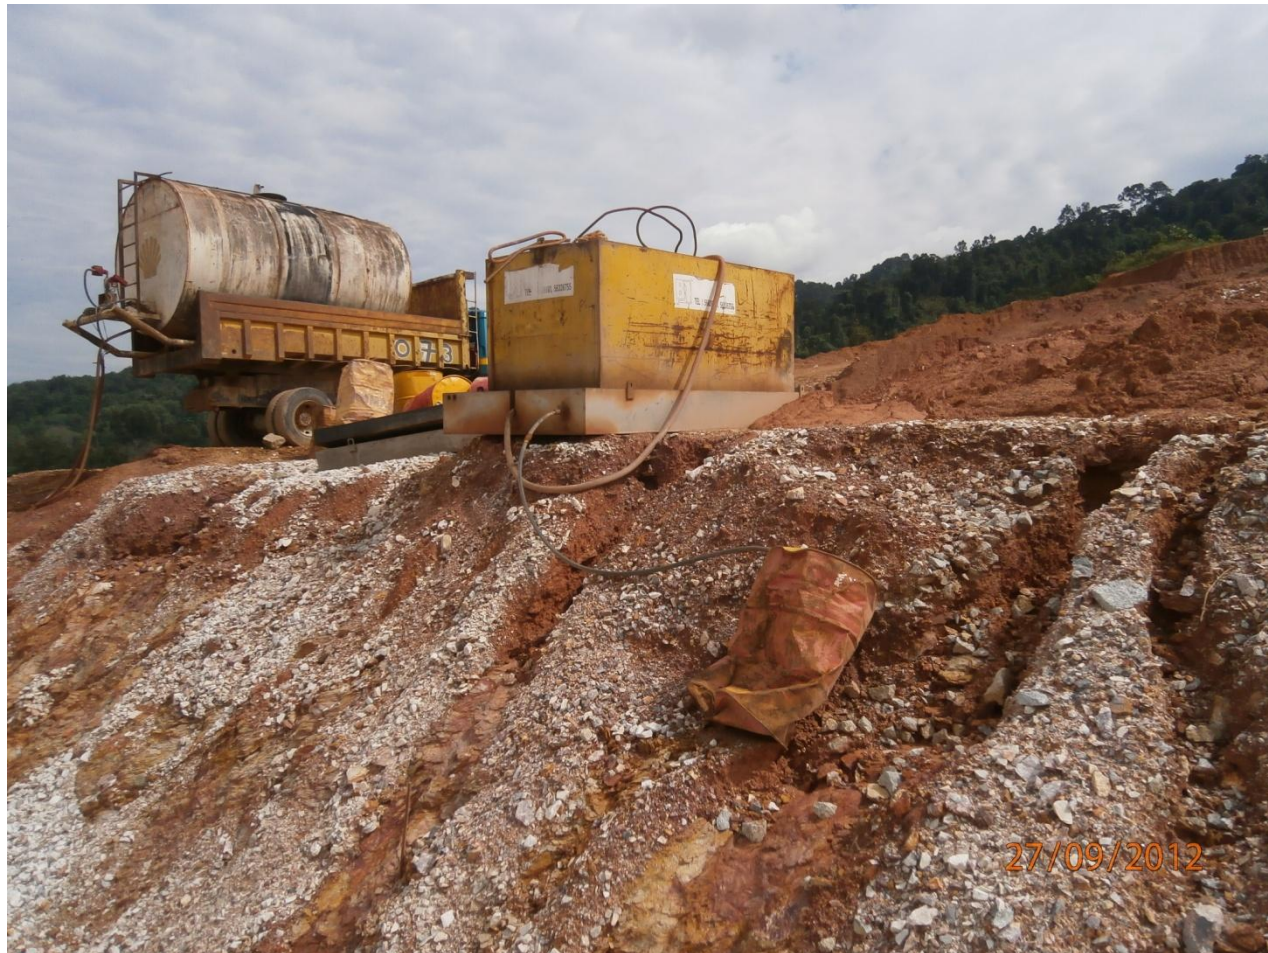
# Bad Location

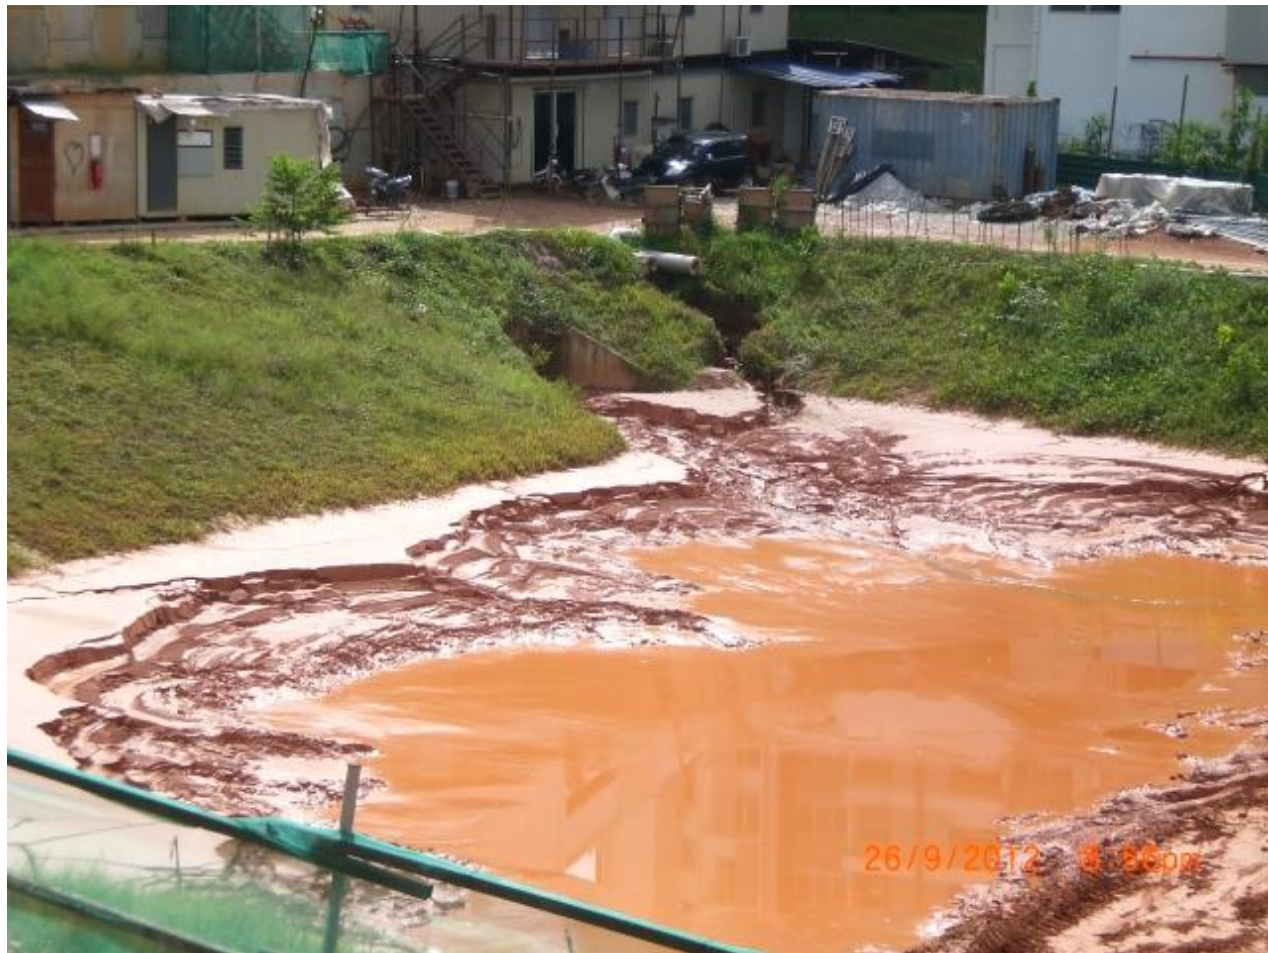
# Just imagine the thickness of the silts
